REAL-TIME STRUCTURAL MONITORING OF BIBI-KHANUM IN SAMARKAND (UZBEKISTAN) COMBINED WITH SUBSEQUENT LASER SCANS

SHAKHZOD M. TAKHIROV^{1*}, ILYAS ARIPOV² AND DAVRON MATRASULOV²

Keywords: Structural Health Monitoring, Seismic Assessment, Laser Scanning, Seismometers, Real-time monitoring, Bibi-Khanum, Samarkand, Great Silk Road.

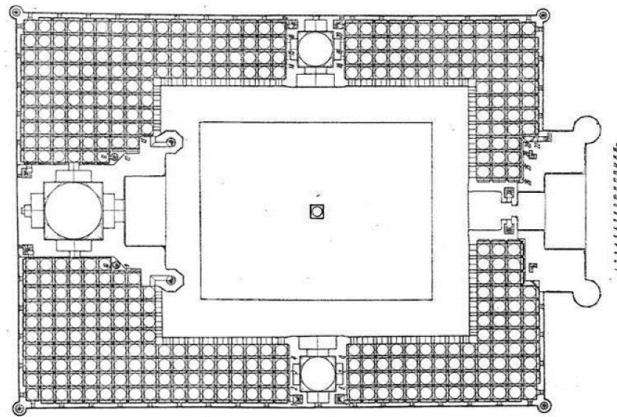
Figure 1: Plan view of Bibi-Khanum Mosque (after [1])

The Bibi-Khanum Mosque was originally built in 1399-1405 and was one of the largest and most magnificent mosques in the Islamic world during the 15th century. The heritage structure was studied by Rattiia in the 1940s. Based on these studies, Rattia developed the first restoration plan drawings in his book published in 1950 [1]. One of these drawings is reproduced in Figure 1. As shown in the plan drawing, the Bibi-Khanum Mosque was built as a courtyard ensemble with three domed masonry structures (mosques) along the walls. The main mosque is located on the west side, and two smaller mosques are located along the north and the south walls. The Bibi-Khanum Mosque was also studied in [2].

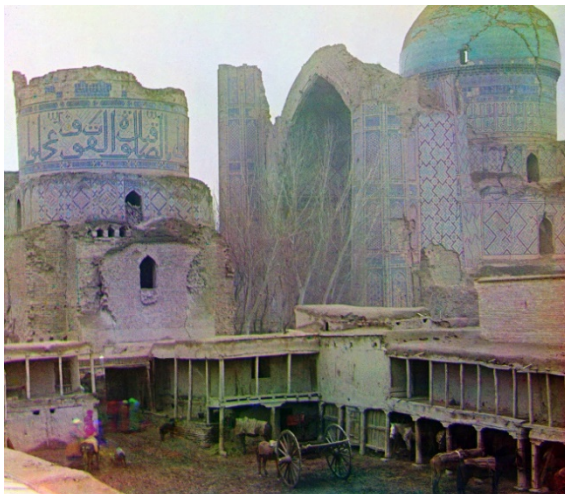
a) Photo dated by 1905-1915

The photograph presented in Figure 2a was taken between 1905 and 1915 by color photography pioneer Sergei Mikhailovich Prokudin-Gorskii. It shows the mosque's appearance after its collapse in the 1897 earthquake. Figure 2b shows its aerial view taken from Google maps.

One of the most recent studies on its history and architecture is published in [3]. In recent years, the monument underwent several complex reconstructions and some of them are mentioned in [4]. Among many other major restoration activities, the inner arch of the portal that collapsed in the 1897 earthquake was restored. The view of the monument at the beginning of the twentieth century is presented in Figure 2a.

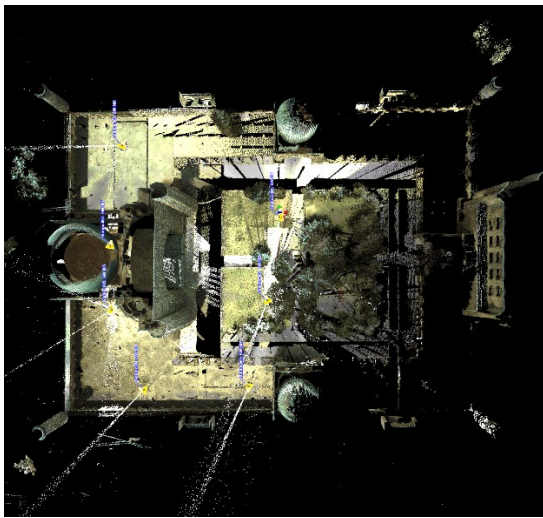
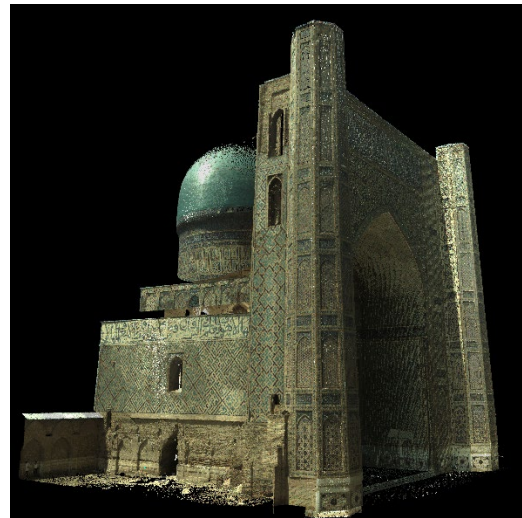
Figure 3: Fully registered point cloud combining seven stations

a) TruView with stations

b) Ground view of point cloud: main mosque

The scanning was conducted from seven stations to capture the exterior and interior walls of the monument. No reference targets were used in the laser scanning process. To stitch the point clouds collected from each station, a point cloud to point cloud matching was utilized. A complete registration of the point clouds collected from these seven stations is presented in Figure 3a and the registration was conducted in Cyclone [6]. Figure 3a also shows the locations of the stations (yellow triangular icons) on the fully registered point cloud of the monument. The point cloud was colored based on the photos obtained from the scanner's built-in camera. Figure 3b shows a typical point cloud of the mosque with its natural colors. A view from the ground level is shown here.

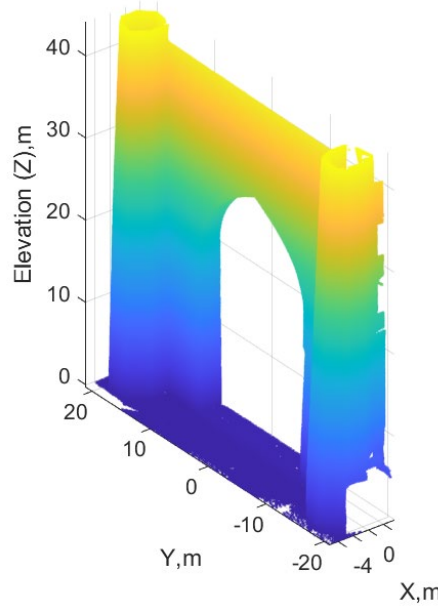
The portal of the main mosque is presented in Figure 4. A new coordinate system with the

origin at ground level and coinciding with the middle of the portal's arch was introduced.

Figure 4: Main mosque's portal

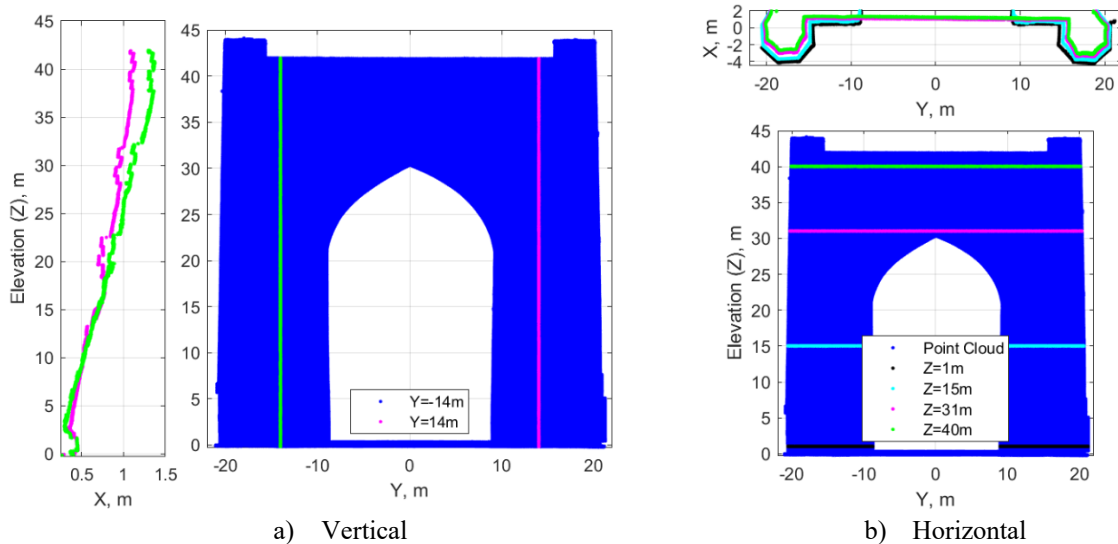
Figure 5a shows cross sections of the portal's front surface. The images quantify the inclination of the surface that can be also related to the wall's taper. Figure 5a shows vertical cross sections, whereas Figure 5b presents horizontal cross sections. The largest difference of inclination on the top of the portal is about 0.25 m between the sections at $Y=-14$ m and $Y=14$ m. Most likely this difference in inclination is related to the age of construction and does not represent any structural concern as it did in the case of the Kuk-Gumboz monument in Shakhrisyabz (Uzbekistan) [8]. Nevertheless, subsequent laser scanning expeditions are planned to ensure that this difference in the inclination does not progress.

Figure 5: Cross sections of the frontal surface of the portal

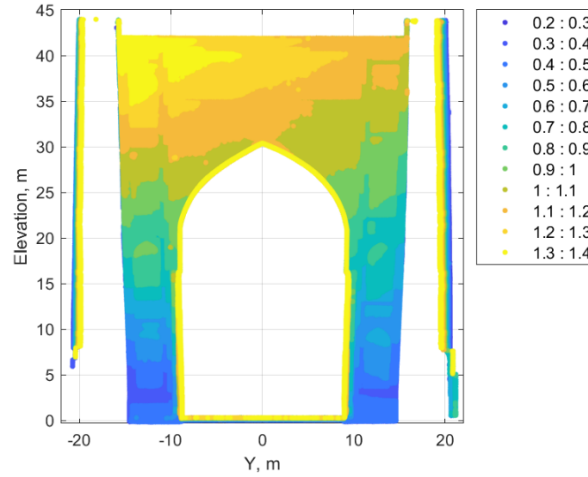
Figure 6 shows a contour map of the inclinations of the portal. The points are colored based on the distance from the vertical plane. This color map clearly shows the difference in the inclinations on the left and right sides of the portal as was mentioned earlier in the example of the two vertical sections. As shown in the image, the inclination of the portal is gradually increasing towards the top left side. Since the region of interest is relatively narrow, the minarets on both sides of the portal are not presented in Figure 6.

Figure 6: Color map of portal's inclinations (legend's units are meters)

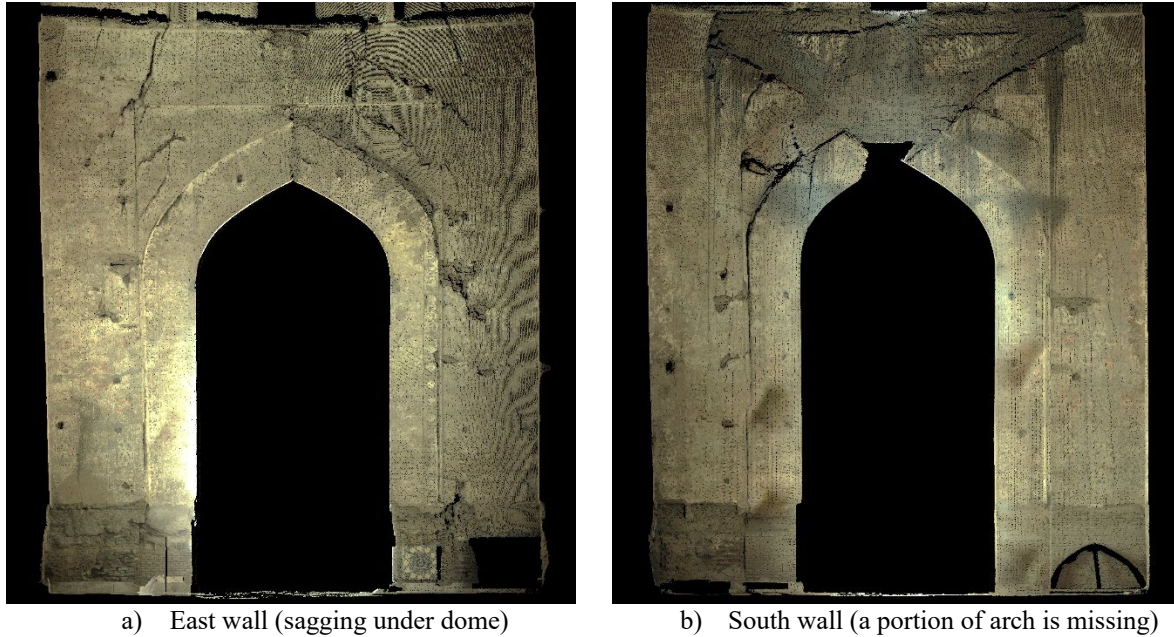
Analysis of the walls' point cloud is discussed herein. Due to the size limitations of this paper, only two walls of the main mosque are discussed below. The inner surface of the east wall is presented in Figure 8a. It shows a sagging in its top middle portion right under the dome. Several cracks serve as evidence that the structural integrity of this wall needs to be investigated and addressed. In the case of the south wall shown in Figure 8b, there is no sagging, this most likely relates to a concrete retrofit that is incorporated into the wall.

Figure 8: Analysis of point clouds (main mosque's inner walls)

As can be seen from the right image, a large volume of reinforced concrete was introduced above the arch. The arch is missing a piece at its tip. The reinforced concrete is most likely very beneficial for holding together the failing parts of the wall; however, it may result in an introduction of a large weight at higher elevation of the building due to the large difference in density of concrete and masonry. The latter can result in significant changes in the dynamics of the whole structure. In the earlier studies [9, 10] an experimental investigation of a typical brick material was conducted. The test results show that the density of the bricks is about $1,600 \text{ kg/m}^3$. The latter test results are consistent with the results obtained for the bricks recovered from heritage buildings in Europe [11]. Hence, the bricks are about 1.5 lighter than the reinforced concrete, the density of the latter is typically assumed as $2,400 \text{ kg/m}^3$.

The following conclusions can be drawn from the analysis of the walls' point clouds. There is a large difference between the east and south walls that will result in a difference in their structural performance under static loads. In addition, a large mass of reinforcement in the south wall can result in large differences in structural performance during seismic events.

To assess the performance of the building with such large irregularities, extensive monitoring is required. The latter is addressed by utilizing seismometers at critical locations throughout the monument.

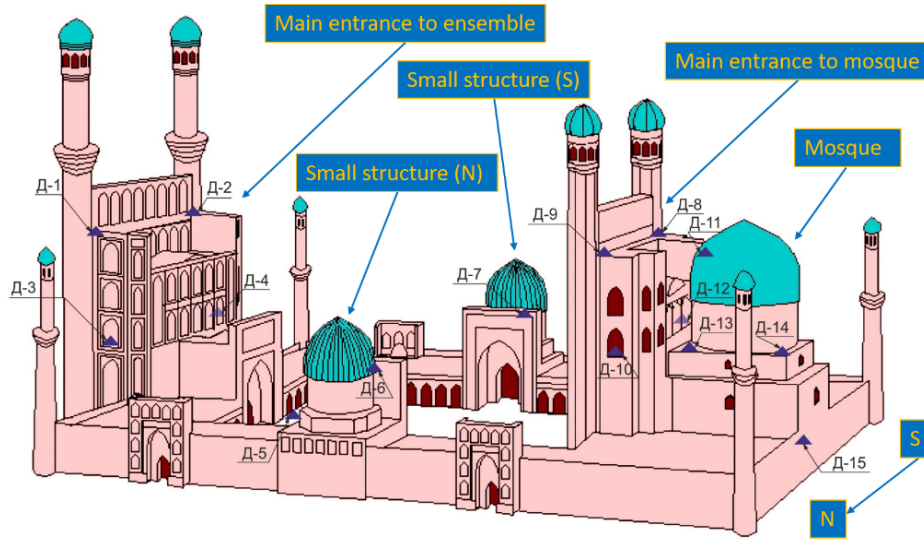
A layout of the instrumentation is presented in Figure 10. As seen in the image, fifteen tri-axial seismometers are installed at strategic locations throughout the monument. The main entrance portal to the whole ensemble is instrumented by four seismometers. Smaller structures on the north and south sides of the ensemble are instrumented by three seismometers. The mosque is instrumented by eight seismometers, from which four seismometers monitor the vibrations of the mosque's portal and the other four seismometers are installed on the main structure of the mosque. The latter set includes one seismometer to monitor the dome's

vibrations. A summary of the accelerations' locations is presented in Table 1.

Figure 10: Preliminary layout of seismometers

The instrumentation layout shown in Figure 10 was considered to be the first step in determining of the best possible location for the seismometers. In the next step of the study, a finite element model of the monument will be developed which will reflect all anomalies captured by the laser scanner. The finite element model will be calibrated by utilizing the ambient test data collected from the instruments at the locations presented in Figure 10. As a result, a finite element model closely replicating the actual monument will be developed. The model will be used in the optimization process to identify the best locations for the seismometers. Depending on the results of this optimization study, the seismometers will be rearranged at the newly identified locations. Based on the results of ambient vibration tests from the new locations, the finite element model will be updated. This part of the project is ongoing.
