Study on Reinforced Concrete Slabs Subjected to low velocity impact - The method of preventing scattering debris by steel deck plates -

Key words: Steel Deck, Steel Pipe, Reinforced Concrete Slab,
Impact Test, Finite Element Analysis

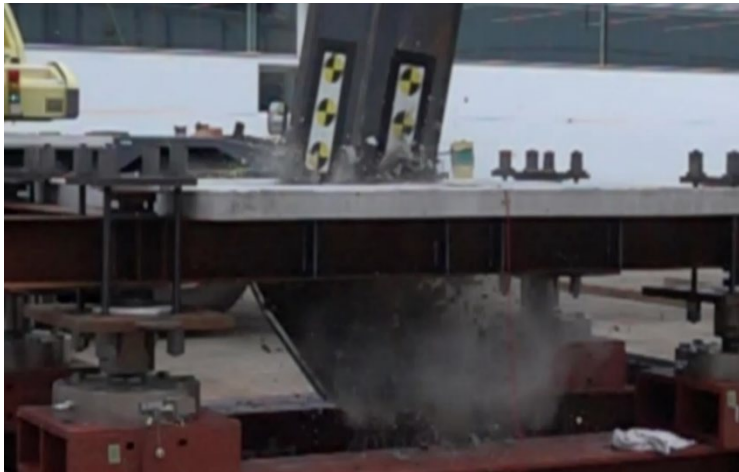
Figure 5: Result of impact test (N-13)

Figure 5 and Figure 6 show the test result of N-13 and F-13. In N-series, deck plates fell off and debris of broken concrete scattered below the RC slab in all cases. In F-series, the deck plates did not fall off and debris scattering was prevented in the cases the drop height is 13m and 14 m. It was confirmed that this anchoring system can prevent debris scattering even when the projectile is dropped from about twice the height of that without it. Even when the anchoring system was installed at the end of the deck, the deck fell off and debris scattered to the backside of the RC slab in the case of F-15, where the drop height was 15 m.

(a) The moment of impact

(b) Close view of impact area

(c) Close view of deck end

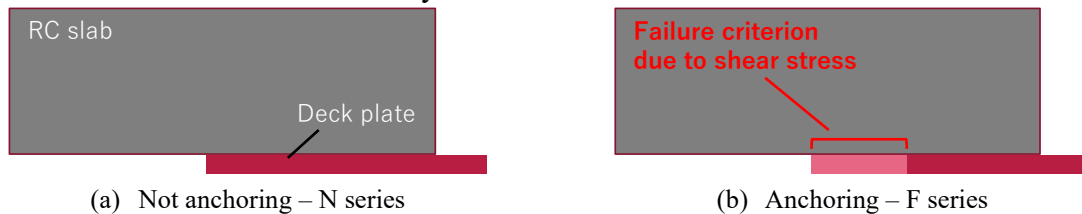
Figure 8: Modeling of deck plate end

Figure 8 shows an overview of the modeling of the anchoring system. The folded-up shape of the deck end was not modeled but was assumed to be the same as that without the anchoring system. The deck end has a failure criterion due to shear stress acting between the concrete and the deck end to express the anchoring system. An overview of the detachment criterion is shown in Figure 9. Based on the parameter study, the shear stress at the start of detachment was set at 4.0 MPa. The distance at which the reaction force is zero was set to 30 mm, and the distance between the two was modeled linearly.
