# Assessment of Nourishment Project at the Maresme Coast, Barcelona, Spain

Antonio Lechuga  
Coastal Department  
CEDEX- Ministry of Fomento, Spain  
Antonio.Lechuga@cedex.es

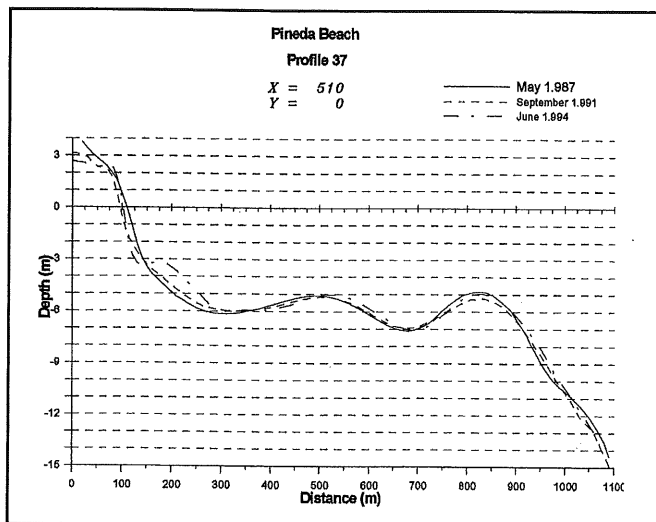
Figure 7. Three bar system at Profile 37, Pineda Beach.

This beach has a three-bar system. The shoreward bar is barely detectable. The intermediate bar is located 450 m from the shoreline. The seaward bar is 750 m from the shoreline. In both cases, the crest depth is 5 m. The submerged slope is 4.5% seaward of the outside bar (Figure 7).

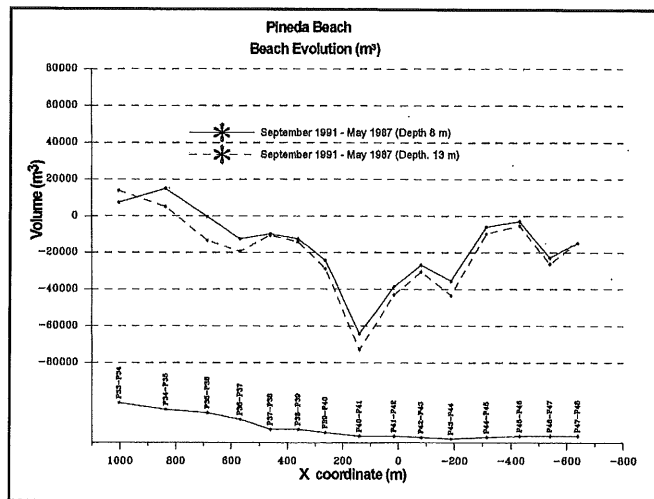
Figure 8. Volume changes between surveys at Pineda Beach, showing computations using different closure depths.

The erosion was computed using the closure depth of 13 m. Another point is that most of the erosion took place between 1987 and 1991. The beaches began recovering to a certain extent after 1991 (Figure 8).

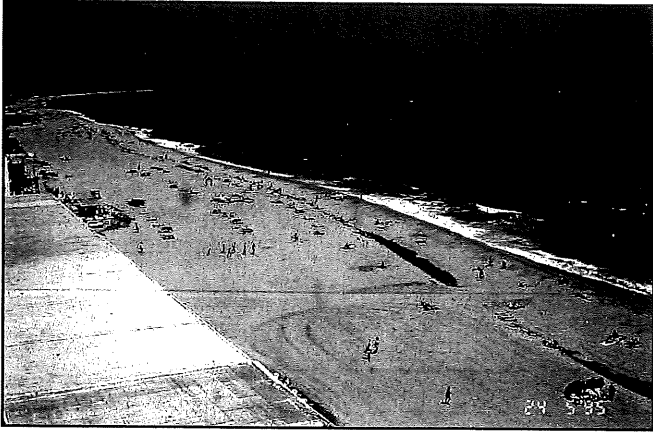
Figure 9. Picture of Malgrat Beach after the last nourishment (1995). To the left is the Tordera River.

Overall, it has been concluded that the beach nourishment has been successful for two reasons. First, of course, is that the area had been degraded prior to the replenishment, so the improvement has been a remarkable benefit for recreation and for protection of the railway (Figures 9 and 10). Second, the borrow

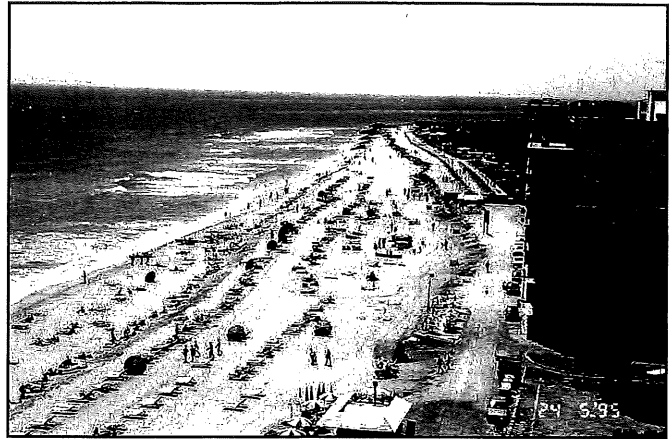
Figure 10. Picture of Malgrat Beach (1995) to the south. We can see the convex zone at Bon Repos.
