# STRUCTURAL EVALUATION AND MAINTENANCE OF GREENHILL MINE TIPPLE STRUCTURE HISTORIC SITE

**Abstract.** *The tipple building located within the Greenhill Mine complex (a Provincial historic site) in southern Alberta, Canada is a reinforced concrete frame with a steel superstructure. The structure has been analyzed to assess its current state and the extent and causes of deterioration. The analysis is performed using data obtained from field and laboratory tests and evaluations and by using SAP2000 structural analysis software. Possible ways for conservation and restoration of the building for two different future uses are explored, and recommendations are provided.*

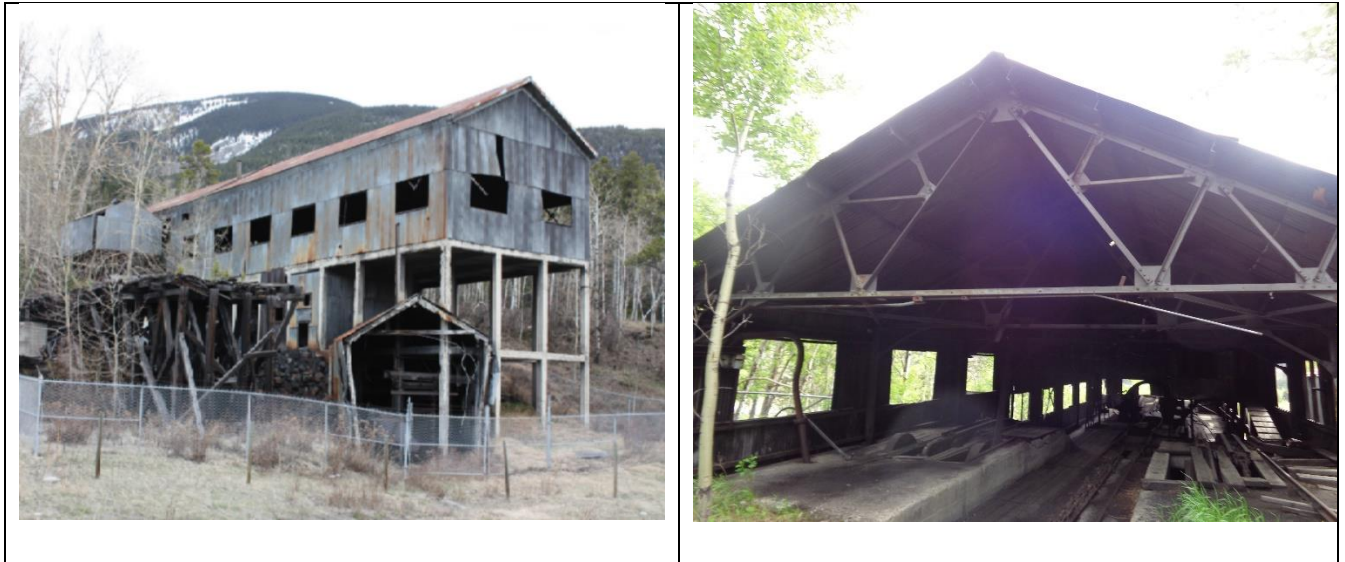
**Figure 1:** Overall view of Greenhill mine tippie structure and its roof trusses

The primary tippie building consists of a concrete moment frame supporting a steel superstructure. The steel superstructure consists of Fink trusses at the roof (Figure 1) built from double angle chords, single angle web members, and channel purlins.

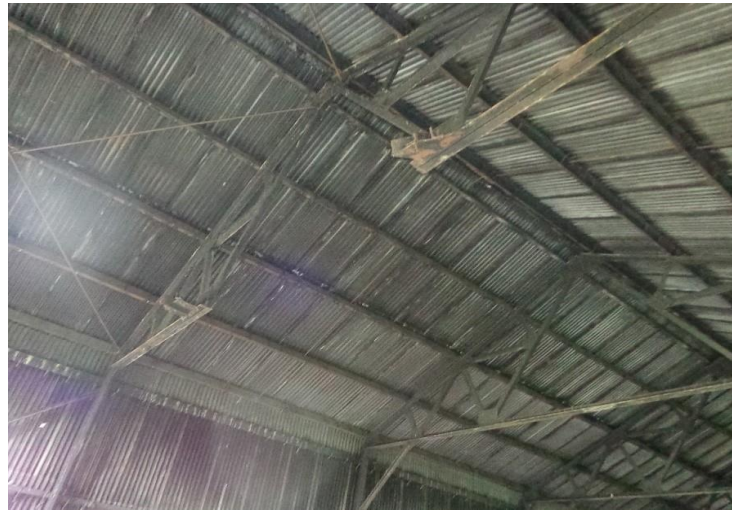
**Figure 2:** Roof truss with part of the bottom chord removed

The columns of the steel superstructure are built-up members of channels and angles. Single angle braces located at two bays on each side of the building provide lateral load resistance in the longitudinal direction. Some parts of the braces, as well as some steel elements of the roof trusses, have been removed at some unrecorded time in the past (for example Figure 2). No lateral load supporting system exists in the short direction of the superstructure and it is not clear if any bracings existed originally in that direction, as there are no records of design, construction, alterations or maintenance. As a result, only moment frame action of the steel columns provides lateral resistance in the short direction. Thus, additional bracings have to be provided in the short direction to ensure the stability of the superstructure. This issue is discussed later.

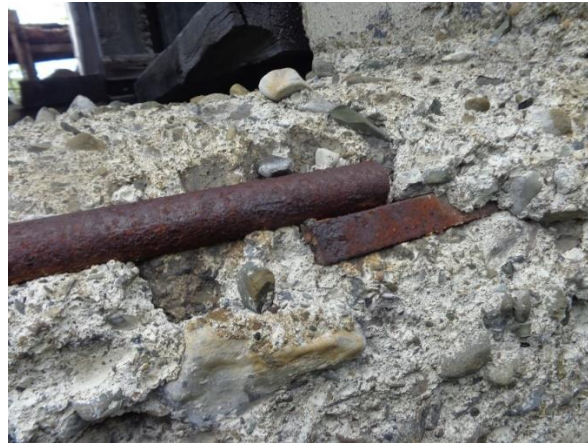
**Figure 3:** A round bar overlapped with a square bar in a splice. Also note variation in aggregate size and shape

The steel superstructure was built on a 200 mm-thick concrete slab, which is supported on an exposed concrete frame with 300 mm square concrete columns and beams. The beams and columns are each reinforced with at least four round rebars of 20 mm diameter. Bars of different dimensions and sections were used with inadequate lap splicing (for example, see Figure 3).

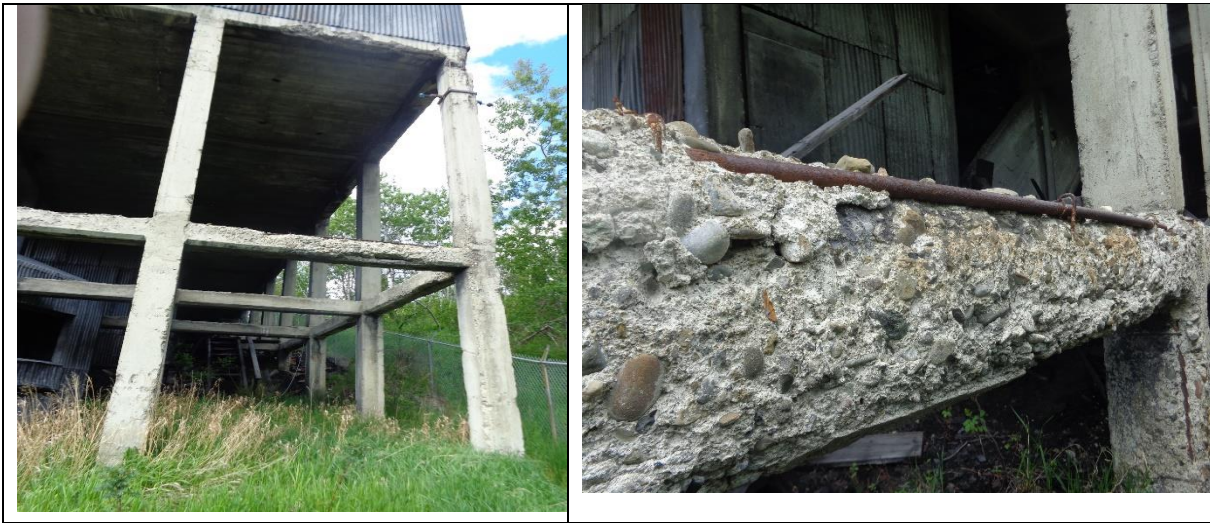
- 1- Section loss and spalling due to freeze-thaw in concrete columns
- 2- Removed members in the steel superstructure
- 3- Section loss and spalling due to freeze-thaw in concrete beams

**Figure 4:** Signs of deterioration on concrete members

Based on the results of structural analysis and the section properties of the concrete members, and due to satisfactory past performance of the building under similar or higher loads for more than 100 years, according to Commentary “L” of the NBCC [3], no further strengthening other than repairing the deteriorated members to their original shape and protecting them from further deterioration is required for this case. Thus, the damaged beams and columns should just be repaired with compatible and durable material, and a coating applied to protect them from the ingress of water and other damaging materials as well as freeze-thaw cycles. Accumulation of water has to be avoided in the top of the beams, the bottoms of columns, footings and other susceptible areas by providing proper slopes and drainage systems.

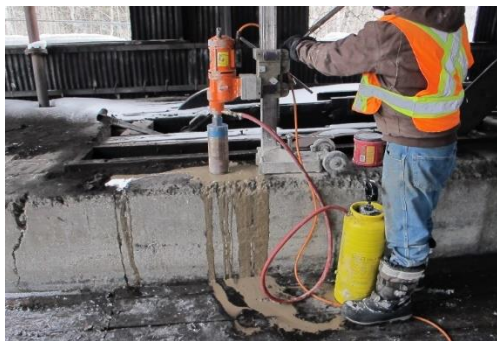
To investigate the condition of the structure further, field sampling was performed (Figure 5). To avoid inclusion of steel reinforcement in the concrete samples as well as to identify the location of rebars in the concrete for further analysis, a ground-penetrating radar scan device called “structure scan” was used during the sampling process (Figure 6). “Structure scan” is manufactured by GSSI (a member of the OYO group) and can find the location, depth, and size of reinforcing bars as deep as 500 mm. The existence of large size aggregate particles in the concrete caused some difficulties such as the failure of several cores during the sampling process. Fourteen concrete cylinder cores were obtained. Six cores had a diameter of 95 mm (3.75 inches), and eight had a diameter of 70 mm (2.75 inches). The core samples were cut wet with diamond cutters. The sample holes were filled with a cementitious mortar.

**Figure 5:** Concrete sampling

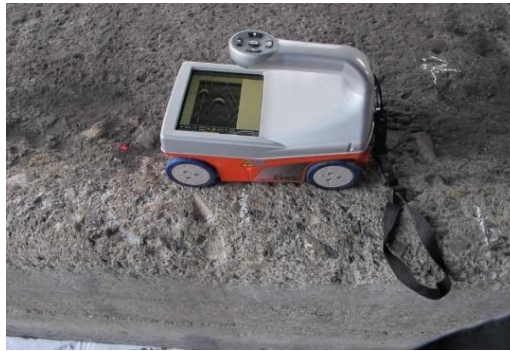
**Figure 6:** Ground-penetrating radar scan

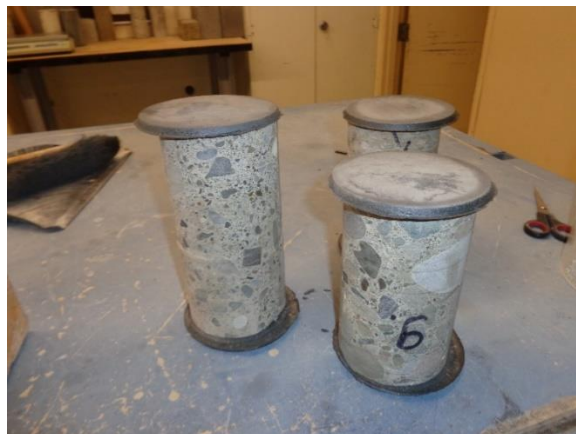
Three core samples were tested to obtain the compressive strength of the concrete. Samples were prepared for the compressive testing by cutting the ends with a 20" masonry saw. The ends were then glyccapped (Figure 7), and the samples tested according to ASTM C-39.

The compressive strengths obtained from the three core samples were 12.1, 23.4 and 17.9 MPa, so the equivalent compressive strength of the concrete for the Greenhill mine structure based on ACI standard 562-16 (Code requirements for assessment, repair, and rehabilitation of existing concrete structures) was calculated to be 15 MPa [2]. This value was used as the initial concrete compressive strength in the analysis and strengthening of the structure. The average mass density of the concrete samples was 2323 kg/m<sup>3</sup>.

**Figure 7:** Preparation of samples for compressive test. Note the large aggregates in the samples

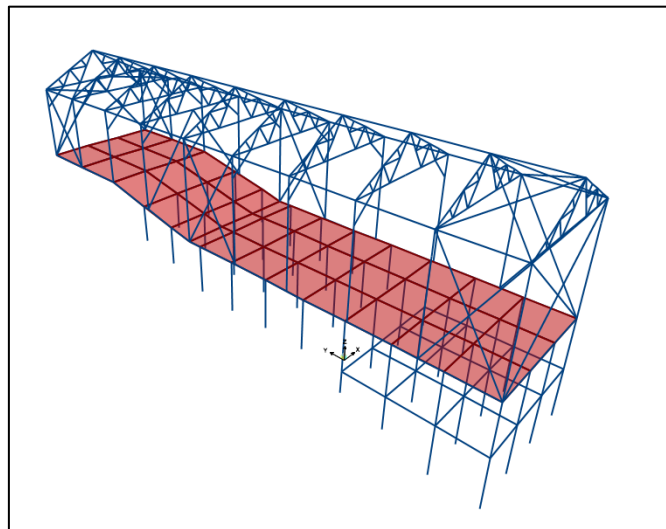
For the case of adaptive reuse as a restaurant, a live load of 4.8 kPa and superimposed dead load of 1 kPa in the main floor were considered based on NBCC 2015. The missing steel members of roof truss were replaced, and steel bracings added in both directions of the building to ensure the stability of the steel superstructure. Figure 8 shows the structure modelled.

Figure 8: The structural model of Greenhill building in SAP2000

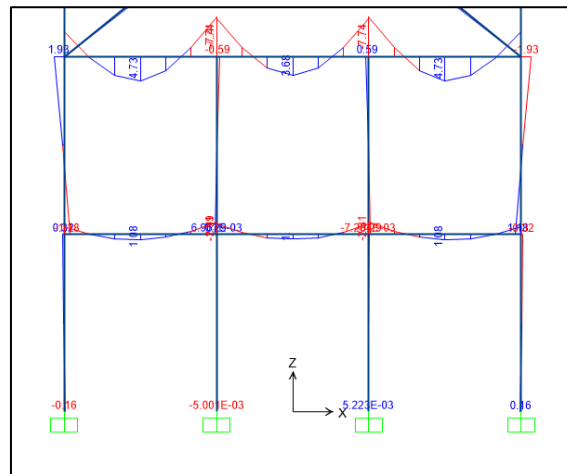
with respect to the ability of the structure to provide alternative load paths in the case of a local failure, such as losing a column due to an accident, overloading, deterioration, etc. This criterion was checked in the structural analysis of the building and effect of the most severe local failure (losing a corner column) was added to the results of other load combinations. Examples of the axial forces and bending moments due to some load combinations are shown in Figure 9.

2- Columns: The columns are slender and in a sway frame. Based on the site inspections, they do not satisfy minimum code requirements for transverse reinforcement (ties). They are subject to a maximum combined axial load of 170 kN compressive load and 21 kN-m bending moment. In some extreme cases, the column can be subjected to 120 kN tensile force (uplift) combined with 23 kN-m bending moment.

**Figure 9:** Bending moment in members due to applied vertical loads (Max=10 kN-m)

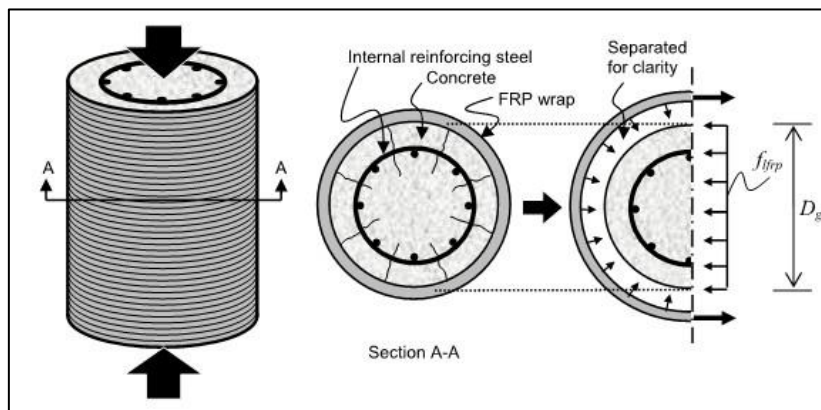
Confining concrete columns with externally-bonded FRP (EB-FRP) wraps is an effective way to improve the behaviour of concrete columns in several ways such as increasing column axial load capacity, preventing buckling of reinforcement bars, reducing the lap length required for the rebars, and reducing the rate of water ingress into concrete which slows the rate of steel corrosion (Figure). FRP wrapping also improves the ductility of the member which is beneficial in the dynamic and seismic response of the structure.

**Figure 12:** Confinement mechanism for the axial strengthening of circular concrete columns using externally bonded FRP wraps [7]

Given the new occupancy and loadings and existence of uncertainties in quantity and quality of concrete and rebars in the members, and to satisfy the life safety requirement in respect of the reuse of the structure, it would be preferable to strengthen the columns and make sure about the structural stability and integrity of the tipple building. It can be observed that confinement by FRP wraps can theoretically increase the compressive strength of the concrete in the columns from 15 to 20.7 MPa. The compressive strength of the columns could be further increased by circularization of the existing rectangular-shaped columns which will increase the effectiveness of confinement by FRP wraps.
