CLASSICAL STRESS ANALYSIS OF A FUSE PLATE THAT FAILED DURING HURRICANE MARÍA IN PUERTO RICO¹

Juan C. Morales², Jey N. Sánchez³, Seira N. De Jesús⁴, Jorge A. Caraballo⁵

Keywords: failure theory, fuse plate, hurricane, breakaway sign, stress analysis

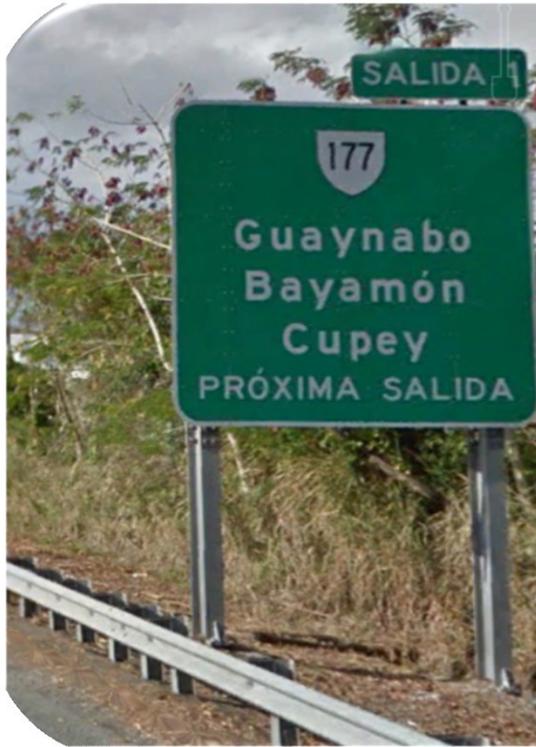
Figure 3: (a) Sign used in the case study, as it looked before hurricane María. It was located on PR-52 between PR-199 and PR-177 in the direction from Caguas to San Juan. Photo obtained from Google Earth, Street View. (b) The remains of the sign after María. Only the left posts survived (upper and lower). The fuse plate indicated in the photo was removed before the remains were scrapped. The torque required to unfasten the bolts was approximately 2200 lb; ft, using a 6 ft moment arm. Photo taken by first author.

The methodology was based on analyzing one specific case of a breakaway-type highway sign that toppled over during hurricane María (Figure 3a). A wind gust speed of 155 mph was assumed at the top of the sign. This was the measured sustained wind speed of María as it entered Puerto Rico. The yield strength and ultimate strength of the fuse plate were obtained experimentally with one tensile specimen machined from one of the fuse plates that ruptured. The actual fuse plate that was used is shown in Figure 3b. Finally, compare the stress analysis to an appropriate failure theory, discuss the results, and reach a conclusion

9. The size of the sign may be scaled off from the Google Earth photo (Figure 3a). The flange width of the post that survived (Figure 3b) was measured and served as the basis to determine the scale.

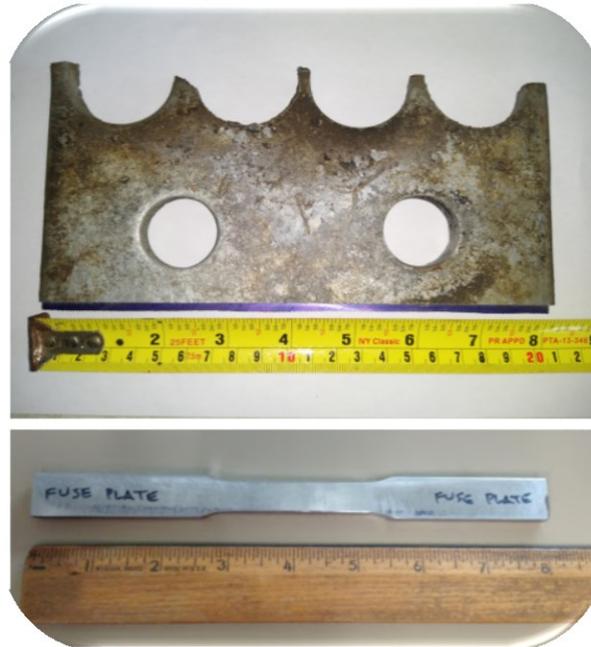
Figure 6: Actual fuse plate that failed and the specimen machined from the bottom of the plate.

The mechanical properties were determined by machining an 8-inch tensile specimen from the bottom section (below the bolt holes) of the actual fuse plate (Figure 6). The dimensions of the specimen were based on the ASTM A370 (2016) standard.

Two primary limitations were confronted in this study: 1.) Due to the limited amount of material (Figure 6), only one specimen was tested to determine the mechanical properties, i.e., an average from several specimens could not be determined. 2.) A wind gust speed of 155 mph at the top of the sign was assumed because the wind speed at the site remains unknown.

In addition, several of the assumptions used in the study limited the accuracy of the stress analysis. For example, the sign dimensions were scaled off from a photograph because the sign disappeared after María. Also, the study assumed that the holes in the fuse plate were equally spaced; however, Figure 6 clearly shows that they were not. The study also assumed that all points in the failure plane were equally stressed which may not have been the case.
