## THE STATE AND CONDITION OF HISTORICAL BUILDINGS LOCATED ON PARTISAN HILL IN WROCLAW

**Abstract.** *The paper presents fragments of original archival documentation, which are used to identify the historical outline of the colonnade building and the peristyle pavilion located on Partisan Hill in an old part of Wrocław. Traces of these buildings date back to the Middle Ages. The state of preservation of these objects was presented on the basis of conducted assessments, drilling cores, and non-destructive and semi-non-destructive tests. Much attention was devoted to the brick walls, brick and reinforced concrete ceilings in flat roofs, as well as to the elements of architectural detail. The presented results include tests of the moisture content and salinity of walls, tests of the compressive strength of concrete and distribution of reinforcement in ceilings. They constitute the first stage of activities that aim to restore the buildings to their former glory.*

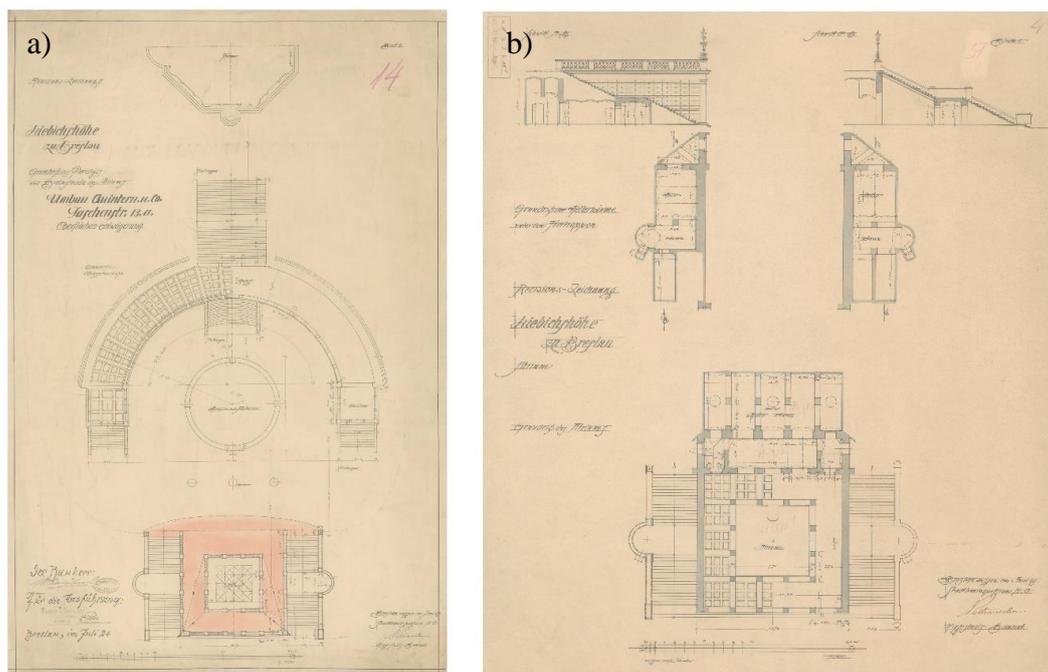
**Figure 2:** A fragment of the original documentation of the buildings that exist to this day: a) colonnades; b) the peristyle pavilion (source: archive of the Museum of Architecture in Wrocław)

In the 1860s, the hill was developed with a complex of entertainment and recreation buildings that were founded by Adolf Liebich and designed by the architect Carl Schmidt. The complex included a belvedere standing on a plateau with a lookout tower, and also a colonnade building (Fig. 2a) and a peristyle pavilion (Fig. 2b), which were integrated into a terrace on the western slope of the hill. The peristyle pavilion was located at the foot of the

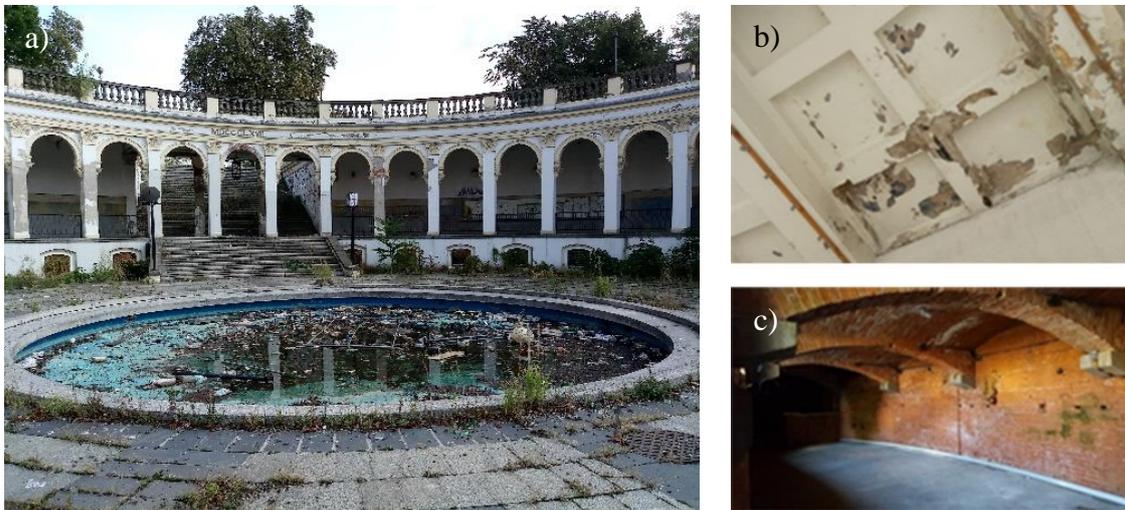
The colonnade building, which is shown in Figure 3, has two floors, one of which is mostly recessed in the ground. Its building area is about 460 m<sup>2</sup>. The walls of the lower floor are made of brick, and their thickness is in the range from 50 to 90 cm. The flat roof based on them has a brick ceiling in the form of arched vaults with ribs (Fig. 3c). In turn, the ceiling of the above-ground floor is slab-ribbed and partly based on walls and partly on brick columns with a diameter of 50 cm (Fig. 3b). Both flat roofs were made in around 1870 and they are accessible directly from the area adjacent to the building.

**Figure 3:** General view: a) the colonnade building (in the foreground is a swimming pool with a fountain); b) the slab-ribbed reinforced concrete ceiling; c) the basements and the brick ceiling

The brick construction elements of the basement, both the walls and the ceiling, are preserved in relatively good condition. They are free from significant damage in the form of wall cracks and deformations of arched vaults and ribs. However, they are very moist and covered with salt efflorescence and mold fungi. This is the result of a lack of vertical and horizontal damp-proof insulation, which was proved by the executed exposure works of the walls. In addition, due to excessive moisture, these elements have local losses of brick fragments and numerous places with crumbling of the mortar between the bricks.

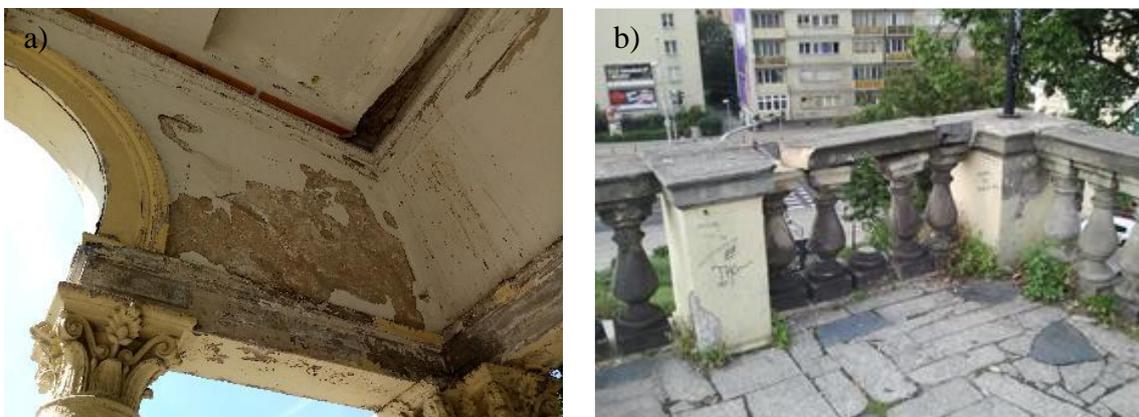
The brick elements of the above-ground structure, in particular its columns, are in a similar condition. They are also damp and show mortar crumbling between bricks on surfaces that are partially free of plaster. The reinforced concrete ceiling of the roof is also very damp. Its bottom surface shows numerous patches of corrosion in its reinforcement (Fig. 4b).

Elements of architectural detail, such as e.g. posts, balusters, the stucco decorations of arches and column heads, plasters, and also granite flooring are incomplete, damaged, or completely damaged, as illustrated in Figure 4.

**Figure 4:** View: a) damage to stucco and plasters in the colonnade building; b) incomplete elements of the balustrade and granite floor

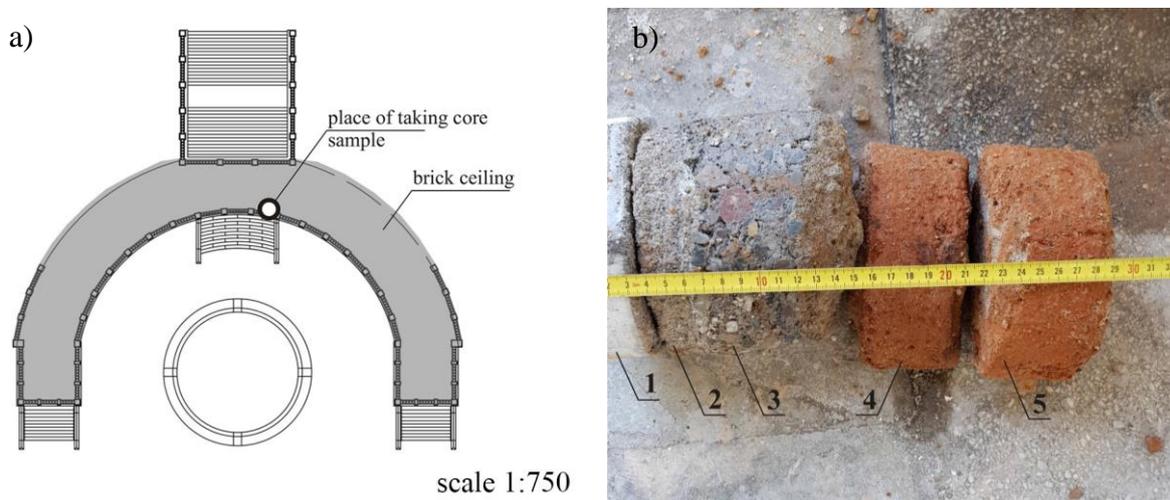
In both flat roofs of the colonnade building, semi-non-destructive testing was performed by taking core samples with a diameter of 100 mm in order to determine the layout of layers and their thicknesses. The places of taking samples, as well as the obtained core specimens, are shown in Figures 5 and 6. In the layout of the layers in the flat roofs above the floor embedded in the ground, which is shown in Figure 5, the lack of damp-proof insulation is noteworthy. In the layout of the layers of the flat roof above the ground (Figure 6) it can be seen several layers of concrete with different thickness, a layer of bituminous insulation, a layer of mortar and granite slab all laid on reinforced concrete ceiling slab.

**Figure 5:** Colonnade building: a) place of taking core samples in the flat roof above the floor embedded in the ground; b) flat roof system: 1- granite slab with a thickness of 30 mm, 2 - cement mortar with a thickness of 40 mm, 3 - concrete with a thickness of 100 mm, 4- brick vault with a thickness of 120 mm

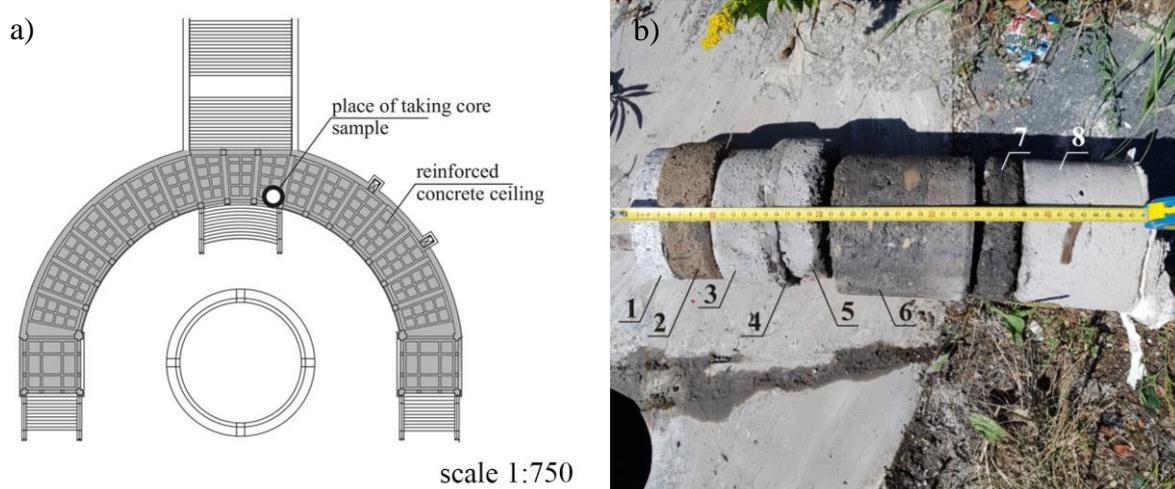
**Figure 6:** Colonnade building: a) place of taking core samples in the flat roof above the ground floor; b) flat roof system: 1 - granite slab with a thickness of 30 mm, 2 - cement mortar with a thickness of 45 mm, 3 - concrete with a thickness of 55 mm, 4- bituminous insulation with a thickness of 5 mm, 5 - concrete with a thickness of 40 mm, 6 - concrete with a thickness of 120 mm, 7 - concrete with a thickness of 30 mm, 8 - reinforced concrete ceiling slab with a thickness of 100 mm

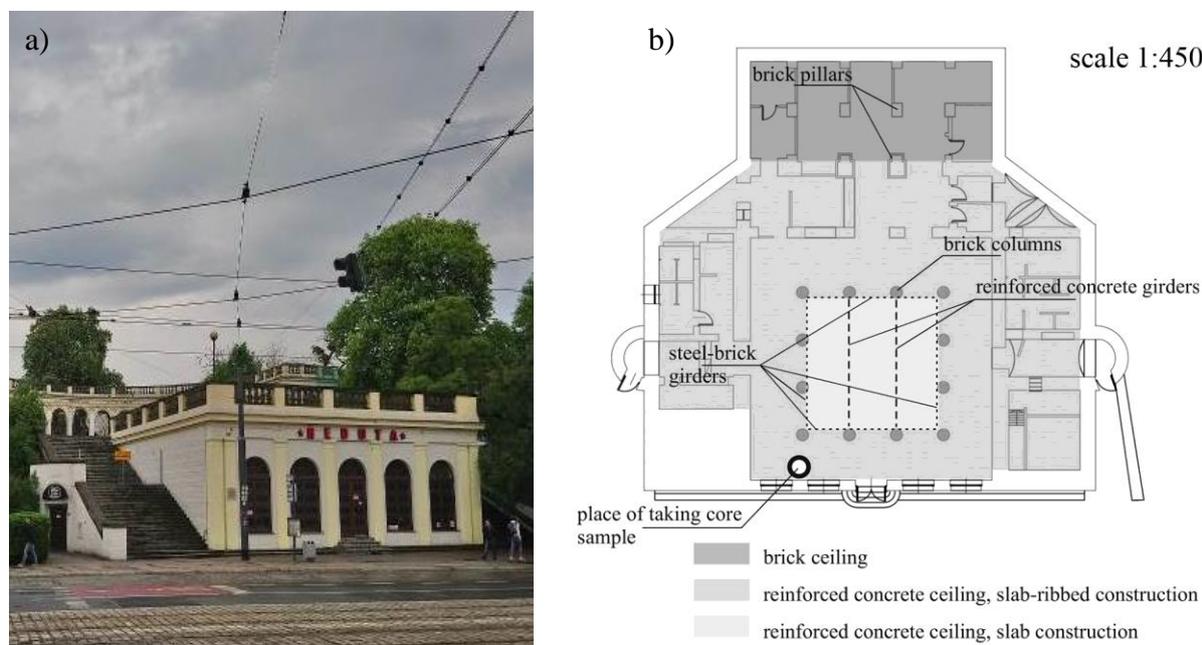
The peristyle pavilion is a one-story building with a building area of about 610 m<sup>2</sup>. It is on one side completely, and on two sides partially recessed in the ground. It is shown in Figure 7a. Its external and internal walls are made of brick with a thickness in the range of 50 to 70 cm. Inside the pavilion, there are brick pillars with a thickness similar to the thickness of the walls, as well as brick columns with a diameter of 50 cm.

**Figure 7:** Peristyle pavilion: a) view of the building; b) scheme of the projection with marked structural elements

The pavilion's ceiling is directly accessible from the adjacent area. It has a reinforced concrete, partly slab-ribbed, and partly slab construction, while the girders are reinforced concrete or steel-brick. On a small fragment there is also a brick ceiling. The layout of the specified structural elements is shown in Figure 7b.

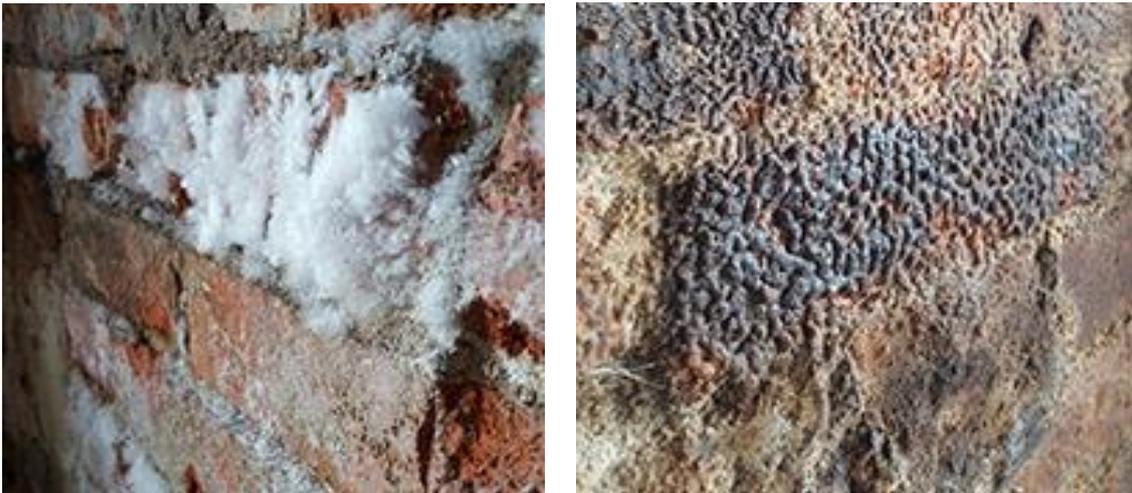
The brick constructional elements of the pavilion, as is the case with the colonnade building, are preserved in relatively good condition. However, they are very damp and covered with salt efflorescence and mold fungi (Fig. 8). The execution of the exposures showed that neither vertical nor horizontal damp proof insulation was executed in this building. The mortar in the joints between the bricks is crumbling, and in some places reaches a depth of up to several centimetres.

**Figure 8:** View of a fragment of a brick wall that is very wet and covered with mold fungi

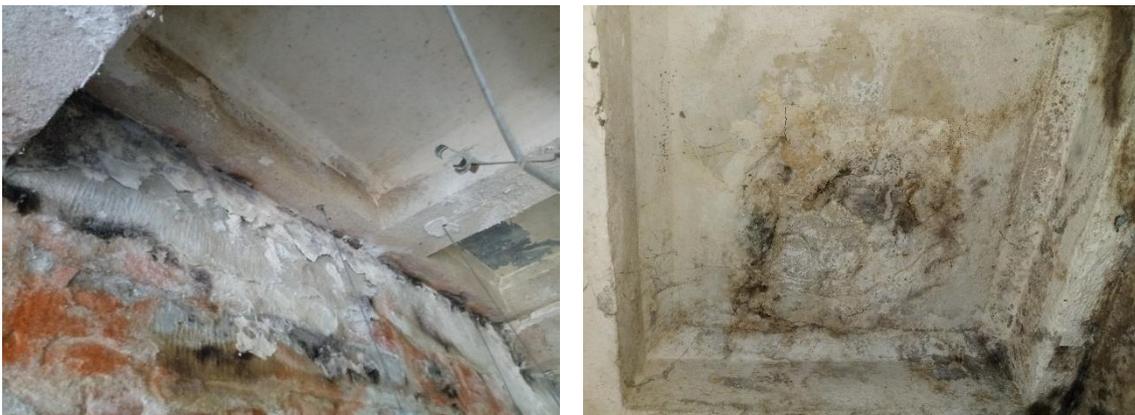
The reinforced concrete ceiling of the flat roof, despite the existence of bituminous waterproof insulation, is very damp in the support zones. In addition, in the area of masonry walls, the corrosion patches of the reinforcement are visible on its lower surface, as illustrated in Figure 9. In this flat roof, semi-non-destructive testing was performed in order to take a core sample. The layout and layer thicknesses were found to be the same as those in the flat roof above the ground floor in the colonnade building.

**Figure 9:** Sample view of moisture and patches of corrosion of a reinforced concrete ceiling

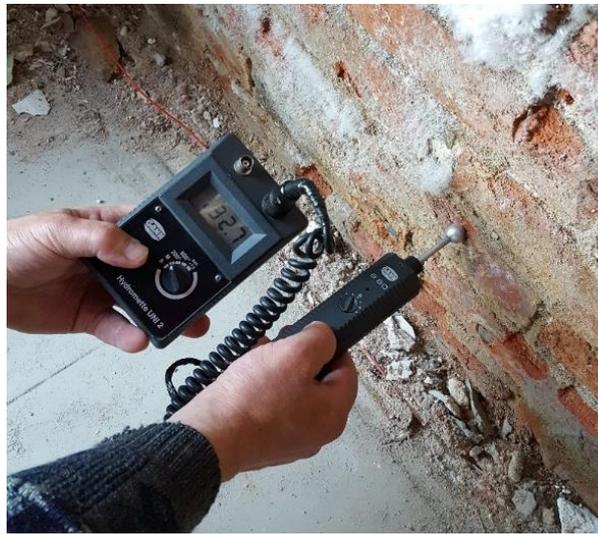
The moisture content tests were performed using the weighing method and the non-destructive dielectric method (Fig. 10). It was found that in both buildings, the brick walls that are covered with soil from the outside are wet, because according to the classification adopted in literature [3,4,5], their mass moisture content along the entire height exceeds 12%. In the case of the internal walls, pillars, and columns, a similar situation occurs up to a height of about 50 cm above the floor level. Above 50cm to a height of almost 100 cm, the brick walls are very and moderately damp, with their moisture content being in the range of 12% to 5%.

**Figure 10:** Examination of the moisture content in a brick wall using the dielectric method

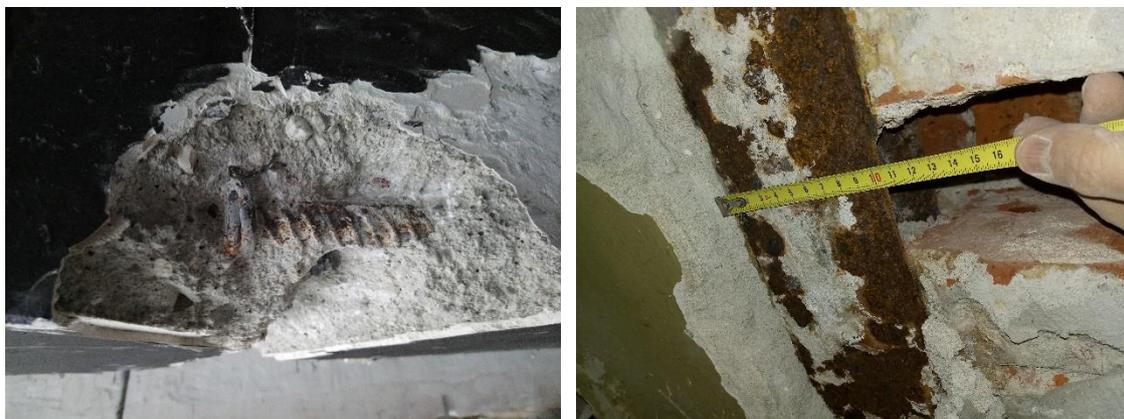
Tests on the distribution of steel in the reinforced concrete ceiling elements, slabs, ribs and girders were carried out using the non-destructive electromagnetic method and then verified by executing the exposure works. It was found that the reinforced concrete slabs are reinforced with 12 mm smooth bars with a spacing of 150 mm, whereas the reinforced

concrete girders are reinforced with ribbed bars  $\varnothing$  22 mm that are spaced every 60 mm. In turn, the reinforcement of the steel and brick girders consists of a flat bottom rail with a height of 149 mm [7].

**Figure 11:** Exemplary view of: a) reinforcement in a reinforced concrete girder; b) flat bottom rail's foot
