THE “PIEVE DI SANTA MARIA” IN AREZZO (ITALY). FROM THE LASER SCANNER SURVEY TO THE KNOWLEDGE OF THE ARCHITECTURAL STRUCTURE

PIETRO MATRACCHI¹, CARLO BIAGINI¹,

¹ Department of Architecture (DIDA)

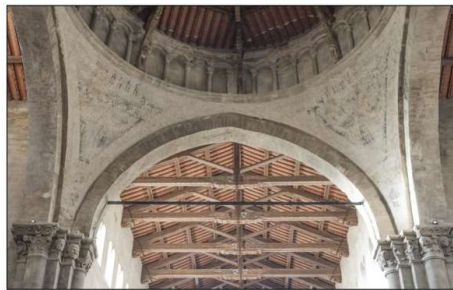
View of the triangular pendentives

The pendentives of the crossing, analysed with plans at different levels, look similarly curved. The diagonal sections highlight pendentives with similar and slightly curved profiles.

We have no specific information on the facing wall of the pendentives. However, as far as visible from their facing, it can be assumed they were made by rows of progressive overhanging ashlar and they are probably part of a wall extended in depth until reaching the extrados of the adjacent arches. The pendentives are probably a type of massive masonry block which extends as far as inserting itself into the haunches of the arches. At the same time, the pendentives made stiffened the haunches and created a cantilever supporting the drum. In fact, in the arch in front of the nave, the center is the most subjected part to deformation over the level of the haunches.

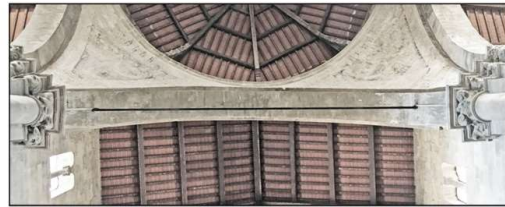
View of the T-arch from below

The arch of the crossing in front of the nave has a number of unique features (Figure 3). Its horizontal projection is not as straight as one would expect, but is visibly curved towards the crossing. In addition, the arch has the intrados with a marked vertical displacement in the central part; it is a deformation that must be related to the fact that, at the height of the capitals, the underlying pillars are inclined outside by a total of about 31 cm.
