# ANALYSIS OF THE EFFECT OF PROVISIONAL TIES ON THE CONSTRUCTION AND CURRENT DEFORMATION OF MALLORCA CATHEDRAL

Luca Pelà <sup>a \*</sup>, Julien Bourgeois <sup>a</sup>, Pere Roca <sup>a</sup>, Miguel Cervera <sup>a</sup>, Michele Chiumenti <sup>a</sup>

<sup>a</sup> *Technical University of Catalonia (UPC), Campus Norte, Jordi Girona 1-3, 08034 Barcelona, Spain.*

**Running Head:** Use of ties in Mallorca Cathedral construction

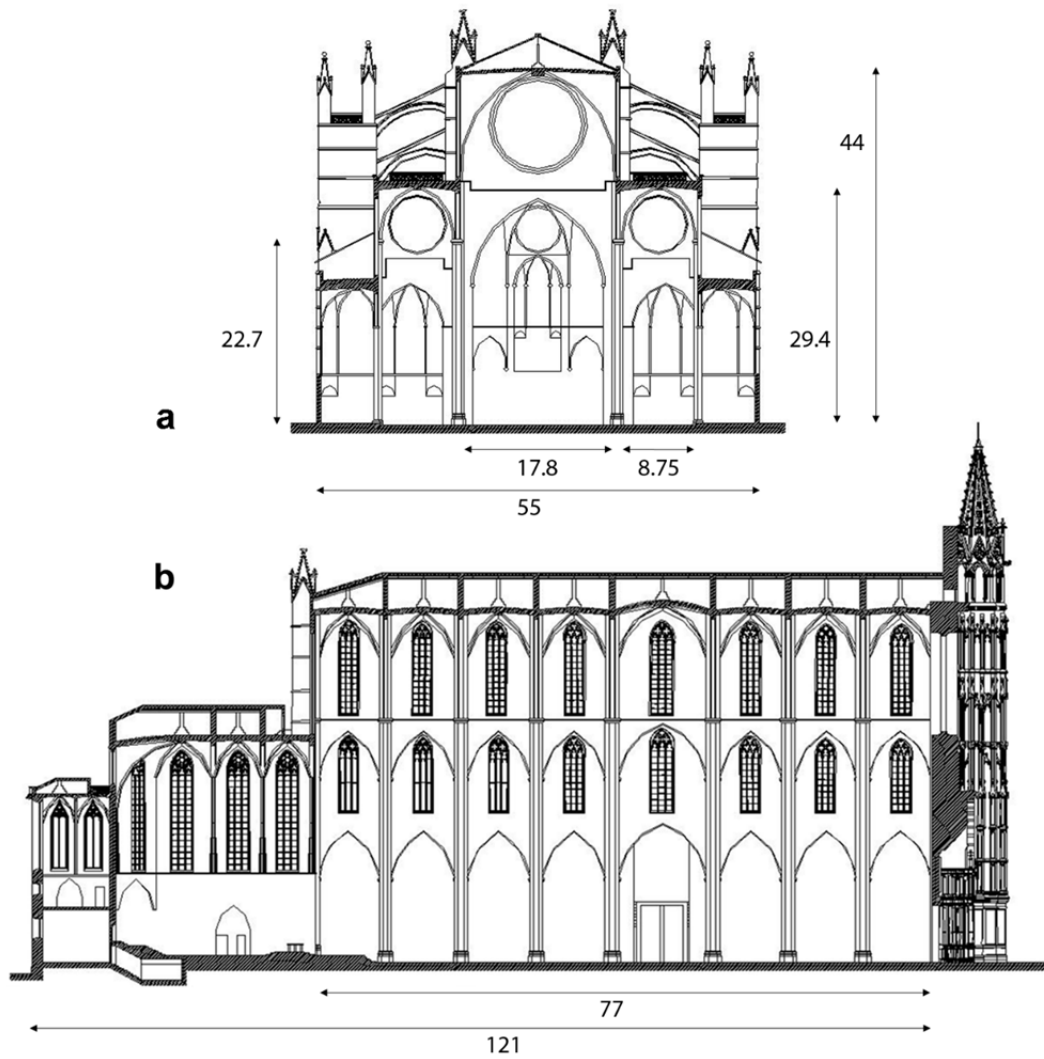
**Figure 3** – Transversal (a) and longitudinal (b) sections of Mallorca Cathedral.

The cathedral has an overall length of 121 m and a width of 55 m (Figure 3). The central nave has a length of 77 m, the free span of the vaults is 17.8 m and the height from the ground to the top of the interior vaults is 44 m. The height of lateral naves is

29.4 m and the span of their vaults is 8.75 m. The piers have an octagonal section with circumscribed diameter of 1.6 or 1.7 m and a height of 22.7 m to the springing of the lateral vaults. There are a total of seven bays, including a false transept with lateral entrances.

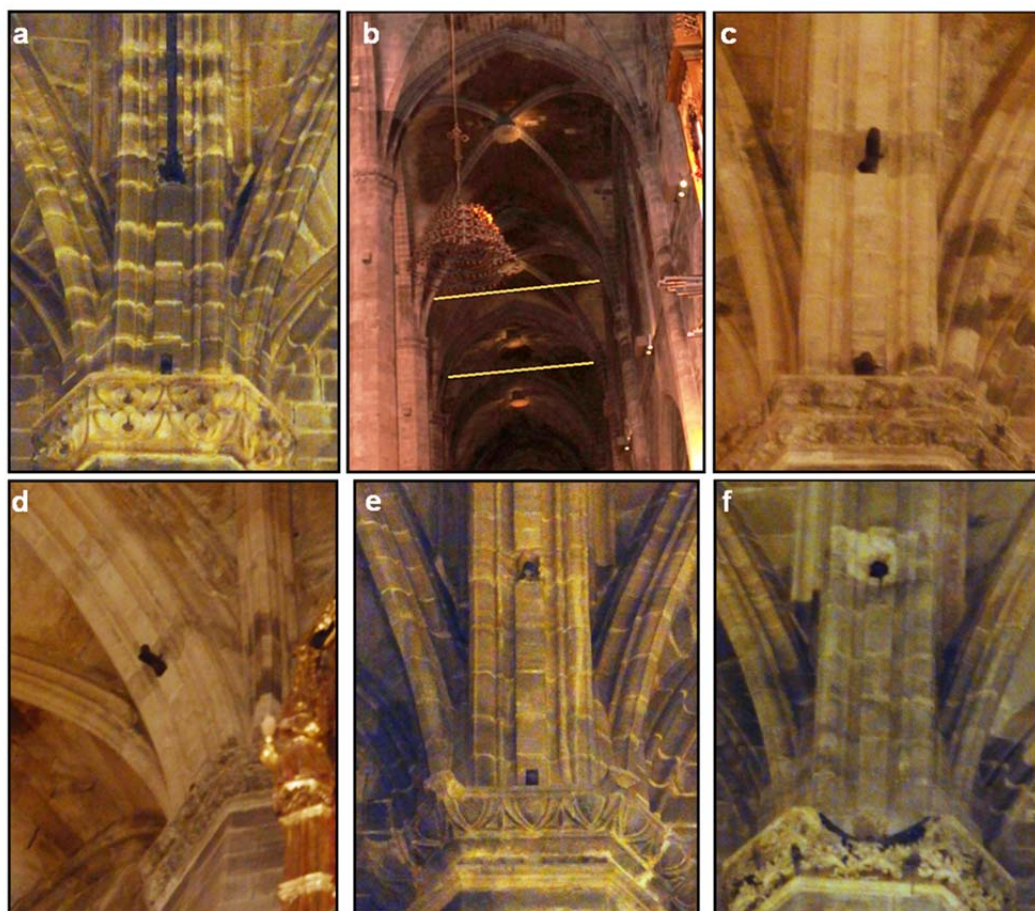
**Figure 5** – Visual evidences of the remains of temporary iron ties for different locations: northern aisle, bay 6-7, exterior side (a); the two remaining ties in the bays 5-6 and 6-7 of the northern aisle (b); iron hook, southern aisle, bay 4-5, exterior side (c and d); northern aisle, bay 7-8, exterior side (e); northern aisle, bay 4-5, exterior side (f).

These features seem to be a proof of the possible use of structural iron ties during the lifetime of the cathedral. Moreover, the similarities between these elements and the ones previously observed in Amiens Cathedral in France cannot be disregarded and should be considered to reinforce the hypothesis of the use of temporary ties during the construction process of Mallorca Cathedral.

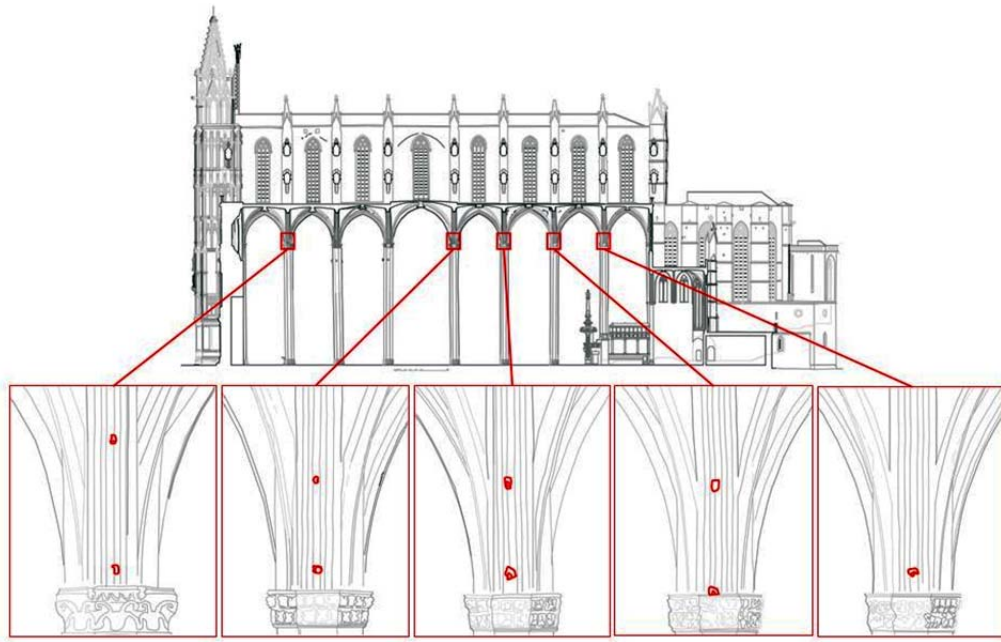
**Figure 8** – AutoCAD section of the south nave based on the photogrammetric survey.

The on-site combined study provides a good approximation of the height of the ties remains and a rough estimation of the section of the missing ties. In particular, it has been possible to evaluate the height of the ties of the fourth bay, whose structural analysis is reported in Section 4. Accordingly, the connection of the first set of ties with the masonry has been considered to be located at 0.40 m from the top of the capital of the pier to the centre of the lower tie section (i.e. at 78% of the total height of the aisle,

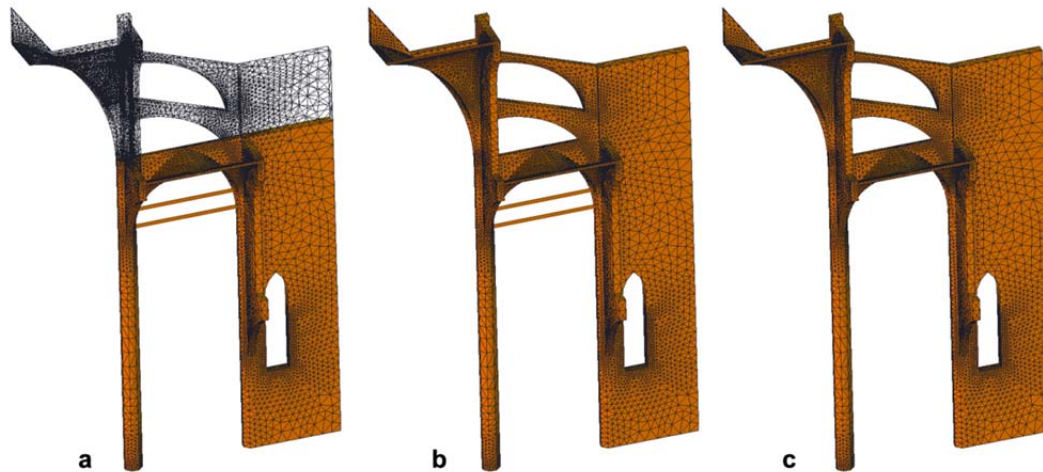
**Figure 9** - FE analysis of the construction process: a) first stage (construction of the aisle), b) second stage (completion of the bay) and c) third stage (removal of ties).
