# LESSONS LEARNED FROM THE VIRGINIA REFLECTIVE CRACKING STUDY UNDER ACCELERATED PAVEMENT TESTING<sup>1</sup>

Freddie Salado Martínez<sup>2</sup>, Gerardo W. Flintsch<sup>3</sup>

**ABSTRACT:** Road administrators encounter situations where they must make decisions regarding the maintenance and rehabilitation of a road network without knowing the outcome of those decisions until years later. The Heavy Vehicle Simulator has been widely used as an accelerated testing tool to study pavement performance in a shorter period and under more controlled conditions than in the field. The Virginia Department of Transportation, in conjunction with the Virginia Tech Transportation Institute and the Virginia Transportation Research Council, has initiated a research project to study the behavior and performance of different pavement materials and structures under accelerated load through a Heavy Vehicle Simulator. Six pavement sections with different structures were built and instrumented with strain gauges, load cells, temperature gauges, and linear vertical displacement transducers. Two lanes were dedicated to study reflection cracking. They included a concrete pavement with joints 9.5 mm (3/8

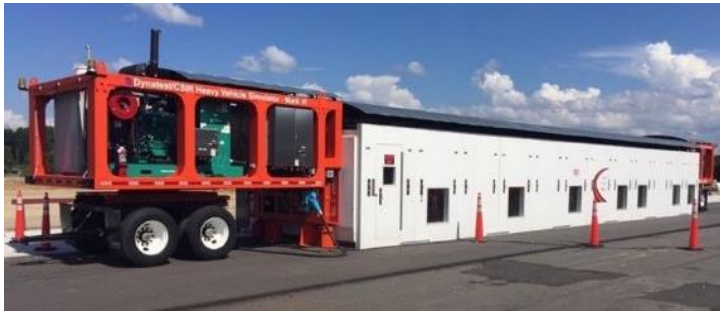
Figure 2: HVS MK VI testing on Lane 4, Cell A.

The HVS used for the loading application was the model Mark VI designed and built by Dynatest Consulting, Inc. (Figure 2). The Mark VI has a standard test wheel speed of  $20 \pm 3.2$  km/h ( $12.4 \pm 2$  mph) for loads that range from 30 kN (6.744 lb) to 100 kN (22,500 lb). It has the capability of testing bidirectionally, achieving 24,000 passes in 24 hours, or unidirectionally with 12,000 passes in 24 hours (Figure 3; Cooke, 2011).

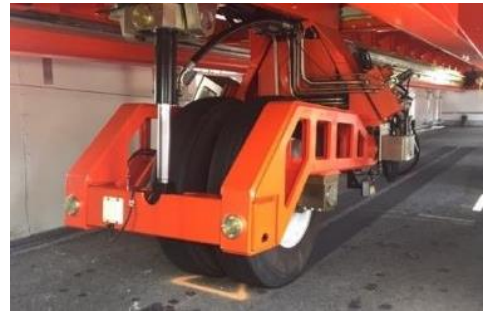
Figure 3: Dual tire load application.

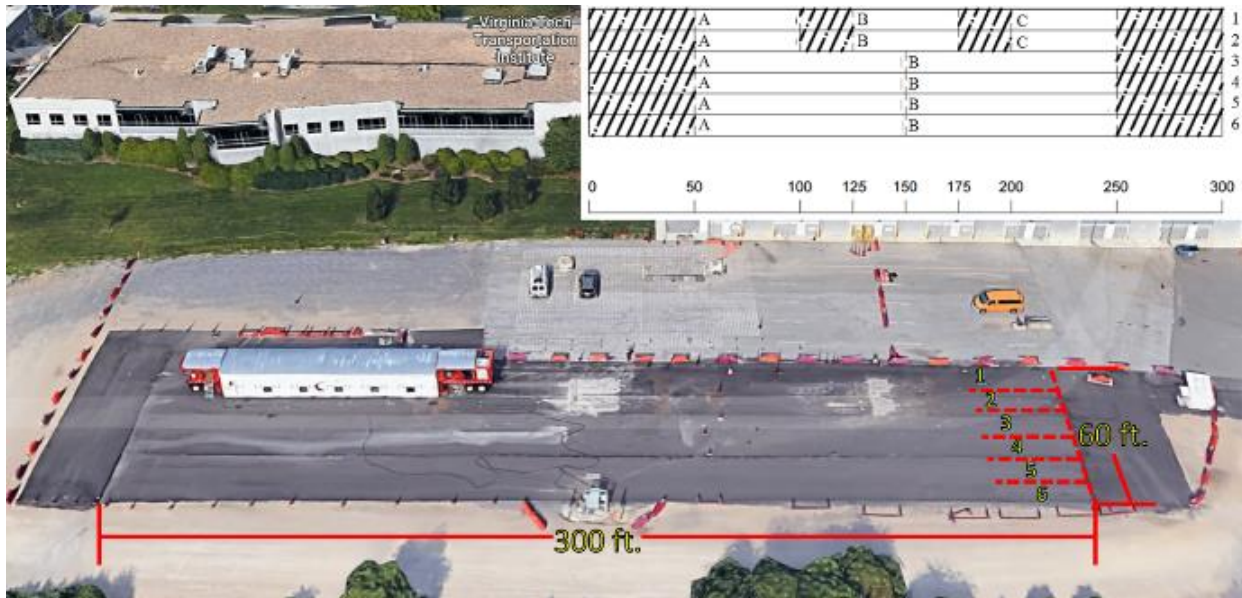
Figure 4: Dimensions of pavement test sections.

The APT program included the construction of an 18.3 m by 91.4 m (60 ft. by 300 ft.) pavement test section located at VTTI's facility. Figure 4 shows the sections included in the initial APT study and the HVS located on Lane 1, Section A. The pavement testbed was equally divided into six lanes with a width of 3.0 m (10 ft.) each. The third experiment of the first set focused on reflective cracking, was situated on Lanes 5 and 6.

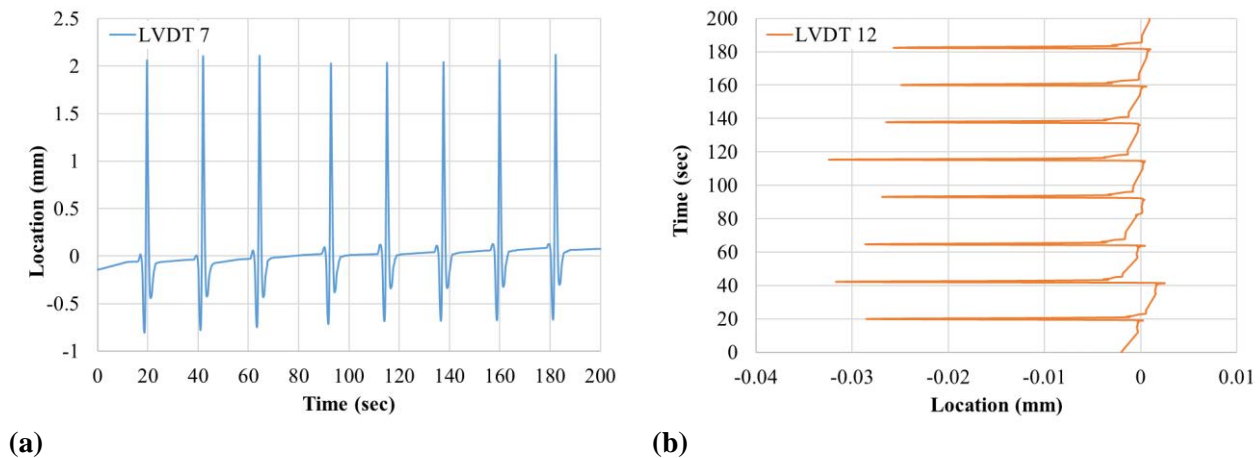
Figure 10: (a) Vertical and horizontal displacement measured by LVDT 7 and (b) LVDT 12.

Figure 10(a) shows an example of the vertical displacement measured by the LVDT located in the slab of Joint 4. The plot presents the peak displacements of more than 2 mm for a period of 200 s measured every time the wheel passed on the joint at approximately every 20 s.

Figure 10(b) shows the horizontal displacement during the same period of 200 s with a maximum displacement of 0.032 mm (.001-inch).

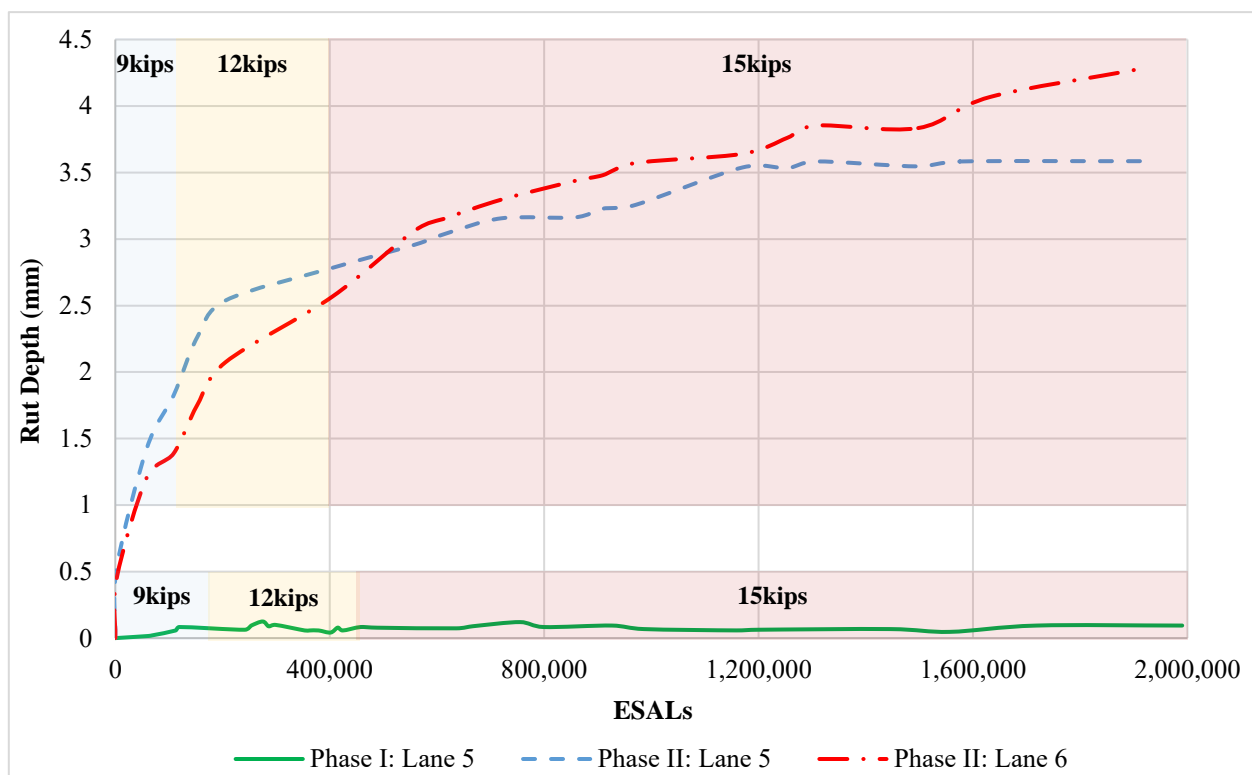
Figure 15: Rut depth vs. ESAL plot for Lane 5 during Phase I and Lanes 5-6 during Phase II.

Figure 15 shows the rut depth versus ESAL plot for the data acquired while the HVS was on call B of Lane 5 and after it was relocated between Lanes 5 and 6.

The first line, “Phase I: Lane 5,” shows the results obtained during the first cycle of the study before it went through the experimental changes mentioned above (e.g., subbase drilling, load direction). The maximum rut depth measured by the sensors from the HVS was negligible, 0.2 mm.

During Phase II, in which the HVS was relocated between Lanes 5 and 6, maximum depths of 3.6 mm and 4.3 mm (0.14-inch and 0.16-inch) were measured for Lane 5 and 6, respectively. The nonuniform increasing trend reflects the accumulated rubber from the tire, asphalt binder, and uneven surface due to the cold milling performed and the accuracy of the method used to determine the rutting.
