# Assessment of Reasons behind and Level of Destruction of Aquatic Supports in a Hydraulic Ash Removal Bridge

**Abstract.** *The presented article describes a case of damage to concrete in the aquatic supports of a hydraulic ash removal bridge in a power plant. Carrying out an assessment of the causes of concrete damage, as well as determining the possibility of the occurrence of corrosive phenomena within it, and thus, consequently, predicting the durability of the building structure and selecting, on its basis, a proper repair-renovation procedure, required a series of essential studies and analyses to be carried out. Therefore, in the analyzed case, a complex study was carried out on the structure as well as tests on samples of concrete cut out, in the form of core drillings, from the damaged structure (among others: macroscopic, microscopic SEM, XRD, DTA, chemical analyses). Based on these studies, the types of corrosion responsible for the analyzed damage were determined.*

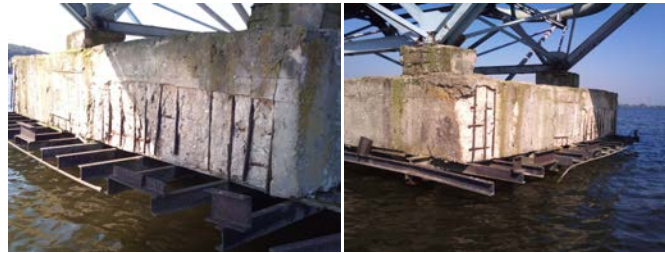
After many years of service, the supports of the hydraulic ash-removal bridge are in a bad technical condition. Corroded and spalling concrete can be seen, as well as the progressing corrosion of reinforcing steel (Fig. 1, 2).

**Figure 1, 2.** Damages to pillars in the form of spalling corroded concrete and corroded reinforcing steel.

As indicated by the results of the carried out laboratory studies and conducted analyses, the corroded surface layer of the concrete ought to be removed all the way to the reinforcement bars, with the uncovering and cleaning of the rebars. Next, new layers ought to be made in accordance with one of the systemic repair technologies.

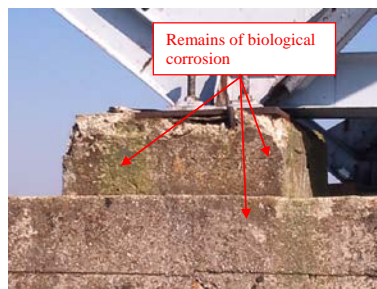
Centres of biological corrosion are also visible (Fig. 3 and 4).

**Figure 3.** Reinforced concrete support with corrosion Centres.

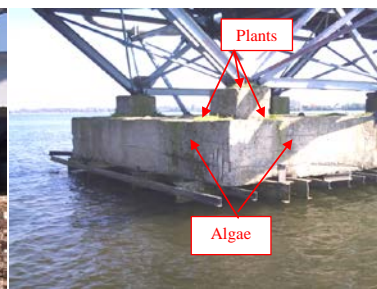
**Figure 4.** Reinforced concrete support along with the covering vegetation and algae.

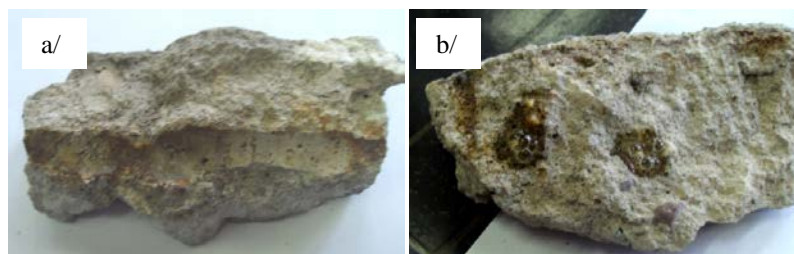
granulation as well as certain amounts of carbonate aggregate was determined in the analyzed types of concrete. Concrete samples are characterized by a porous structure and varying dimensions of pores, with the remains of corroded reinforcement bars (Fig. 7a) and carbonate aggregate (Fig. 7b) determined on the majority of the samples.).

**Figure 7.** Piece samples of concrete: a/ porous structure and remains of corroded reinforcement bars, b/carbonate aggregate reacting with 10% HCl.

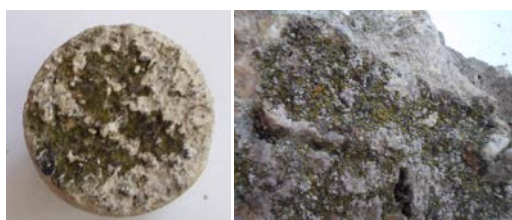
The presence of biotic factors in the form of algae and mosses, which can cause biological corrosion, is confirmed on the outer side of samples A and B (Fig. 8).

**Figure 8.** Concrete samples with visible biotic factors.

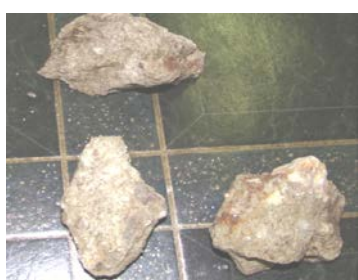
In order to assess the estimated course of carbonization in the analyzed concretes, the cross sections of concrete samples were sprayed with 1% phenolphthalein solution. Piece samples (Concrete B) are completely carbonized (Fig. 9), whereas in the samples from the core drillings (Concrete A), the carbonized layer is 1-3 cm in thickness (Fig. 10). Carbonization is not noted deeper within.

**Figure 9.** Pieces of Concrete B; completely carbonized concrete (all the way to the reinforcement bars) with visible remains of corroded reinforcement ( $\text{pH} > 9$ ).

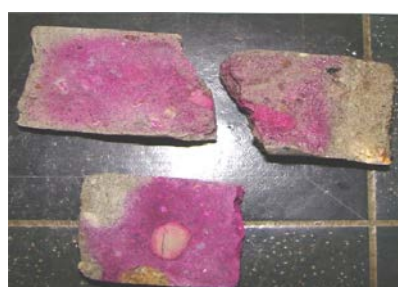
**Figure 10.** Pieces of Concrete A; visible layer into concrete with an alkaline pH, carbonized 1-3 cm in thickness.
