## Post Peak Behavior of Carbonated Concrete Structure - A Case Study of the Former Shime Mining Office Vertical Derrick in Japan

**Abstract.** *This paper is a report on the investigation results of the Former Shime Mining Office Vertical Derrick, which was built in 1943 and was 75 years old at the time of the investigation. The building suffered from serious deterioration including rebar corrosion, which led to large area of concrete spalling. In this report, aggregation data of concrete spalling has been presented along with the investigation results of cover thickness. According to the investigation results, concrete spalling occurred in places where cover thickness was less than 25 mm. And According to the aggregation data, concrete spalling flakes increased by approximately 200 pieces per year, with the average size of 10 cm in diameter. Also, a possible relation between concrete spalling and rainfall was observed during the investigation. Equations using the proportion of wet area affected by rainfall to estimate the area of spalling are proposed, although the value of empirical coefficient  $\alpha$  needs further discussion, including collecting data from other buildings

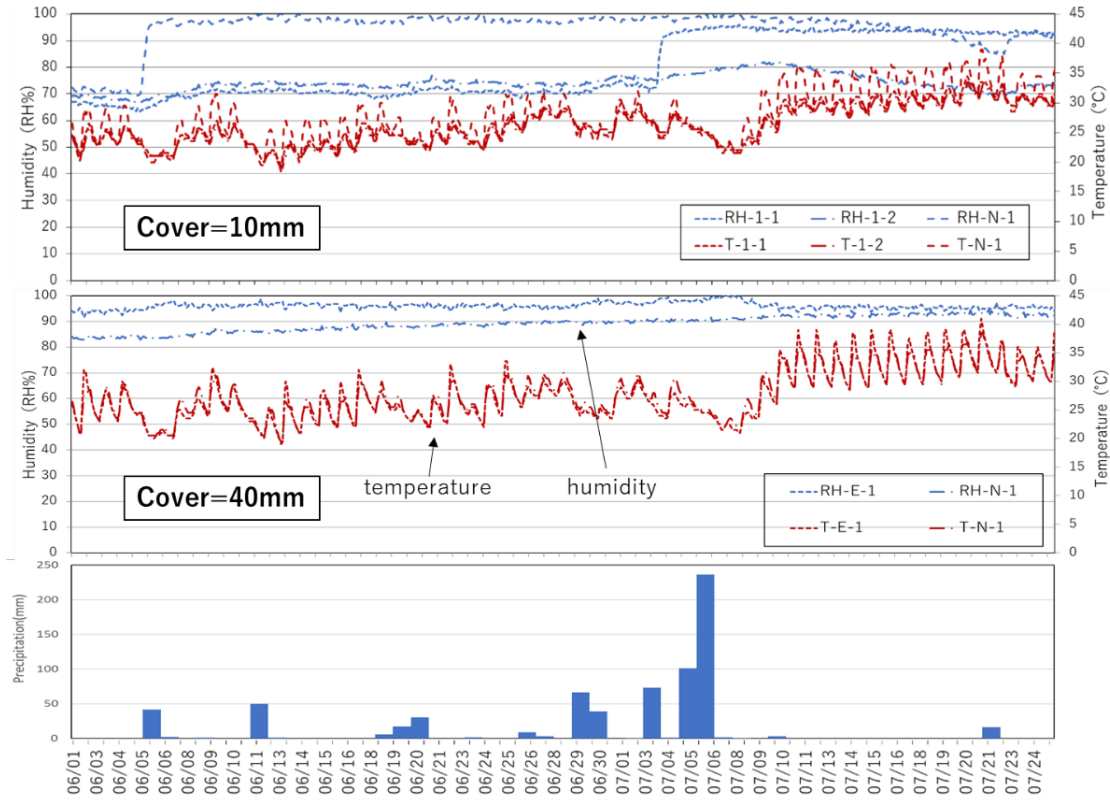
The results of relative humidity and temperature monitored during June 1<sup>st</sup> to July 25<sup>th</sup>, 2018, along with precipitation observed by Japan Meteorological Agency are shown in Figure 2. These results indicate that places with thinner cover thickness tend to be influenced by weather events such as rain.

**Figure 2.** Evolution of Relative Humidity and Temperature (Upper: Cover=10mm, Middle: Cover=40mm) and Precipitation.

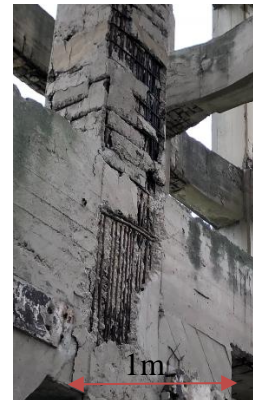
**Figure 4.** Rebar exposure due to spalling.

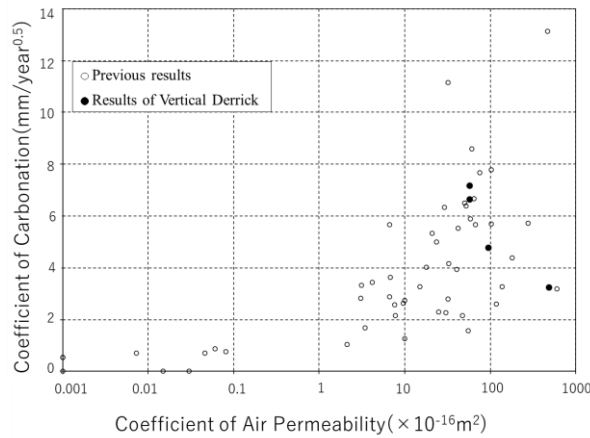
The results of the relation between the coefficient of carbonation and the coefficient of air permeability are shown in figure 7, along with previous investigation results of other buildings. The coefficient of carbonation is calculated by  $C/\sqrt{t}$ , where  $C$  stands for the depth of carbonation and  $t$  stands for years of use. The depth of carbonation is measured by applying phenolphthalein solution to concrete cores following the instructions in JIS A 1152. The coefficient of air permeability is calculated by the Torrent method (double chamber method). According to previous investigations, the coefficient of air permeability increases when the coefficient of carbonation increases. According to Figure 5, the results Vertical Derrick are within the range of previous results.

Figure 7. Relation between coefficient of air permeability and coefficient of carbonation. (Akio Tanaka; Kei-ichi Imamoto, 2013)

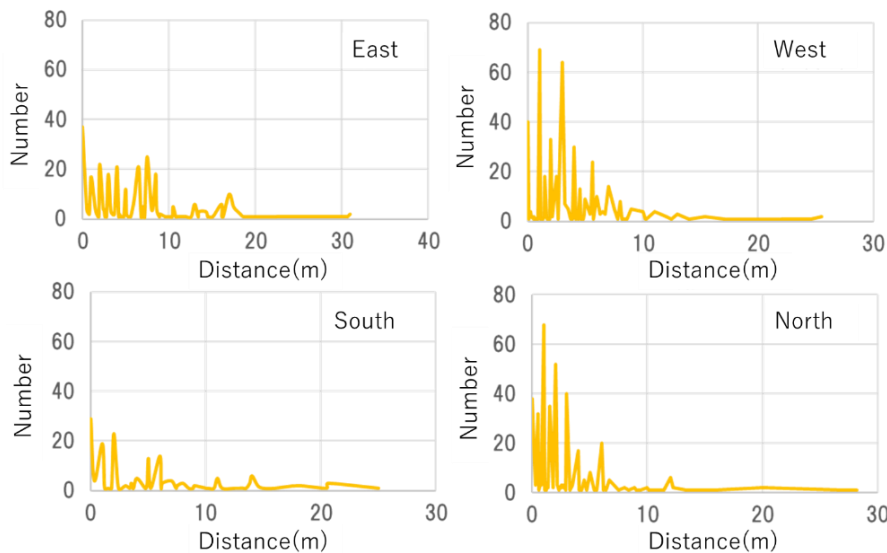
Figure 8 shows the number and horizontal flying distance of flakes of each direction. According to Figure 8, concrete flakes mostly fell within the 7 meters range from the building. The height of the building was 47 meters. For the flying distance of 7 meters, the falling degree was  $21.7^\circ$  and the horizontal flying distance was 0.15 times the height of the building. Concrete flakes that fell out of this range needs further discussion concerning the windswept condition of this location. Table 2 shows the percentage of the spalling area of each direction. According to Table 2, the percentages of spalling area are between 5~10%.

**Figure 8.** Number and horizontal flying distance of concrete flakes.

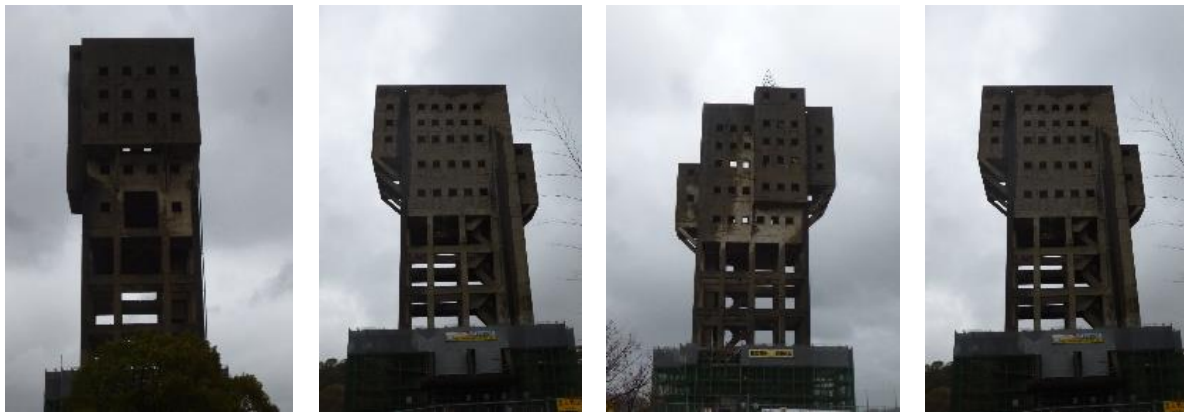
Figure 9 shows the percentage of wet area after rainfall. The percentages were calculated by wet /total area of each side of the wall. The calculation of wet areas from photos involved the image processing software, ImageJ. By circling the target areas, ImageJ automatically calculated the pixels of the selected areas. The manual selection of the wet areas brought an uncertainty to the results. To increase accuracy, image processing method should be further discussed in future researches. According to the results, the north and the west side with higher number of concrete flakes also showed higher percentage of the wet area. At this location, due

to northwest wind blew throughout the year, the north and the west side of the building were more possible to be affected by rainfall than the south and the east side. This observation indicates that there might be a relation between spalling and rainfall. The following equations are proposed considering the relation between the two.

**Figure 9.** Percentage of wet area (wet/total area of each side) after rainfall
