Sealing Simulated Leaks
Technical Topical Report

Michael A. Romano
September 2004

DE-FC26-03NT41858

Seal-Tite, LLC
500 Deer Cross Drive
Madisonville, Louisiana 70447

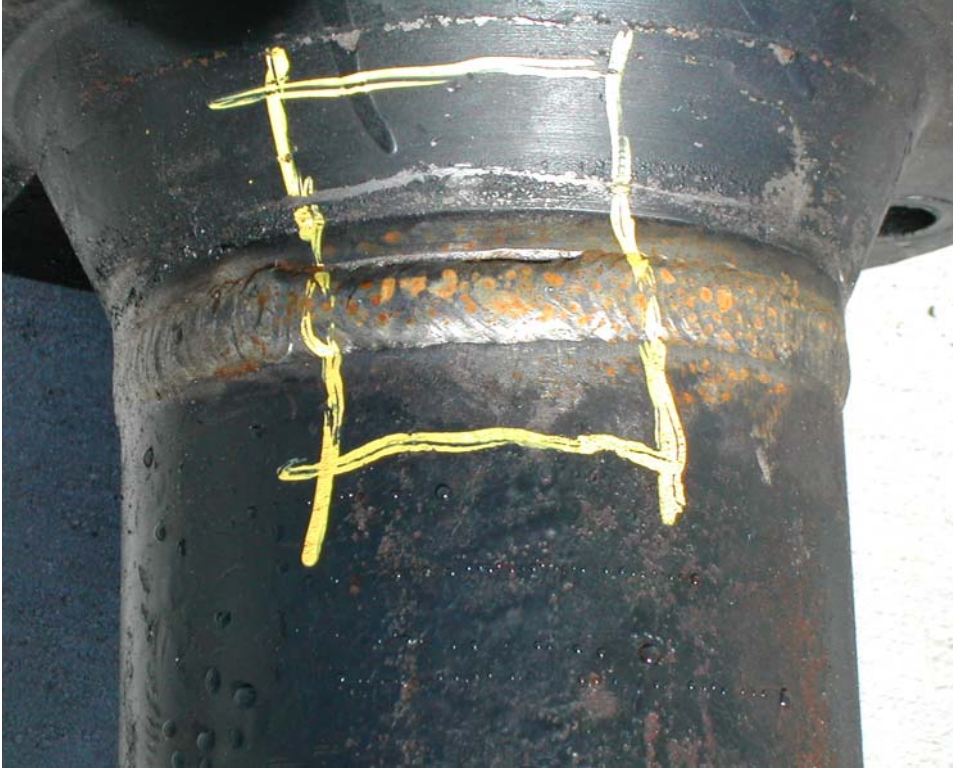
Photo 1: Weld Defect

The DFW, DGW and DPS defects were represented by a single Weld Defect Section (Photo 1) that simulated common irregularities associated with welds including cracks and wormholes. Since 68.3% of the externally corroded pipe and 64.1% of the internally corroded pipe is described as either “localized pitting”, “pinhole” or “pinhole with localized pitting”, the EC and IC defects (Photo 2 and Photo 3 respectively) will simulate localized pitting with pinholes⁵. The defect section with two (2) pinholes (Photo 4 and Photo 5) represents defects with higher leak rates. The dimensions of the 100 cm (3.29 ft) defect sections are summarized in SI units in Table 2 and inches in Table 3 with photos of the defects following.

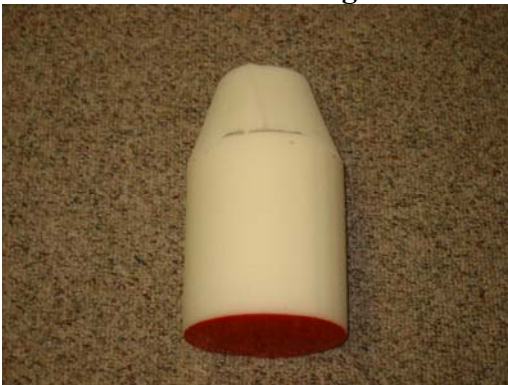
The 32 kg/m^3 (2 lbm/ft^3) density yellow swab pig (Photo 13) was tested for use in multi-diameter pipelines where more rigid pigs are not as easily transported. During preliminary testing, it was noted that while straddling the liquid sealant the swab pig acted like a sponge and became saturated, resulting in the nitrogen creating channels around the pigs and subsequently not allowing the nitrogen to move the sealant train. Higher gas rates that are experienced in the field most likely would have moved the sealant train.

Photo 13
2 lbm/ft³ Yellow Swab Pig with Nose

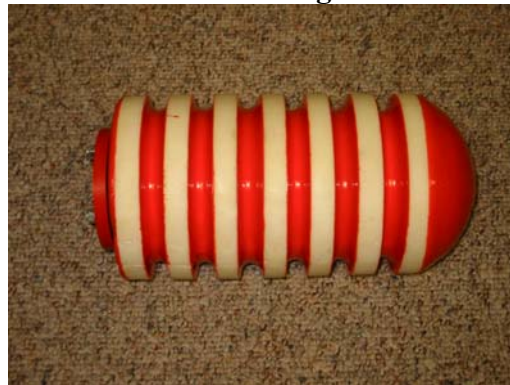
The 80 kg/m^3 (5 lbm/ft^3) density foam disc pigs (Photo 14) on the other hand formed a tight seal against the pipe internal diameter and were very easily moved by nitrogen with only a 20 psi differential.

Photo 14
5 lbm/ft³ Foam Disc Pig with Nose

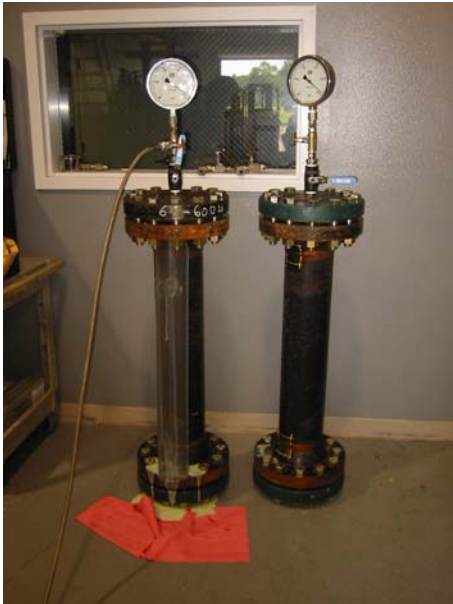
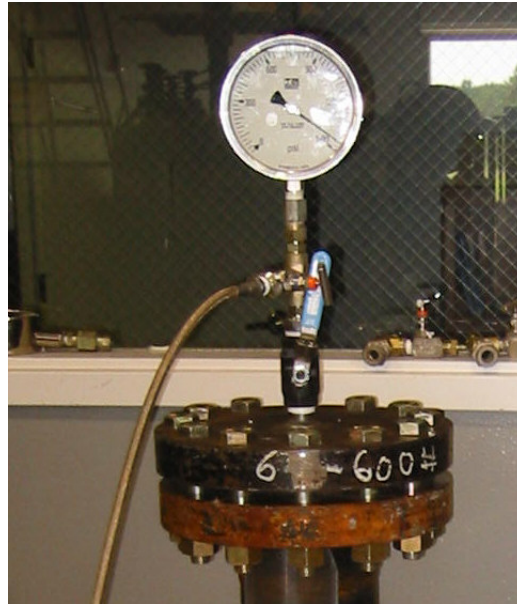
The defect sections utilized were the same as previously described under Establishing Leak Rates. In addition, as seen in Photo 17 and Photo 18 below, the defect section was fitted with a blind flange on bottom and a ported flange with a ball valve, needle valve with 6.35 mm (1/4”) JIC connection for nitrogen injection, and gauge on top.

Photo 17: Full Scale Lab Fixture

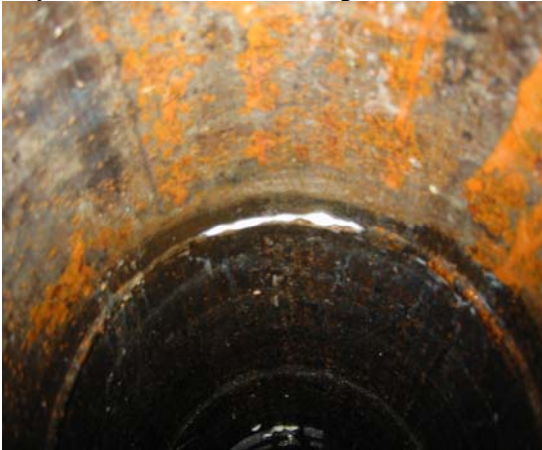
It can also be noted from the results that Gly-Flo “G” had a strip of medium consistency, as seen in Photo 20. The other sealant formulations resulted in either a soft lump, which was wiped off with the swab wiper pig (Photo 21 and Photo 22), or a hardened strip of sealant, which probably resulted in the seal being pulled out of the defect by the wiper pig.

Photo 20:
Gly-Flo “G” Sealant Strip

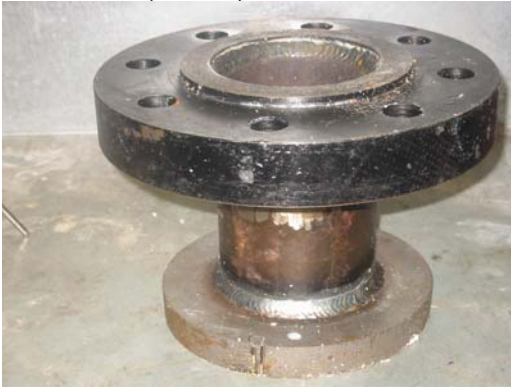
The internal corrosion defect used in this testing stage was the same described in Establishing Leak Rates. For the pinholes in varying sizes we made 114.3 mm OD x 97.2 mm ID x 152.4 mm L (4-1/2" OD x 3.826" ID x 6" L) Schedule 80 test fixtures. The fixture had a steel plate on bottom that would allow fixture to stand vertically and a ported flange on top for connection of a nitrogen injection and gauge manifold (Photo 23 and Photo 24).
