## INTERDISCIPLINARY ASSESSMENT, ANALYSIS AND DIAGNOSIS OF A HISTORIC TIMBER ROOF STRUCTURE FROM THE 20TH CENTURY

*Therefore, based on the roof structure of the Löffler Palace, built between 1912-1913, placed in the historic centre of the city, the paper tries to highlight that roof structures from this period are also far more than structural systems. Based on a thorough historical analysis and visual inspection of the structure, by using a multidisciplinary assessment procedure [1], the paper shows that 20th century roof structures are closely related to the building they belong, to their context and have a significant philosophical/symbolic and aesthetical value.*

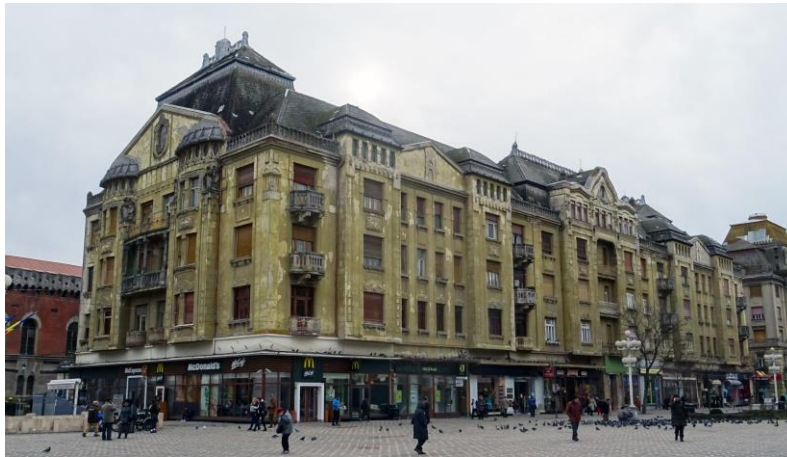
**Figure 2:** Loffler Palace overview

The building is comprised of an underground floor for storage, a commercial ground floor, three stories of apartments for tenants and loft rooms for technical facilities and storage. The general dimensions of the building are 88 x 29 m. It consists of three distinct parts which function independently each with an interior courtyard. The structural system is quite innovative for the period. The massive brick masonry is mixed with concrete such as beams and columns to obtain larger openings at the ground floor. The slabs above the basement and the ground floor are made of concrete while the others are made of timber.

Architecture also plays a significant role in shaping the roof and the roof structure. The secession style of the building and the adopted urban principles led towards the definition of the tall roof above the gable (Figure 2).

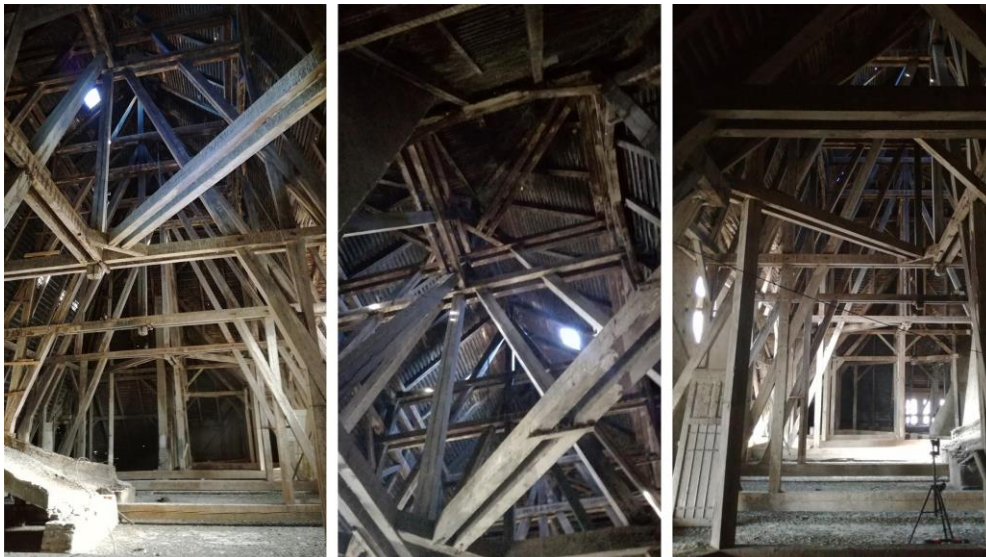
**Figure 3:** Roof structure above the gables

The roof structure has three distinct structural typologies. The first towards the square presents a king and queen post roof structure was used and adapted according to the shape of the roof. The average span is 10.3m and height 6.9m. The part of the roof towards the Castle presents a simplified version of the previous one, a king post roof structure with a smaller span of 6.4m and a height of 4.1m. The unique and sole valuable parts of the roof are the symmetrical areas towering at the extremities. The roof structure above the masonry gables is made of a king and queen post with double compound rafters (Figure 3).

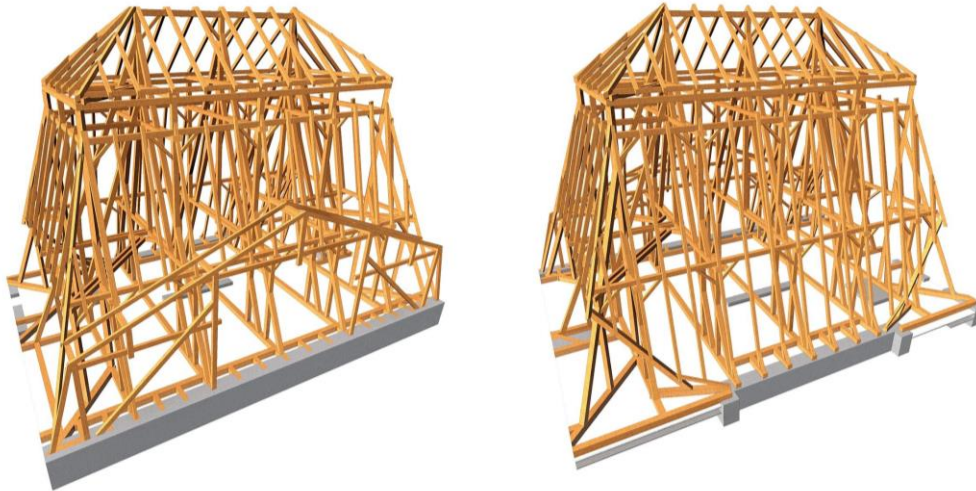
Figure 4: Studied roof model

The towering roof structure consists of five trusses spanning 10.4m and having a height of 12.3m (Figure 4). The main trusses are connected through a secondary truss to the gable wall. On each of the lateral parts, there is a half truss positioned perpendicular to the main trusses and one in each corner composing the hips and adding to the overall stiffness of the structure. The half trusses are connected through the king and queen posts and fastened with double collars at the three purlin levels.

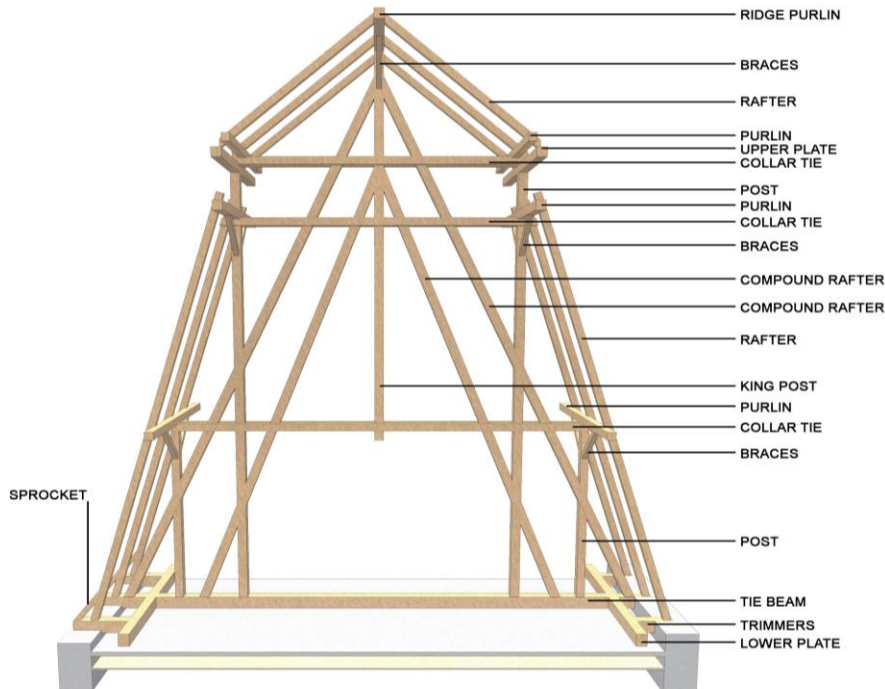
Figure 5: Truss components

The general dimensions for the timber elements are as follows: tie beams, lower plates and trimmers 250x200mm; king posts, queen tall posts and ridge purlin 180x180mm; queen short posts and purlins 160x160mm; collars 160x100mm; rafters 140x100mm; braces and sprockets 100x100mm.

There are two types of joints used for the connection of the various wood elements of the truss. The most common is the mortise and tenon joint, used in all post to beam, beam to beam or trimmer, compound rafter to king post or tie beam, bracket to post, rafter or sprocket to the trimmer. The second type is the half-lapped joint found in the compound rafter to queen-post connections. All the purlins and collars are notched. The rafters are bird's mouth cut and set on the purlins. There are no wooden pegs or wedges used for any of the joints while threaded rods are used in all post to collar or post to compound rafter, or compound rafter to collar connections. Iron straps are used for all the timber elements connected to the tie beam and posts to purlins. Three iron strips are used as brackets to connect the gable to the trusses.

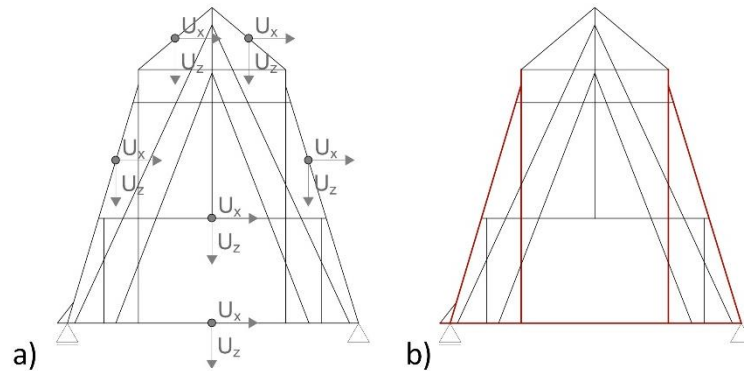
**Figure 7:** Analysed parameters (a) points where the displacements were measured; b) elements where the internal forces were analysed)

In order to identify the differences between the structural behaviour of the two cases, the horizontal ( $U_x$ ), vertical ( $U_z$ ) and total displacement ( $U_{total}$ ) of a selection of six points were analysed. The points are placed in the middle of the structural elements which would suffer the most significant displacement caused by the applied loads: inferior rafters, superior rafters, tie-beam and the base of the king-post (Figure 7a). At the same time, the axial forces and bending moments recorded in the rafters, tie-beams and queen posts were analysed (Figure 7b).

The displacement analysis is highlighting that the rafters are suffering the most significant displacement in both cases, up to about 10 cm, considering the total displacement, while the tie-beam and base of the kingpost are only presenting a slight vertical and horizontal displacement of up to 6 mm (Table 1).
