# Assessment on Materials Quality Control Implementation of Building Construction Projects and Workmanship: A Case Study of Ambo University

Bekele Sitota<sup>#\*1</sup>, Emer T. Quezon<sup>2</sup>, Woyesa Ararsa<sup>#1</sup>

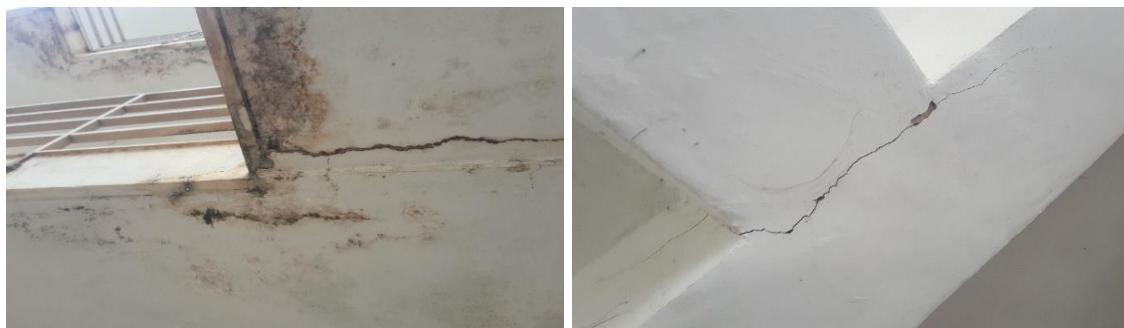
More than half of the building blocks had visible foundation defects like settlements and cracks. The main causes of the settlement are poor compaction, weak bearing soil, moisture changes, and soil consolidation. All studied buildings had cracks in common areas such as exterior walls, interior walls at door and window corners, floors, and ceilings. General measures to protect cracks include correct specifications for mortar, concrete, and all other materials and works, good construction practices (workmanship), and avoiding construction during severe weather conditions.

Fig. 2 Cracks on structural beam and slab: classroom and dormitory, Woliso Campus

#### Suggested repair methods:

**Injection of Epoxy:** The method is very useful for repairing dormant or nonmoving cracks in slabs, walls, columns, and piers.

**Sealing and routing:** The method is preferably used in conditions that require repair and maintenance and where repair of structures is unnecessary. In the process, the crack is enlarged along its face, which is exposed, which is followed by filling with a suitable sealant.

**Dry packing:** It is the process of placing low moisture content mortar, followed by tamping the placed mortar into a particular area.

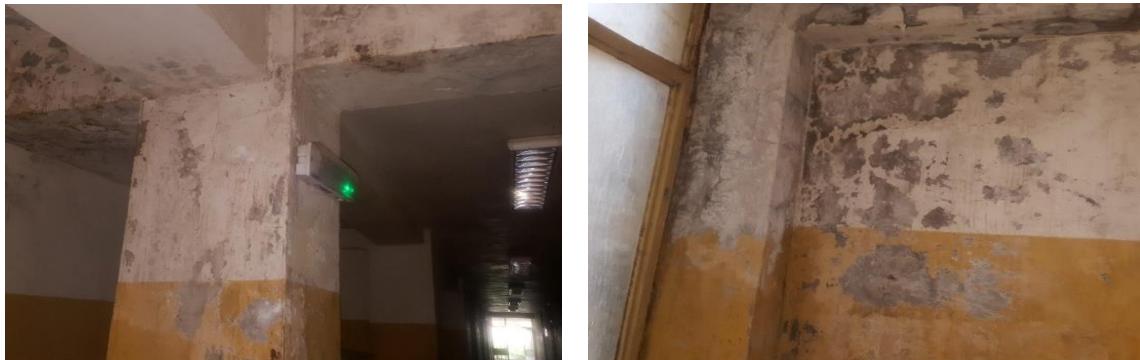
Water may leak from a building's roof or floor if not built properly. Small amounts of water can cause significant issues in a building. On average, 82 percent of the structures studied had moisture leakage. Water leakage causes paint peeling, cracks, and staining, which reduces building life and performance.

Fig. 3 Moisture leakage problems: dormitory blocks, main Campus

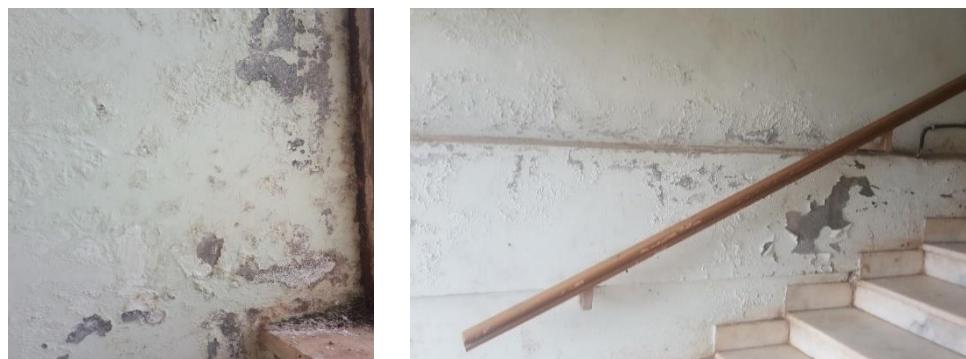
Almost every building in the study had plastering and painting issues. The most common and frequently identified plastering defects were crazing, flaking, and peeling. Using sand containing excessive amounts of dust (15% by mass), inadequate substrate preparation, insufficient cement, excessively thick layers, adding extra water too long after first mixing (re-tempering), evaporation (when plastering in sun and wind), and inadequate substrate preparation is all causes of sand failure.

Fig. 4 Paint defects observed on walls from the four campuses.

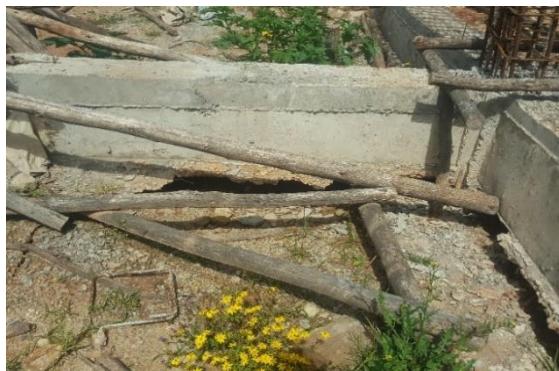
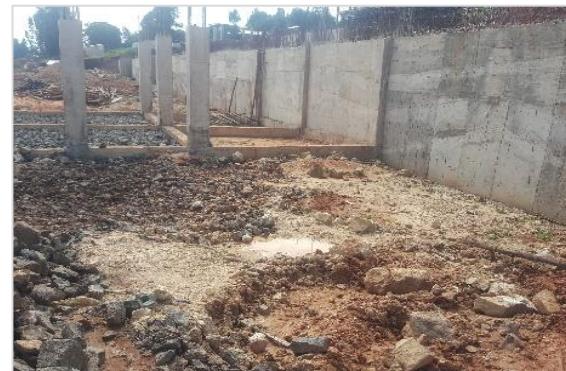
According to the general technical specification document, materials and workmanship must meet technical specifications and be subject to periodic testing by the engineer (MH-Engineering, 2010). Materials must be approved or tested first. The engineer may reject damaged or deteriorated materials and remove them immediately. Despite this, the Contractor was seen using damaged materials like bricks as membranes on retaining walls. The stone masonry also didn't meet the technical requirements.

Fig. 5 Settlement and non-conforming backfill materials

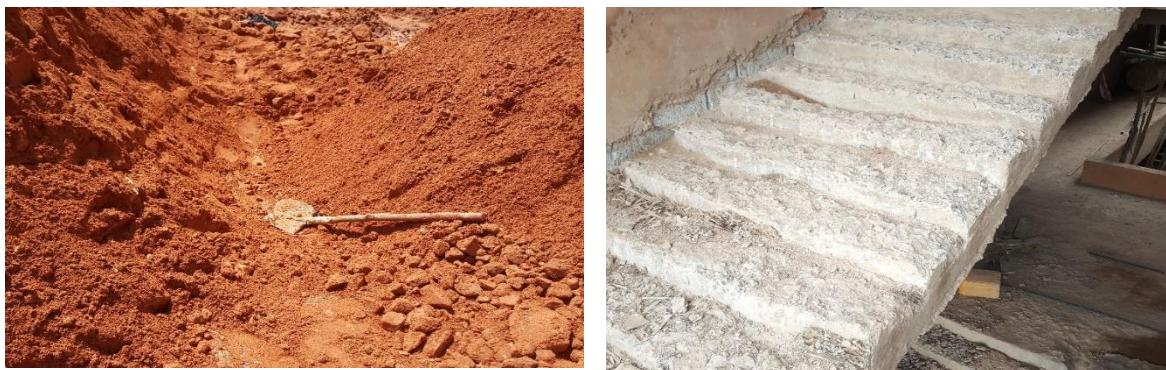
The building is located in Ambo University, Guder Campus, and it was under construction while the study is conducted. Materials management like sand, gravel, marble, floor tiles and others have been observed. The Contractor was using Senkele sands without sieving and washing. As it is surveyed in the literature, Senkele sand has 14.28% silt content, which exceeded 6% based on Ethiopian Standard Specification. Coarse aggregates were used by mixing from two different-sized aggregates. Both

Contractor and consultant were not seen for a long time on the site, resulting in very poor workmanship on the project. It has been observed while the workers were placed concrete beyond the thickness and chiseling after setting.

Fig. 6 Class Room building, Guder Campus
