# Determination of the Deterioration Characteristics of Facade Materials: A Case Study

Nil Kokulu

Antalya Bilim University, Faculty of Fine Arts and Architecture, Çıplaklı Mh. Akdeniz Blv.  
Pk:07190 Döşemealtı, Antalya, nil.kokulu@antalya.edu.tr

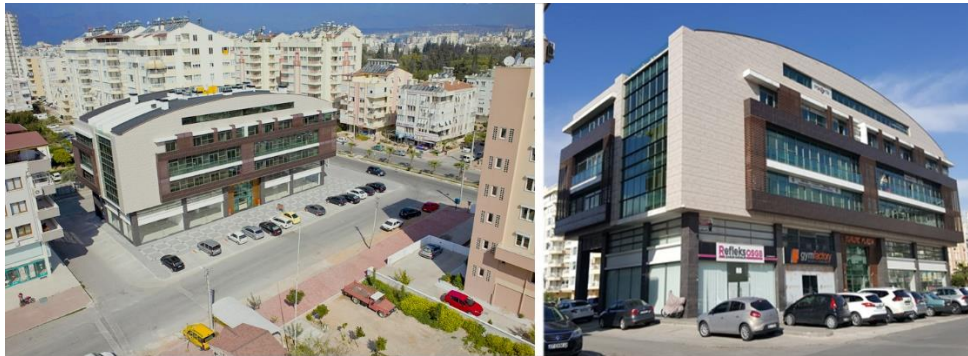
The building is located on the intersected corner of Portakal Çiçeği street and 1460 street in Antalya, Turkey. It is a seven storey-high residential building on the right with a distance of 8.40 meters, ten storey-high residential building on the back with a distance of 14 meters and front with a distance of 40 meters and two storey-car parking on the southwest with a distance of 21.5 meters. The main entrance faces to east (Figure 2). This facade always takes the sun directly without having any shading areas. The temperature and the light play a crucial role on materials. 1460 street and Portakal Çiçeği street have intense traffic. This causes air pollution which may create deterioration. The distance from the sea is 1 km and the height of the building from the sea is 22.5 m. The pedestrian roads and the vegetation around the building can be seen in Figure 3. There is an open area in front of the main facade. There are also car parking areas on the east and the west facade.

**Figure 2.** East facade of the building.

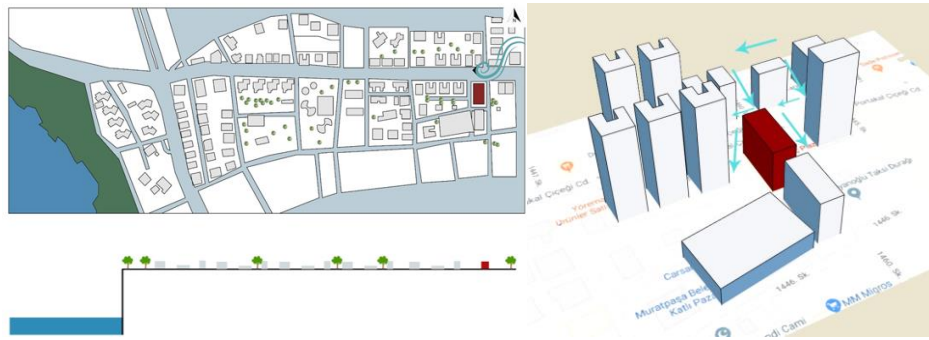
Antalya has a hot humid climate with rainy winters. The dominant wind direction is from northeast to southwest (Figure 3). The temperature changes 10°C to 35°C through the year. October, November and December are the months that take most of the rainfall (Holiday-weather, 2018).

**Figure 3.** The site plan, the section of the site (on the left) and dominant wind direction and the movement around the building (on the right).

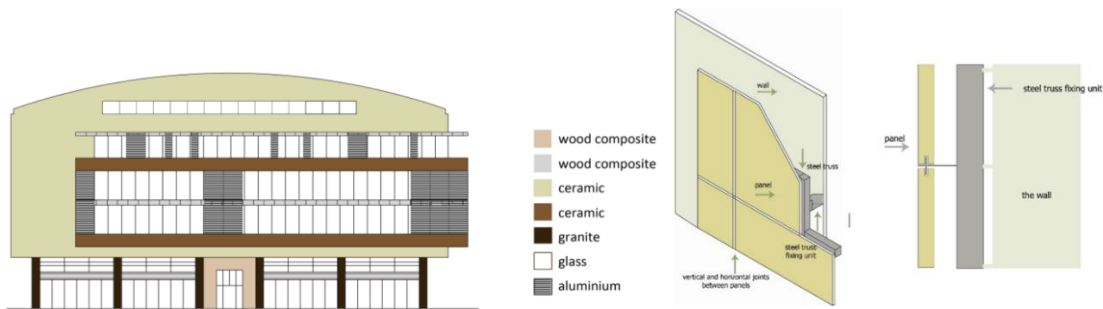
The six-storey office building is three years old. It has a rectangular form with the dimensions of 42.50 meters to 18.95 meters. The height of the building is 18.60 meters. The facade materials of the modern designed building are ceramic, aluminum, glass, granite and wood composite (Figure 4). The properties of the materials can be seen on Table 1.

**Figure 4.** Facade materials of the building and the structure system of the materials.

Steel truss metal panel curtain wall system has been used for the facade system. A cross or vertical steel truss is installed on the structure first. Then, a panel is fixed to the steel truss. Finally, the vertical and horizontal joints between the panels are filled with back-up materials and then finished with sealant. No anchorage system and no joints can be seen from the external (Figure 4) (Song and Lim, 2016). The corner adjoining parts of the granites are unpolished. This part may take water and air to the inside and different types of deteriorations may occur.

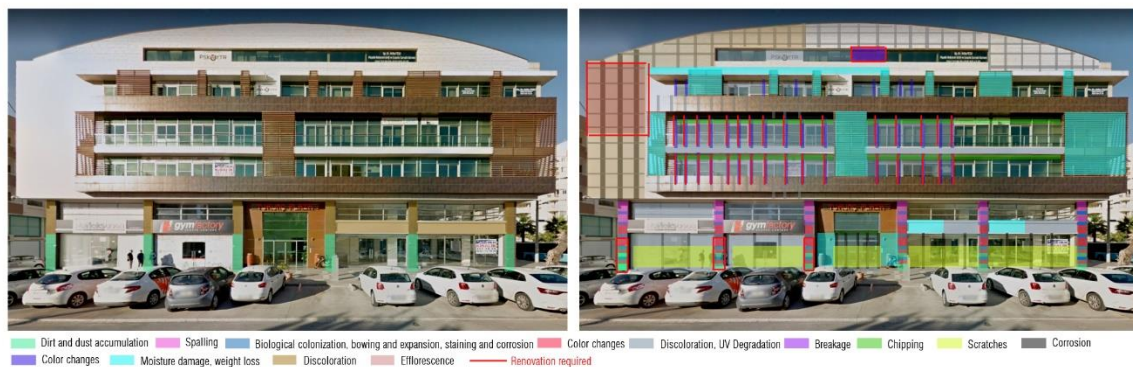
**Figure 5.** Facade of the building (on the left), facade of the building in 30 years (on the right).

The panels would be affected by the temperature. It is clearly seen that no expansion joint was used, either vertical or horizontal. This may cause cracks and/or breakage even falling of the panels. Corrosion may occur on the metal structural supports and anchors of ceramic tiles (Campante and Paschoal, 2002). The panel joints may easily take water and air inside of the structure. Color changes create visually improper aesthetic that can be seen on the ceramic tiles (Song and Lim, 2016). The reason of this can be dirt deposition which comes with the wind. Biological agents may use wood as a food source or for living with the help of water intake from the cracks or joints. This may cause weight loss of the panel (Morrell *et al.*, 2010). The WPC's on the east facade can easily take water from the rain. It is clearly seen that air pollution

came with the rain and created a color change at the surface. Because of the absorption characteristics of the WPC's moisture may cause damage of the material especially on the shading areas (Morrell *et al.*, 2010). The lower parts of the wood composite look better than the upper parts. It is probable that the upper parts would have a mechanical degradation in the future. Especially in the summer, the sun plays an important role. Wood absorbs the UV lights. This causes loss of surface quality and change in the mechanical properties. UV degradation would be seen at the WPC's especially on the unshaded areas in the future.

The method presented in this paper was developed as a tool for the prediction of the service life of building components. Deteriorations have been analyzed by a systematic approach using environmental analysis, visual observations and literature review. It is clearly seen that, deteriorations on the facade of the building will occur in the future (Figure 5).
