## Overview on Testing Method of Internal Damage to Special-shaped Stone Components in Palace Museum

Yu Qian, Fei Qi and Kai Niu

The Palace Museum, Beijing 100009, PR China, [163qianyu@163.com](mailto:163qianyu@163.com) (Yu Qian),  
[qfei87@126.com](mailto:qfei87@126.com) (Fei Qi), [nk\\_paul@163.com](mailto:nk_paul@163.com) (Kai Niu)

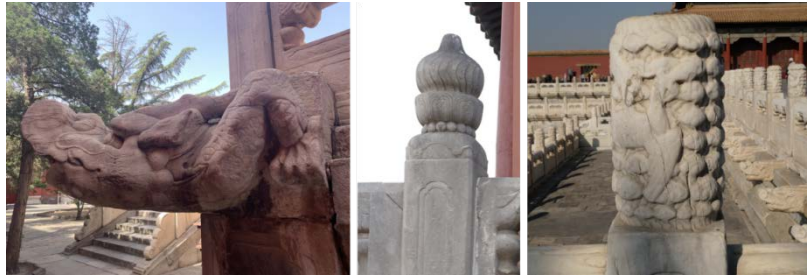
**Figure 1.** Stone components in the Palace Museum.

From 2015 to 2016, through visual inspection, it was found in the special investigation of the visible diseases on the surface of stone components that there are six common stone types in the Palace Museum: Alabaster, which are mostly used for balustrades, the marble waterspouts carved in the shape of hornless dragon's head, balusters. Green White Stone Of Fangshan (Marble) is mostly used for Danchi or Danbi, vermilion steps of stone leading up to a palace hall, the Buddhist Mount Sumeru or terrace of palace with high-grade. Bluestone (Sandstone) is commonly used for the terraces and steps leading up to hall. Granite, used for paved way. Piebald stone, used for the ground of special building's verandah. The Taihu stone is used to build rockeries. In the statistics of diseases, it was found that components looseness is the most common type of disease. The other main types and proportions of diseases are weathering, account for about 27.84%. Scaling, account for about 21.74%. Crack, account for about 21.20%. Shifting, account for about 16.97%. Weathering generally occurs in Bluestone. Crack is dominated by Green White Stone Of Fangshan and Alabaster. Scaling mostly occurs in Bluestone and Alabaster. It shows that the main types of stone diseases in the Palace Museum are comprehensive, and the main types diseases happen with similar quantity.

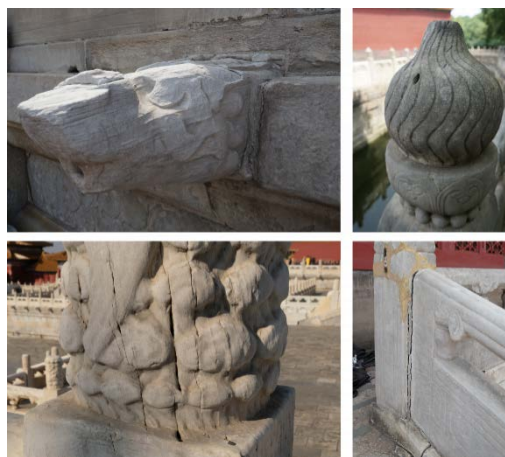
**Figure 2.** Mostly disease type of stone components(Top left: weathering; Upper right: scaling; Lower right: crack ; Lower right: shifting).

During the census, it was found that the disease areas were mainly concentrated in gully drain, steps, and terraces. Balustrades account for about 52.3%, which have Moderate and severe diseases, the marble waterspouts carved in the shape of hornless dragon's head account for about 21.4%, and balusters account for about 7.9%. Among these, there are 12.8% of balustrades, 19.6% of waterspouts, and 66.7% of balusters have serious diseases. The factors that cause its diseases include long-term rainwater erosion, plant growth, sunlight exposure, winter frost heave, and tourist trampling. In the short term, the diseases of the building foundation will not have a significant impact on building safety. In the long run, as the degree of cracking of components further intensifies and the weathering process of components further deepens, it will cause fatal harm to the building foundation. In addition, components such as balusters and the marble waterspouts carved in the shape of hornless dragon's head may cause destructive stress or structural defects during processing on the surface or inside of the stone due to aesthetic or practical requirements.

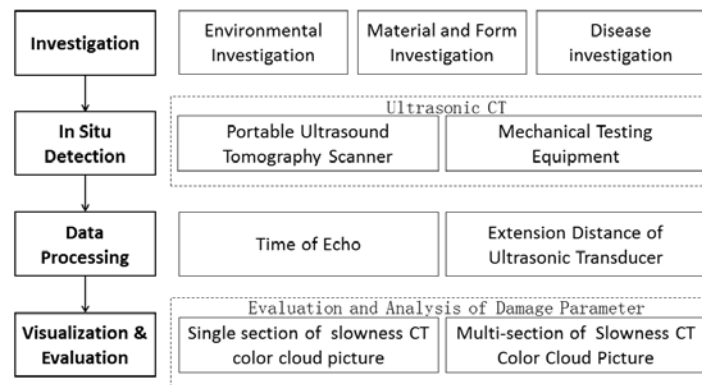
**Figure 3.** Non destructive testing process of stone components.

Based on the experience and achievements of past conservation practices, the Palace Museum has selected terraces with clusters and the fragile waterspouts on Hall of Supreme Harmony and Hall of Martial Valor as the detection objects. Firstly, carried out routine investigation to the obvious diseases on surface of stone components, and the degree of disease is graded according to the degree of disease. Identify components with deterioration characteristics as instrument detection objects, and use the mechanical detection equipment which developed by the School of Civil Engineering at Tsinghua University, with testing technology based on ultrasonic CT theory to detect surface and internal damage of special-shaped stone components.
