UNDERSTANDING TRADITIONAL ANTI-SEISMIC STRATEGIES BEYOND THEIR DISAPPEARANCE AND DISTORTIONS: YAZD QAJAR ARCHITECTURE CASE STUDY

Keywords: traditional seismic strategies, Qajar architecture, earthen heritage, Yazd, Iran

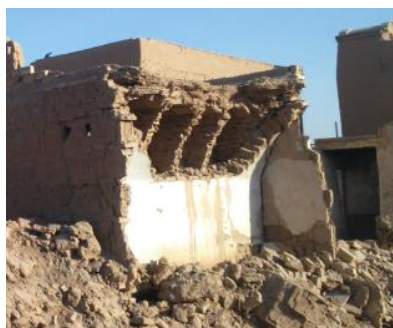
A first assumption relates to the smaller vaults that are built above the haunches of many vaults. A vault stability is compromised mainly by the inertial forces due to its own materials, its own weight and its own deformation. These do not cause the vertical deformation that is efficiently reduced thanks to the fillings that are above the haunches of the vault [13], but these fillings increase the weight of the roofing. In Yazdi architecture, the haunches of the vaults are often not strengthened by fillings but by smaller vaults named *kane poush*, that are either perpendicular to or with the same axis as the main one (Figure 1). These smaller vaults are usually explained by their thermal and execution efficiency, but they are also probably of high importance to increase the resistance of the main vault without burdening it.

Figure 1: An example of *kane poush* filling the haunches of a collapsed vault, Yazd (Crété, 2015)

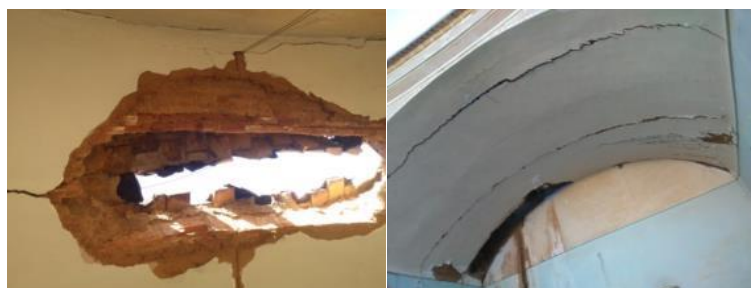
The insertion of baked bricks in adobe vaults is hardly visible as the vaults are plastered. Nevertheless, the authors observed it in three Qajar houses in Yazd historic city center, where plaster was partially removed: *Dar Houkouma*, *Nikbin* and *Shamsaei*. The observation campaign mainly focused on *Shamsaei* house as its condition allowed for a deeper understanding of the technical aspects of these Qajar houses. The latter was in poor condition due to improper maintenance, amongst others related to its roofing plaster, and had been abandoned for a dozen years at the time of the campaign (2016). It was especially interesting as it includes five collapsing or badly cracked vaults built using both adobes and baked bricks. One or two rows of baked bricks were regularly inserted in the barrel adobe vaults, at a distance ranging from 30cm to 1m. Wherever visible, it was noticed that main cracks and partial collapses systematically occurred at the baked bricks rows locations (Figure 4).

Figure 4: Baked bricks rows in an adobe vault and the creation of sectional cracks, the example of *Shamsaei* house, Yazd (Crété, 2015)

This observation campaign confirmed the frequent propagation of cracks at the interface between baked bricks and adobe bricks. An experimental campaign based on the shear strength assessment of brick masonry [25,26,27] was then conducted at 3SR laboratory in order to better understand this phenomenon. The authors first had to determine a composition for the mud mortar they would use for the campaign. They tested several compositions based on clay, sand and fibers. They selected 4 formulas out of 7 thanks to qualitative observations. They then performed shear tests on 8 sandwiches made out of adobe and 4 kinds of mud mortars after complete drying (1 month): clay with 20% fiber by volume of clay (OC20F), clay with 20% fiber and 10% sand (OC20F10S), clay with 10% fiber and 10% sand (OC10F10S) and clay with 20% fiber and 20% sand (OC20F20S). The experimental setup using Schenck press is shown in Figure 5. The average shear stress value ranged from 0.032Mpa for the OC20F20S mortar to 0.059Mpa for the OC20F10S mortar, which was chosen to perform the next tests.

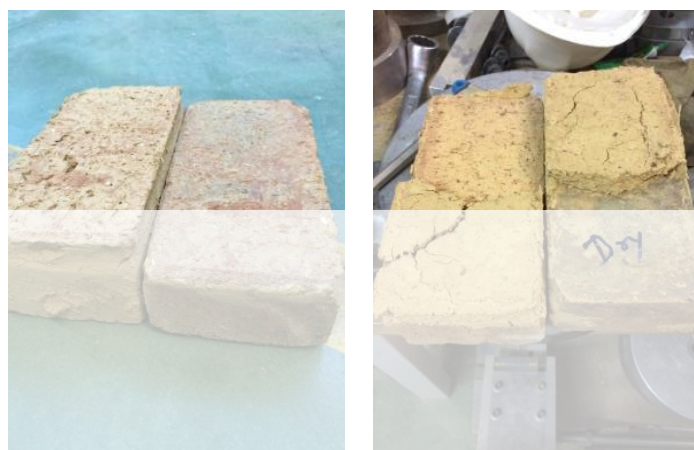
When wet before mortar application, the shear stress values for both baked and adobe bricks are comparable. They are respectively two times and ten times higher than when samples were prepared without wetting the bricks before the application of mortar. This important decrease in shear resistance may be explained by an improper bond development due to a too fast moisture flow between the bricks and mortars, inducing important shrinkage in the mud mortar as can be seen in Figure 6. This phenomenon could also explain the gap between samples 3 and C, as adobe bricks have higher absorption rate than baked bricks.

Figure 6: The joint failure in case of samples prepared with wet brick surface (left) and with dry brick surface (right)
