Latin American and Caribbean earthquakes in the GEM's Earthquake Consequences Database (GEMECD)

Keywords Earthquake consequences · Damage surveys · Lifelines · Earthquake casualties · Loss databases

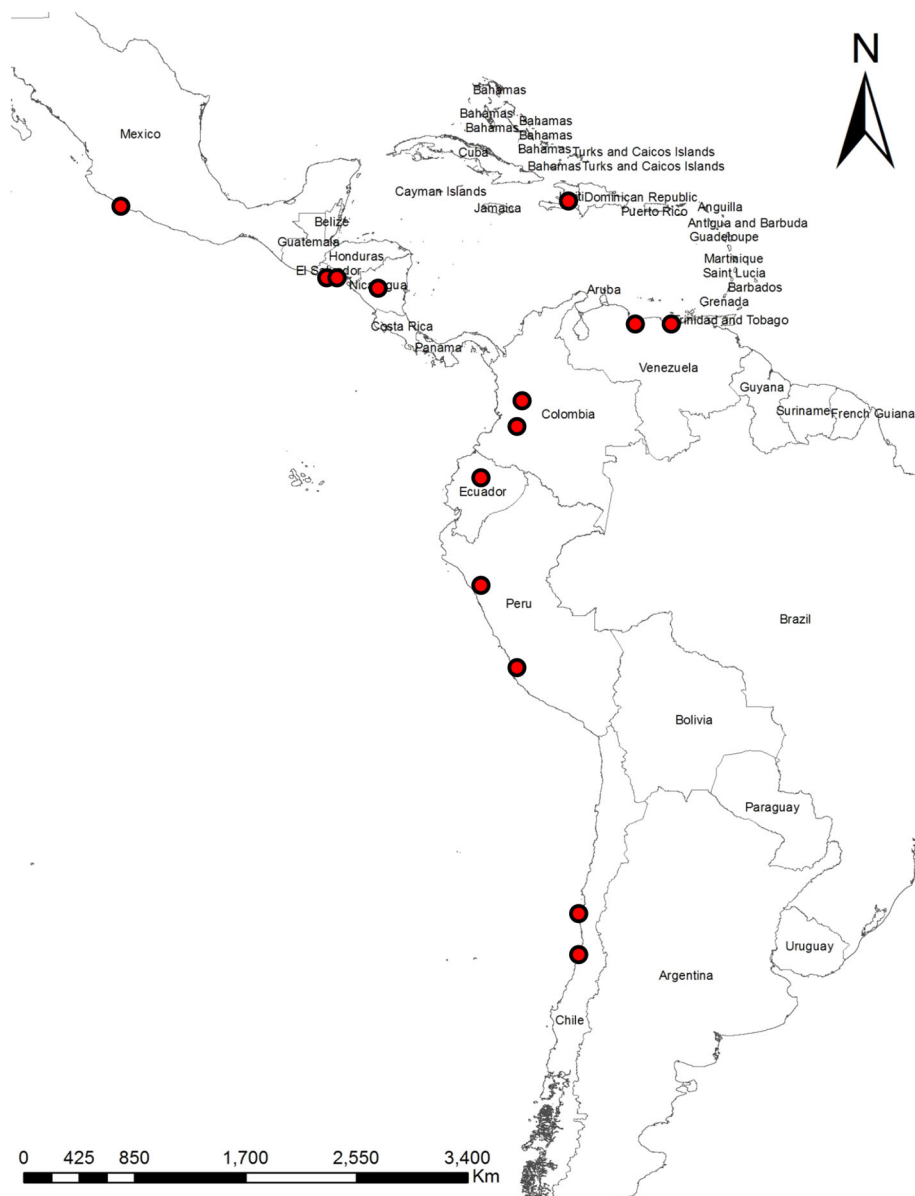
Fig. 1 Epicentres of the LAC earthquakes included in the GEMECED

Due to the large geographical scope of this project, ten different international partners contributed in the development of the GEMECD and among them, in the Latin America and the Caribbean (LAC) Region, ERN-AL Consortium (CIMNE, ERN and Ingeniar Ltda., among others) was in charge of populating the consequences database with data on 16 events which occurred between 1967 and 2010. Figure 1 shows the epicentre of these events.

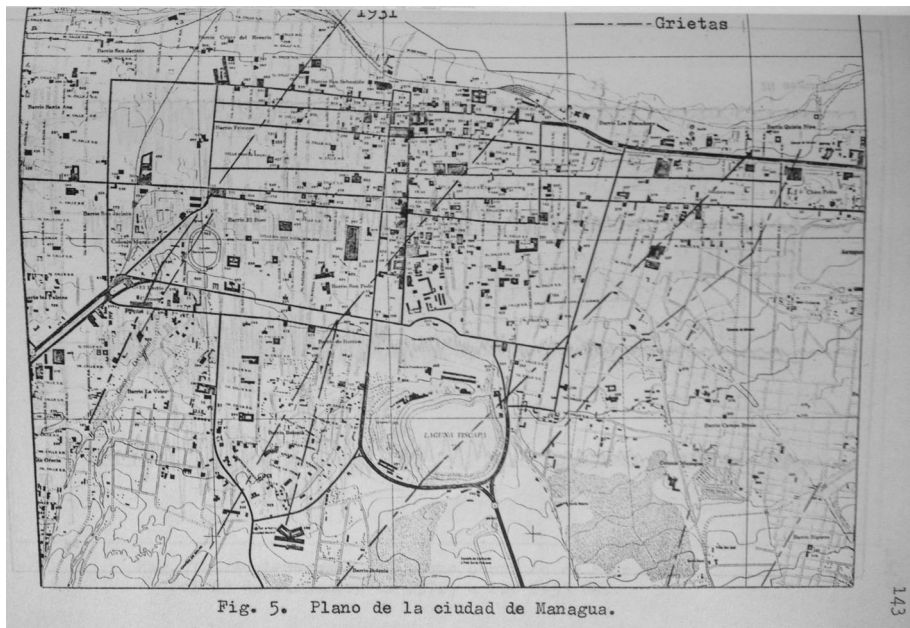
Fig. 3 Damaged buildings in downtown Managua in the 1972 earthquake. (Reproduced after: CEPAL1973)

The Managua 1972 earthquake was other event which, despite having occurred more than 45 years ago, was well and completely documented by several experts in the, at that time emerging, earthquake engineering field. For this M_w 6.2 event, the emphasis of the data gathering was made in the dimension of physical damage, mostly making use of damage distribution maps such as the one shown in Fig. 3. Another source of valuable information about this event was the study conducted by Estrada (1973), a primer in the field at its time, in which in a careful and rigorous manner, the damages on buildings were classified into

categories that ranged between small cracks in structural and non-structural components to complete structural collapse.
