## A FRAMEWORK FOR THE DETAILED FLOOD VULNERABILITY MODELLING OF BUILT CULTURAL HERITAGE

RUI FIGUEIREDO<sup>1\*</sup>, XAVIER ROMÃO<sup>1</sup> AND ESMERALDA PAUPÉRIO<sup>2</sup>

**Keywords:** Cultural Heritage, Flood Vulnerability, Flood Risk, Risk Assessment

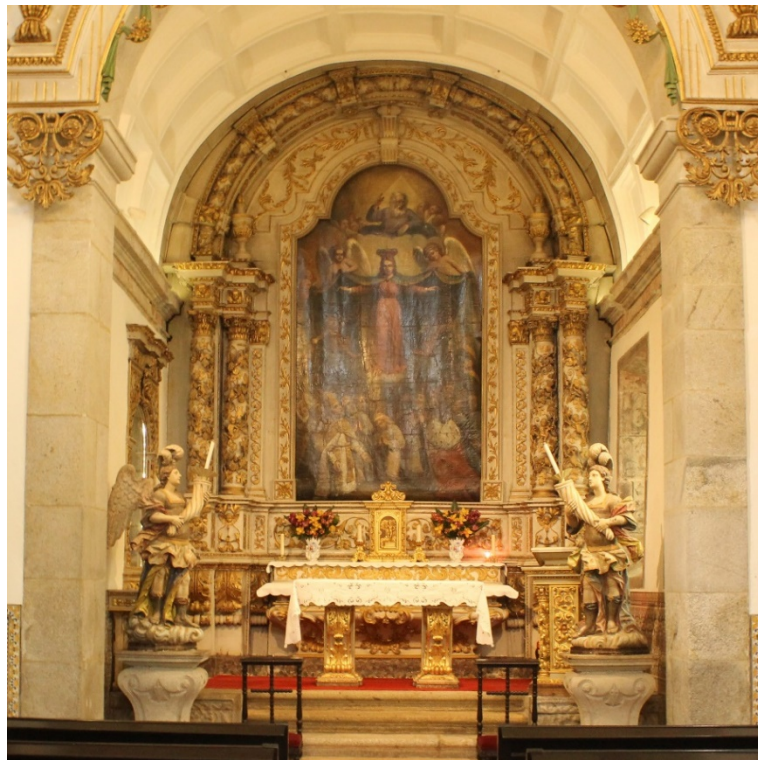
Figure 5: Photograph of the main chapel.

Table 3: Inventory of contents of the main chapel.

Component	Move-able	Material family	Material	Height (m)	Value index	Suscept. index
Plinths (set of 2)		Stone	Granite	0.13	1	1
Statue	✓	Wood	Polychromed wood	1.02	3	4
Statue	✓	Wood	Polychromed wood	1.02	3	4
Kneeling benches (set of 2)	✓	Wood	Blackwood	0.13	1	4
Altar table		Wood	Gilded woodcarving	0.64	3	4
Pulpit	✓	Wood	Gilded woodcarving	0.69	3	4
Altar		Wood	Gilded woodcarving	1.29	3	4
Statue	✓	Wood	Polychromed wood	1.64	10	4
Main altar		Wood	Gilded woodcarving	0.64	10	4
Main retable		Wood	Gilded woodcarving	0.64	10	4
Painting		Canvas	Painting on canvas	2.49	10	5
Candlesticks (set of 2)	✓	Wood	Gilded woodcarving	1.84	1	4
Candlesticks (set of 2)	✓	Metal	Brass	1.84	1	2
Jugs (set of 2)	✓	Ceramic	Porcelain	1.84	1	5
Individual benches (set of 4)	✓	Wood	Blackwood	0.64	1	4
Altar side table	✓	Wood	Gilded woodcarving	0.64	3	4
Chair	✓	Wood	Upholstered blackwood	0.64	1	4
