## EXPERIMENTAL INVESTIGATION OF SCARF JOINT OF 'LIGHTNING SIGN' IN BENDING

ANNA KAROLAK<sup>1\*</sup>, JERZY JASIEŃKO<sup>1</sup>

<sup>1</sup>Faculty of Civil Engineering  
Wroclaw University of Science and Technology  
Wybrzeze Wyspianskiego 27, 50-370 Wroclaw, Poland  
e-mail: anna.karolak@pwr.edu.pl (\*corresponding author)

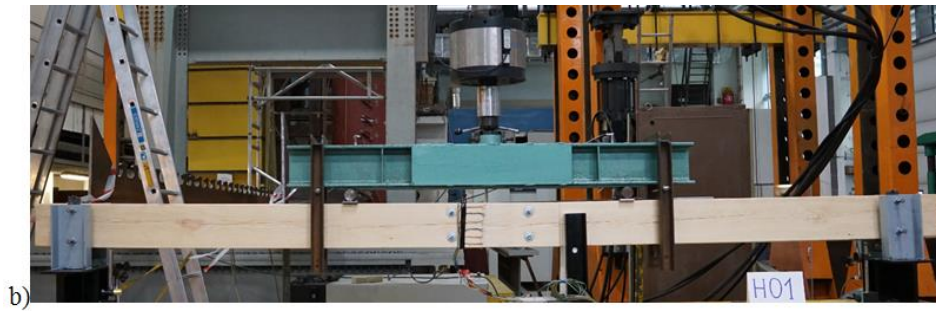
**Figure 5:** a) Schematic drawing of the testing set with the location of strain gauges, b) view of the testing set

The beams were freely supported (with a fork support – no lateral buckling) at both ends. The span between the axes of the supports was 3.24 m. The beams were loaded symmetrically with a loading force applied at 2 points that allowed to obtain pure bending in the central part of the element. Load was applied with the speed of 5 mm/min. Registration of the deformations observed in the material was carried out by means of a series of strain gauges. A schematic model and view of the testing set are presented in Figure 5.

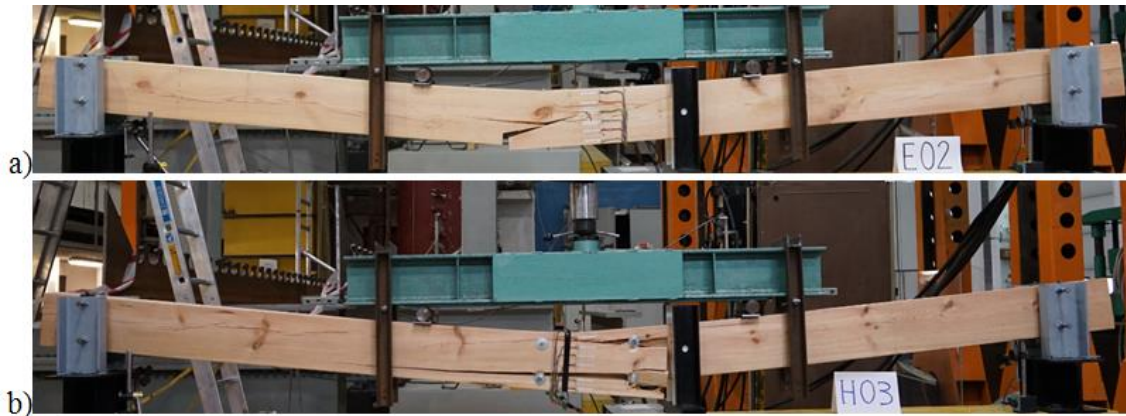
**Figure 7:** Views of the failure of exemplary beams with joints: a) beam E02, b) beam H03

The failure of the tested beams for continuous beams (series A) resulted from shearing of fibers in the bottom part of the central area of the beam. For the beams with joints (series E and H), the failure involved a loosening of the joint in the lower zone of the central part of the beam and the appearance of cracks and fractures on the edges of the joint and in areas which had been weakened by metal fasteners or earlier material flaws, such as knots or primary cracks of the beam. The failure views of the selected models are presented in Figure 7.

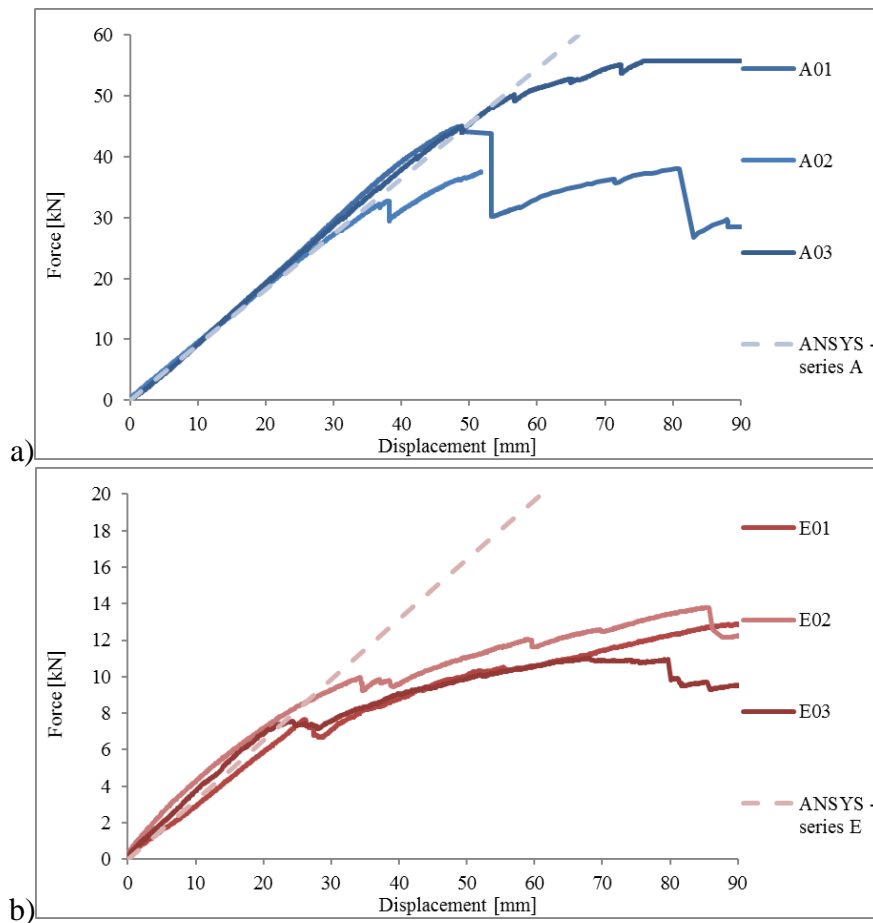
**Figure 8:** Force – displacement paths for beams a) continuous (series A), b) with scarf joint of lightning sign in the horizontal plane (series E), c) with scarf joint of lightning sign in the vertical plane (series H)

The equilibrium paths for each beam obtained from the tests and from FEM numerical analysis are presented in Figure 8. Material deformations registered by the strain gauges set for the selected beams are shown in Figure 9. For the continuous beam, it is a typical image of material strain in bending, whereas for the beam in series E it is a typical curve shape for the composite cross-section in bending (see, i.a. in [10]).
