A PRELIMINARY STRUCTURAL SURVEY OF HERITAGE TIMBER LOG HOUSES IN TØNSBERG, NORWAY

Keywords: Preliminary Survey, Heritage Timber Structures, Log House, 3D Laser Scanner, Visual Inspection, Environmental Attack, Vulnerability Assessment

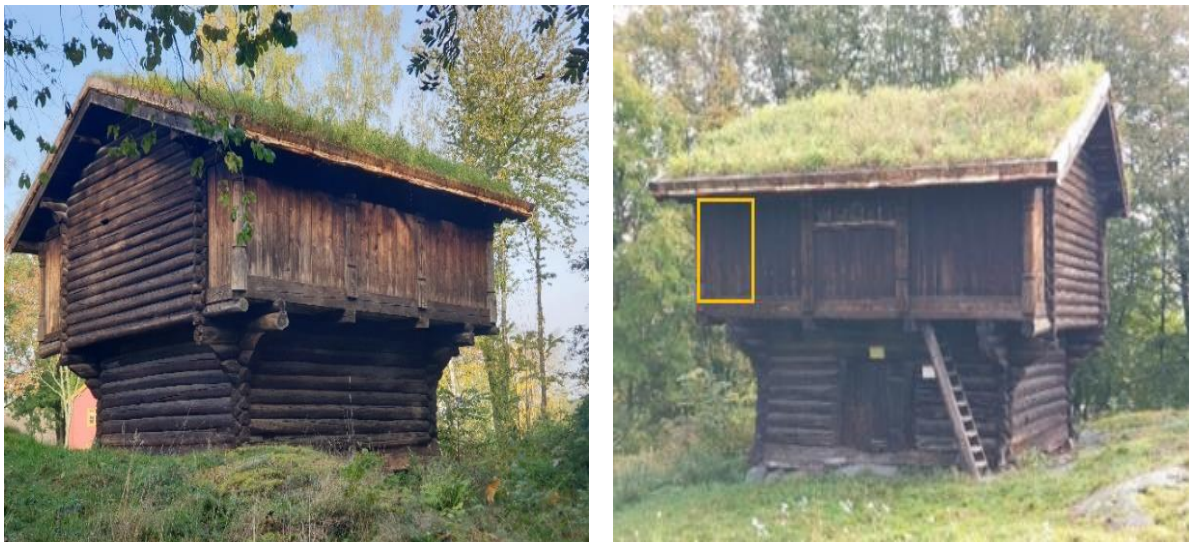
Figure 3: Heierstad Loft case study from two different views

The building has a rectangular plan measuring about 8×9 metres, and a total height of about 9 metres. It is built (logged) of large softwood pine or spruce logs, with a simple gable roof construction. The roofing material is traditional, consisting of coarse wooden boards, a layer of birch bark and turf. The exterior surface has been treated with tar. Two views of the building and details of the roof and connections are shown in Figure 4.

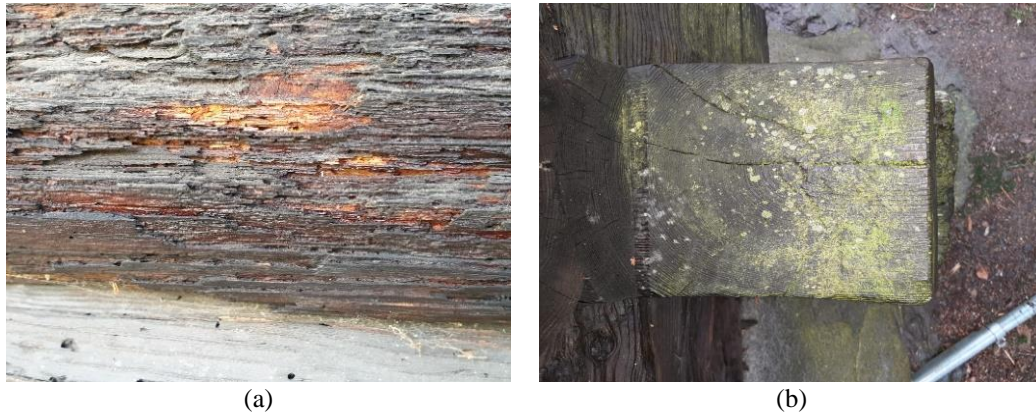
The building is in good condition in general, but it requires continuous maintenance. The most relevant degradation factors are general weathering, high humidity levels, biological decay (see Figure 5) and foundation settlement.

Figure 5: Biological defects in Heierstad Loft

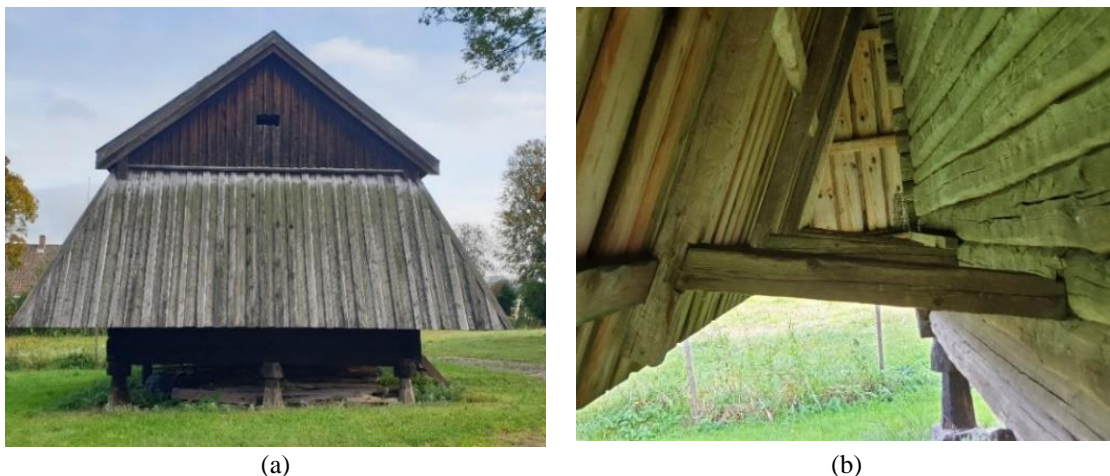
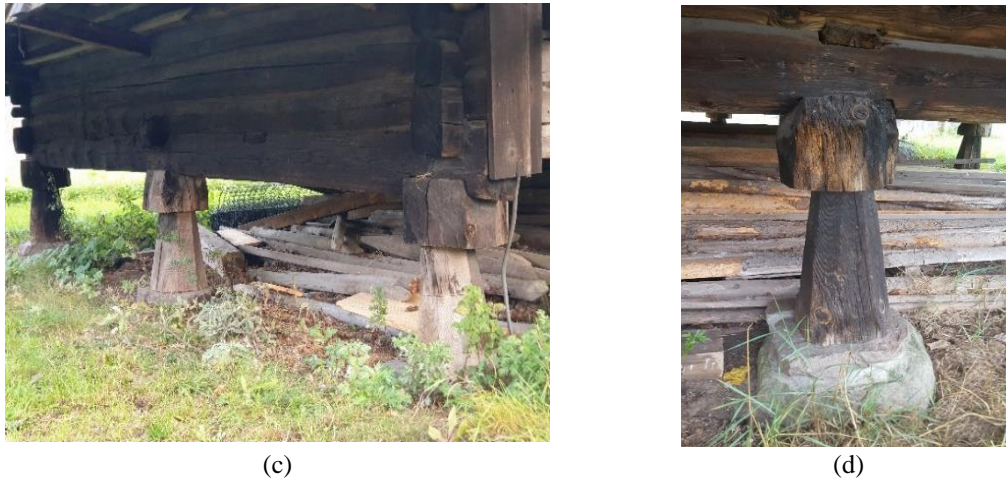
The building and its structural details are shown in Figure 6. As it is illustrated in Figure 6(d), the floor system is laid on the short timber columns which are on stone foundations. The main surrounding beams of the floor are simply connected to the columns without any constraints for rotation.

Figure 6: (a) Fadum Storehouse view, (b) Structural detail inside the coating, (c) Timber short columns under the building, (d) detail of the simply connected timber column

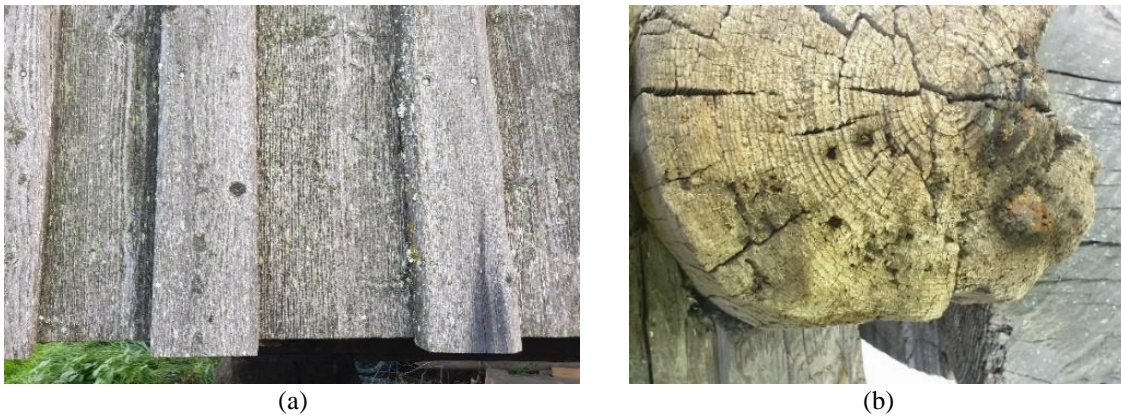
This building is generally in good condition but some deflection in main surrounding beams can be seen as well as biological damages. Figure 7 shows some of the biological damages in logs and on the coating.

Figure 7: (a) Lichen attack to the coating, (b) Insect attack on the timber logs

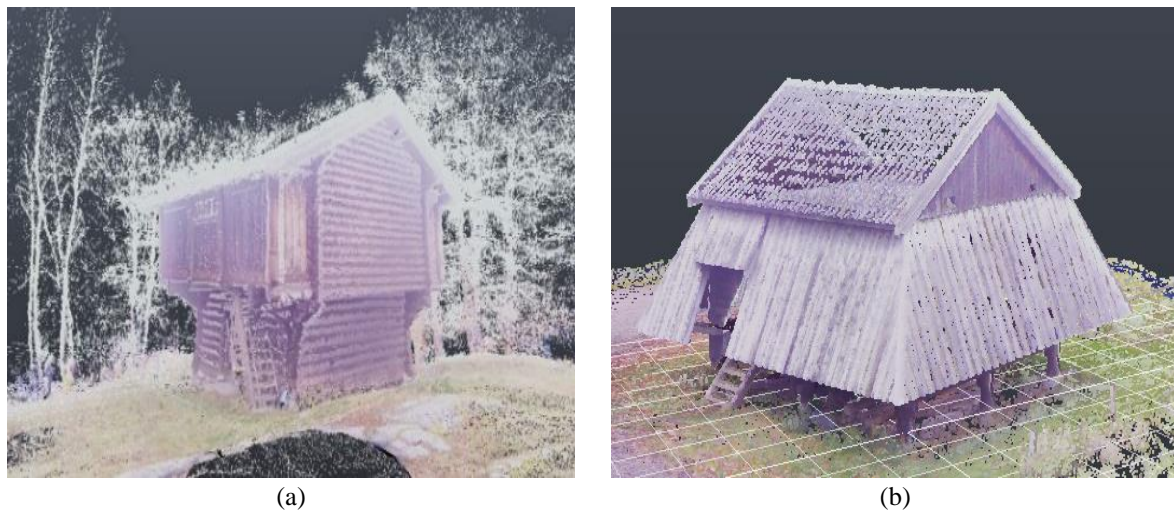
When utilising ReCap to perform the registration process, it was not possible to achieve fully automatic merging, and a manual approach was therefore chosen to complete the process. Based on this, at least three common points in two sequential scans were picked up to execute the registration and to obtain good merging results. Throughout this process, all the labelling rules and notes used in the field were taken into consideration in order to select the right scans to be merged together. The result is shown in Figure 8 for the two case studies.

Figure 8: Raw point cloud data for (a) Heierstad Loft, (b) Fadum Storehouse
