VULNERABILITY ASSESSMENT OF DWELLINGS IN THE HISTORIC CENTER OF CUSCO (PERU)

Keywords: Seismic Vulnerability, Historic center, Cusco, Adobe, UNESCO sites

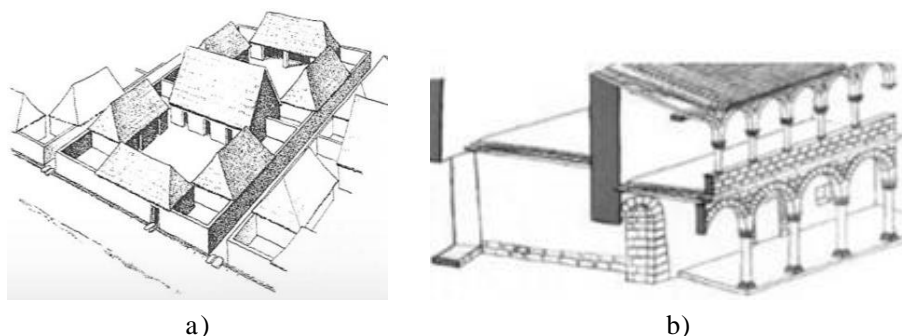
Figure 1: Evolution of structural typologies in Cusco: from the “kancha” of the Inca period (a) to the colonial houses of the Spanish domination (b).

The different historical phases also had repercussions on the built heritage of the city. In fact, the urban configuration of Cusco passed from the presence of common squares surrounded by rectangular-shaped aggregate buildings with internal courtyards of the Inca period (Figure 1a), to the reduction of the common squares extensions, during the Spanish domination, with the construction of adobe buildings atop the ancient walls of the Inca period that worked as foundations (Figure 1b), [11].

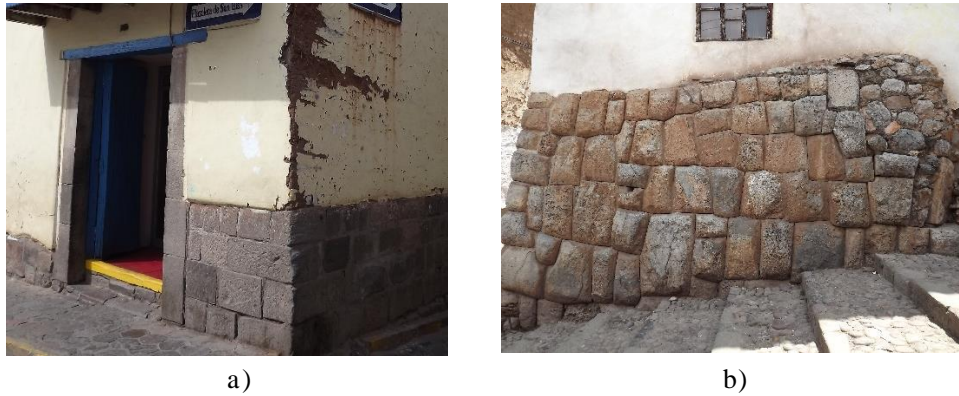
Figure 3: Main foundation typologies: the most recent stone foundations (a) and the ancient Inca foundations (b).

Focusing the attention on adobe structural units, they are mostly organized on two or three floors, with a height of about 2.5m. The adobe walls thickness ranges from 80cm to 100cm. The foundation system extends above the street level, to isolate the adobe walls from the humidity rising from the ground: stone foundations have been identified in about 77% of the

analyzed buildings (Figure 3a), however, in 2% of the structures the ancient Inca foundations are still recognizable (Figure 3b). These are made of very large granite blocks dry assembled. Floors and roofs are made of wooden structures which, due to the poor connections with the vertical walls, do not guarantee any type of restraint. Furthermore, sporadically, steel ties or ring beams that act as anti-seismic devices have been identified.

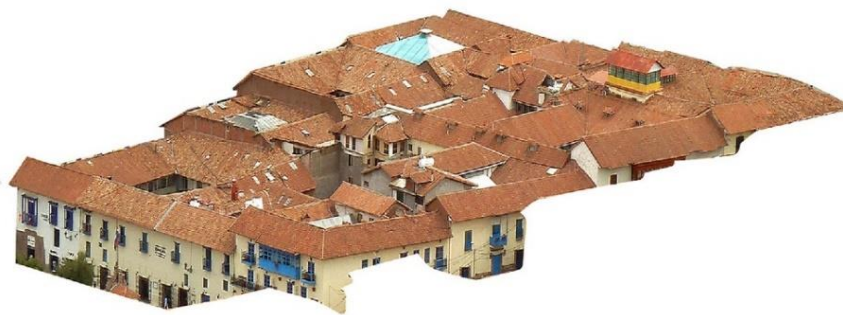
Figure 4: Graphic representation of a typical block in the historic center of Cusco.

Single structural units identified during the survey activity belong to large building clusters called “cuadra”, which have large internal courtyards typical of Spanish colonial houses and which are surrounded by roads, as shown in Figure 4. For this reason, an entry concerning the possible evacuation routes in case of a seismic event occurrence, has been also included in the survey form. This represents an important factor, since the escape route can be blocked by the collapse of a façade overlooking that street.

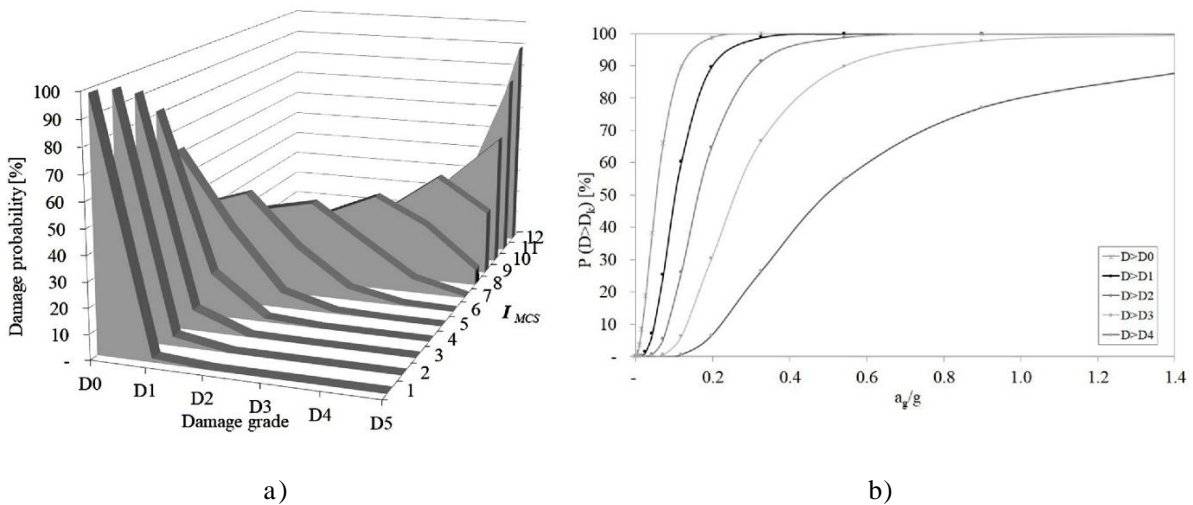
Figure 5: Expected Damage Scenarios represented by means of Damage Probability Matrices (a) and Fragility Curves in terms of Peak Ground Acceleration (b).

The empirical methodology implemented in this study allowed to assess the expected damage scenarios through the Damage Probability Matrices (DPMs) for different seismic intensities I_{MCS} . These are shown in Figure 5a and allow to assess how the damage scenarios evolve when the seismic intensity increases. Moreover, by summing the estimations coming from the DPMs, it was possible to define the Fragility Curves, shown in Figure 5b. They represent the probability of exceeding a certain damage level $P [D > Dk]$, in relation to a given Peak Ground Acceleration (PGA). To move from the Macroseismic Intensity I_{MCS} , in which the Damage Probability Matrices are expressed, to the PGA , the relation proposed by Margottini in 1992 was used [17].

Information that can be derived from these Fragility Curves are of considerable importance. For instance, if Cusco is hit by an earthquake characterized by a PGA/g equal to 0.6, the fragility

curves allow to predict the following damage scenario: about 60% of the buildings will have total collapses or collapses affecting more than 50% of the structure ($D > D4$); serious damage ($D > D3$) recognizable by large cracks and activation of overturning mechanisms, will affect 30% of the analyzed buildings; while, the remaining 10% of the examined stock will suffer damages that go from negligible to moderate ($D0 < D < D3$).
