# NUMERICAL INVESTIGATIONS FOR ASSESSING THE SEISMIC PERFORMANCE OF MULTI-TIERED NEPALESE TEMPLES

**Abstract.** *In this study, the seismic performance of old multi-tiered temples in Nepal has been addressed using three different computational approaches, including a) linear elastic; b) nonlinear static; and c) nonlinear dynamic analyses. Also, a sensitivity study was undertaken to understand the influence of wall thickness and height of Nepalese temples on their seismic behavior. Vertical oscillating modes using the elastic response spectrum of the Nepalese Building Code were obtained using linear analysis. Nonlinear static analysis (NLSA) were implemented to obtain the load carrying capacities of different in geometry temples e.g. different thickness of central core walls and number of tiers. Additionally, nonlinear dynamic analysis (NLDA) using the Finite Element Method (FEM) were performed to evaluate the characteristic tensile damage patterns. The results comparatively indicate the weakest zones depending on wall thickness, central core slenderness, opening distribution, box-like confinement, vertical misalignment of walls and so forth. Also, the results of the NLDA affirm hi

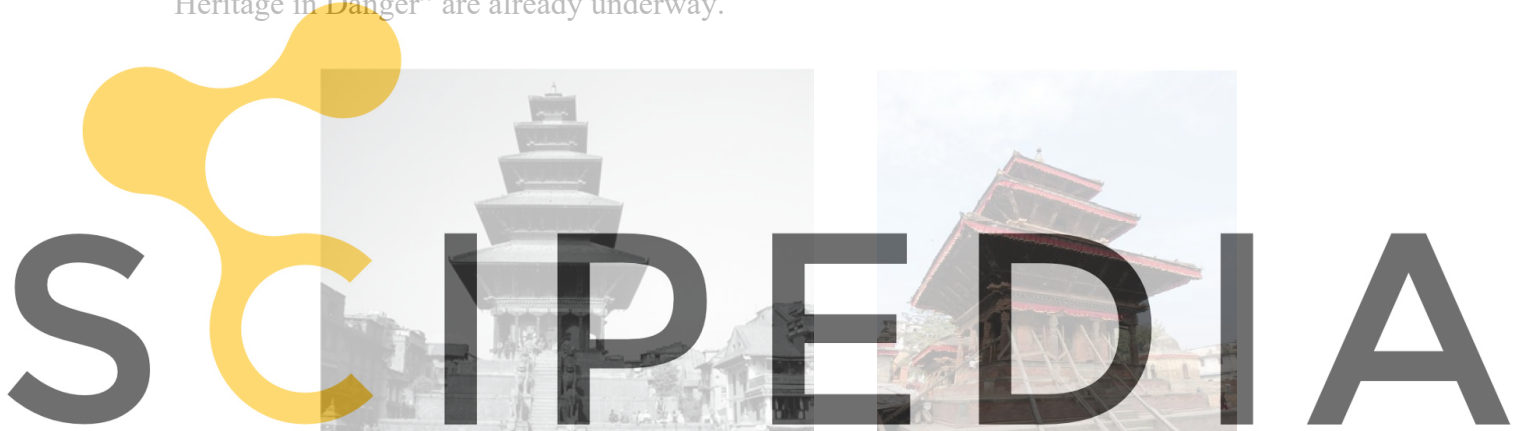
Figure 1 – Multi-tiered temples: Nyatopol temple (left) [5] and Gopinath temple (right) [6].

In particular, Nepalese multi-tiered temples are characterized by a combination of brickwork constructed with mud mortar. These structures are characterized by: a) geometric symmetry; b) asymmetry in mass distribution along the height of the structure i.e. the mass of the structure increases from top to bottom; and c) the temples are resting on a huge and massive plinth (or exposed foundation) [7].

Multi-tiered temples (See Figure 1) built in Nepal are traditional and monumental structures which apart from their architectural significance, present both valuable historic and archaeological importance. However, the 2015 Gorkha Earthquake and its related aftershocks dramatically altered the iconic historic structures in Nepal. According to Nepal's Department of Archaeology, around 750 heritage structures of significant cultural and religious value (e.g. temples and shrines) were affected. Discussions to place it on UNESCO's List of "World Heritage in Danger" are already underway.

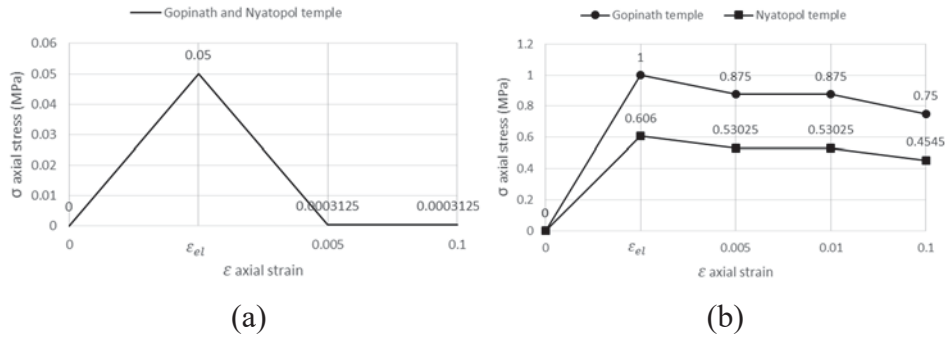
A macro-element model has been developed and the concrete damage plasticity model (CDPM) [8] implemented in ABAQUS has been used. Figure 3 shows actual non-linear behavior of masonry in both tension and compression.

Figure 3 - Non-linear uniaxial stress-strain actual behavior of masonry ((a) in tension; (b) in compression) [9].

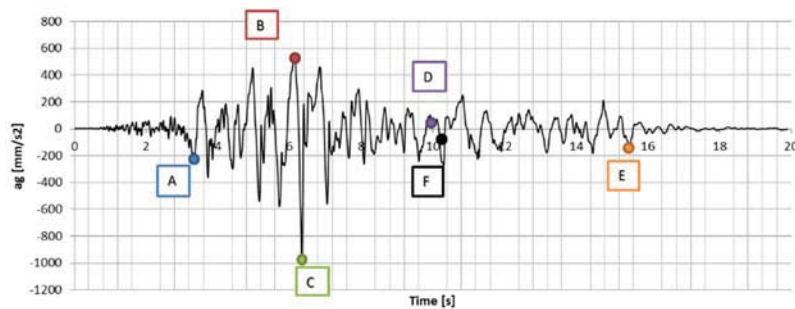
Time-history nonlinear analyses were performed using spectrum compatible for the location of Kathmandu Valley accelerogram as shown in Figure 7. This spectrum compatible accelerogram was used mainly for comparative reasons and to assess the damage and preliminary load carrying capacity evaluation of the temples under consideration.

Figure 7 – Spectrum compatible accelerogram PGA=0.1 g

In the NLDA, the peak ground acceleration has been taken as 0.1g for all 18 structures in each group of temples in order to compare tensile damages. In other words, the analysis was related to comparative damage analysis of two groups of temples with different dynamic responses under the uniform seismic recording applied in X direction for each temple.

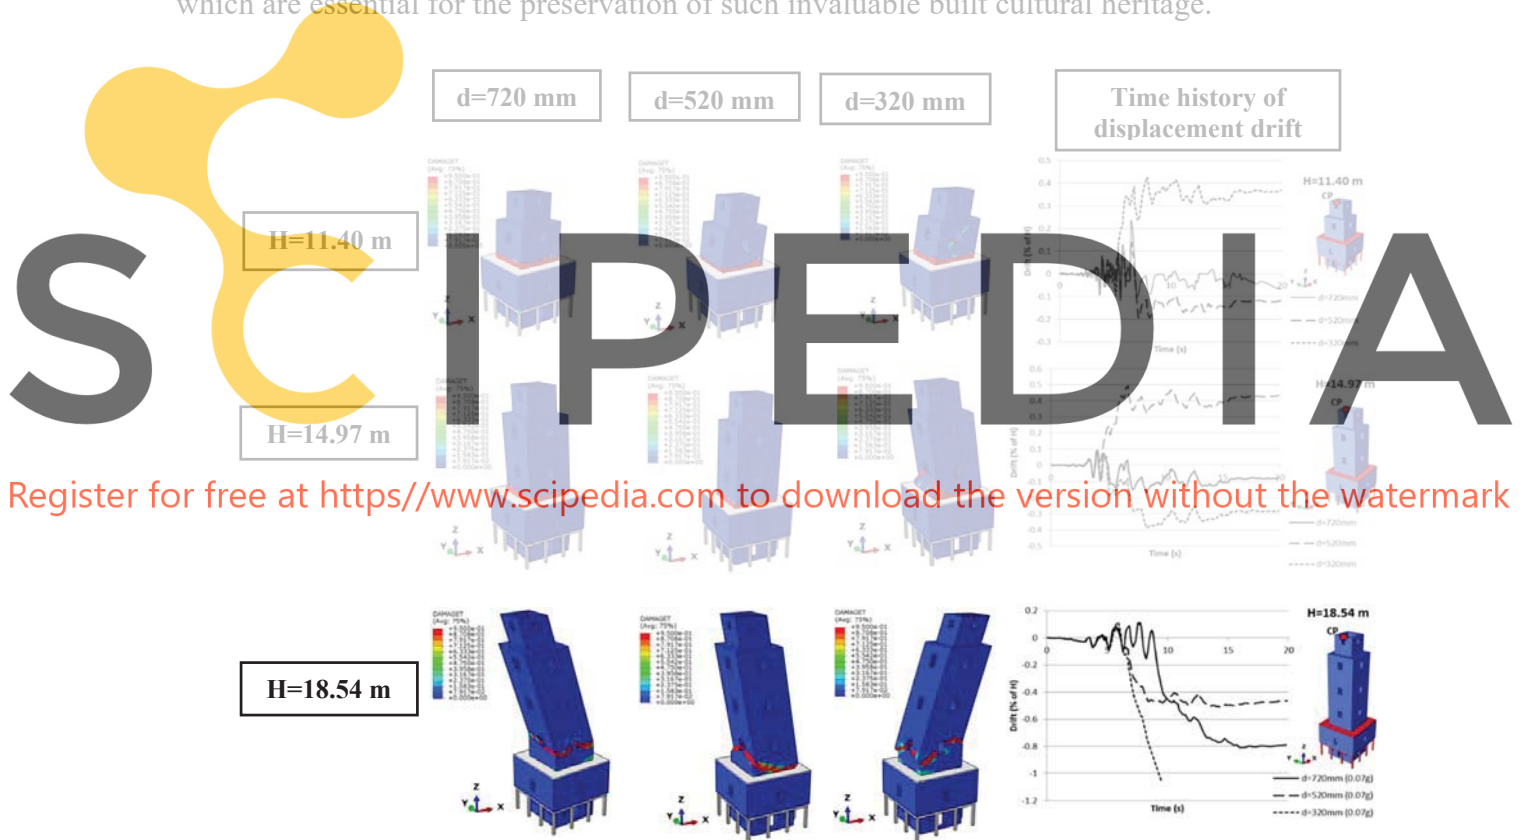
Figure 8 shows the tensile damage patterns and time history of relative drift for the first group of temples. Relative drift has been defined as the displacement normalized with the total height, expressed in percentages. When drift at the top of the structure is greater than 0.8 %, the structure fails. From Figure 8, it can be observed that for the original height which is equal to 11.40 m, damages are dominantly concentrated along the perimeter of the central masonry core at the level of the second floor, independently of the thickness of the walls.

Figure 8 – Final tensile damage patterns and time history of displacement drift of the control points for Gopinath temple with varied thickness  $d=720$  mm,  $d=520$  mm and  $d=320$  mm at the ground floor and varied height  $H=11.40$  m,  $H=14.97$  m and  $H=18.54$  m

For the structures with the height equal to 14.97 m, or in other words when one floor was added in the original geometry of the temple, damage patterns are to the great extent similar to the ones observed in the group of structures with the height equal to 11.40 m. Besides these, there are inclined damages in the case with the thickness of 320 mm which corresponds to

In the case when the height of the temple was equal to 18.54 m, damages migrate at the level of the lowest window openings. Cracks start from the end of the window openings and propagate to the top, allowing the upper part of the temple to overturn. The two temples with 18.54 m height experience incipient collapse (drift surpasses 0.8 % of the total height) with overturning of the tower-like upper part, which can be observed in the final row of Figure 8. Evidently, NLDA shows that plastic hinges for the most slender Gopinath temples occur at the level of the lowest set of window openings, while in pushover analysis overturning takes place around the hinge at the level of second floor.
