## THE DAR AL CONSUL COMPLEX IN JERUSALEM: IMPROVING THE LIVING CONDITIONS AND THE STRUCTURAL CAPACITY

**Keywords:** Jerusalem, Historical Structure, Masonry, Investigation techniques

**Abstract.** *The Custody of the Holy Land, with own and EU funds, and in Partnership with UN-Habitat, is implementing a comprehensive rehabilitation Project in Dar Al Consul civic and residential complex, which is one of the Custody properties in the heart of the Old City of Jerusalem. The complex, which corresponds to a urban block of relevant dimensions (80 x 50 m x 5 levels above and below the ground) and intersects the Roman Cardo, consists of 40 Houses and a basement floor used as a closed storage at the street level, besides sharing part of its ground floor with the old city market. Prior to the planned rehabilitation works in the houses - to improve the living conditions – and in the basement - to be reused as public space - the Custody intended to conduct a safety assessment of the complex for both static and seismic loads, in order to integrate any needed strengthening work within the planned restoration activities. A series of technical activities were then carried out aimed at evaluatin

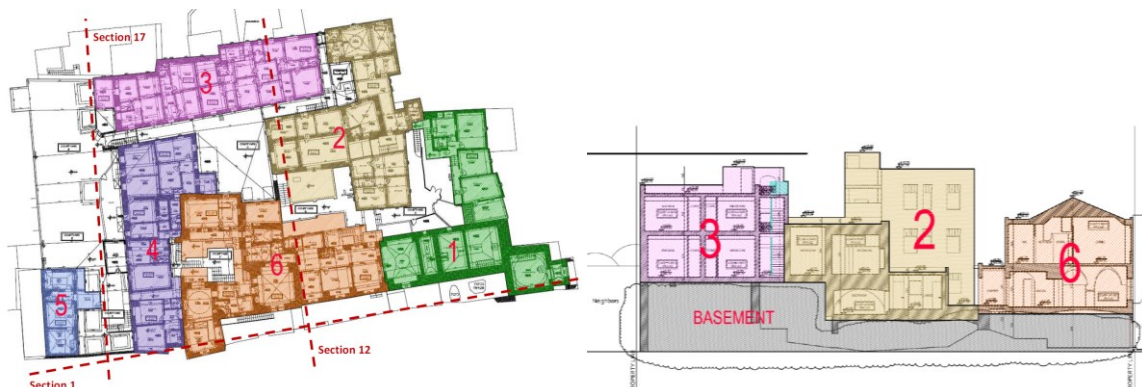
**Figure 1:** plan view and cross section of the Dar al Consul structural complex in the old city of Jerusalem

The building complex covers about 2'400 sq. m divided into 6 buildings, bounded by Khan El Zeit Street, where there are shops of the Jerusalem Souk, and El Tikkyeh Street, where the entrances are. The height of the buildings is variable and reaches a maximum of about 15m from the street level, with 3 floors besides the basement floor (Figure 1).

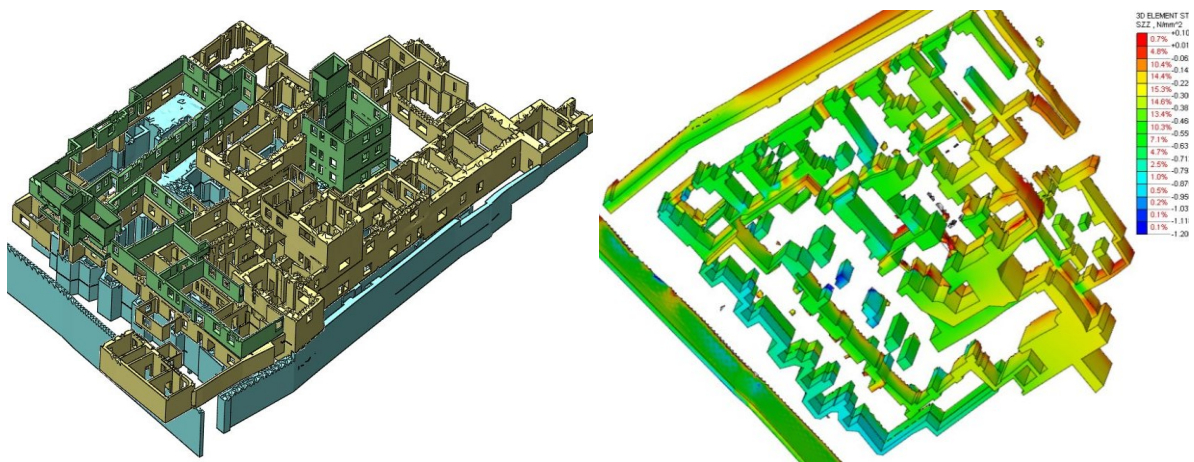
**Figure 4:** the Dar al Consul global FE model (left) and results of the self-weight analysis at the basement (right)

A tridimensional FE model of the Dar al Consul structural complex was created in order to evaluate the stress and deformation patterns in the masonry and concrete elements [9]. The model is bounded to the ground with fixed restraints, and it is composed by 430'291 tetrahedral 3D elements and 891 beams. The typical size of the tetrahedral 3D element is 0,5 m. The self-weight analysis was carried out according to the Israeli Standard SI 412 basic combination [10]. Results obtained in terms of  $\sigma_{zz}$  stress (compression) indicate that the average value of compressive stress at the ground (basement) level corresponds to approximately 0,5-0,6 N/mm<sup>2</sup>. In the upper floors the stresses decrease to 0,25-0,35 N/mm<sup>2</sup>. The maximum compressive stress locates at the basement level, where the poorest masonry quality was found, in the main pillars supporting building nr.4. An average compressive stress of approximately 1,0 N/mm<sup>2</sup> or slightly higher is found in the pillars subject to higher compressive forces. Considered the reduced masonry strength at the basement, and from the stability checks carried out, unsafe conditions emerge for the most stressed elements of the basement, namely the pillars sustaining the building nr. 4, but also for linear elements (walls) subjected to less load but with possible lower strength. The average value of stress found from the analysis is in line with the material strength as prescribed by the standards, and sign of cracks / lack of maintenance – and previous strengthening interventions by r.c. jacketing of the pillars – are present in this area, indicating this part of the complex as one of the most vulnerable from a structural point of view.

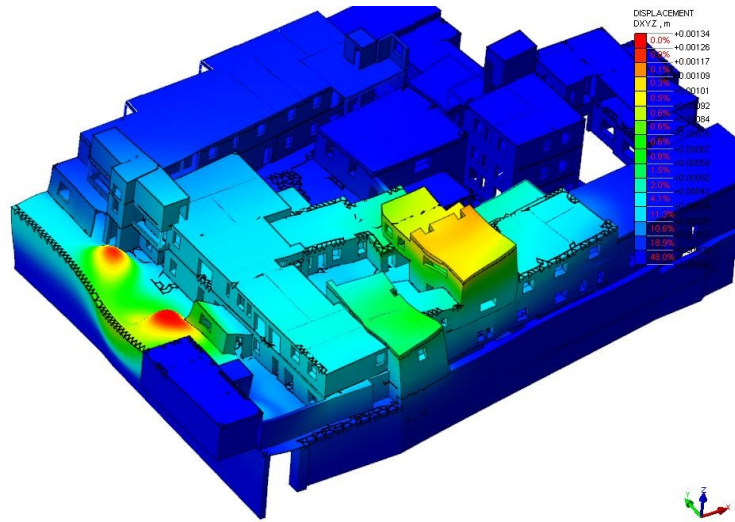
**Figure 5:** 3D FE model: a) mode nr.10 –  $f = 6,10$  Hz – 31% of mass participation, dir.X

In a first step, the FEM model proposed the analysis of the natural frequencies and associated modes of the structural complex, describing its linear dynamic behavior. The strong degree of compactness of the structural complex, as well as the confining action of the adjacent buildings, stiffen the structural dynamics of the complex, and only relatively few well identified modes were clearly identified, all of them related to the upper levels.

Results of the spectral response analysis, by employing the design response spectrum prescribed by the Israeli Standard SI 413 [11], indicate presence of non-negligible shear stresses in the masonry of the upper levels, following the mode shapes distribution. The shear values are however generally limited, reaching only in few points values non-compatible with the material strength, indicating possible damage concentration areas, in case of the design earthquake.

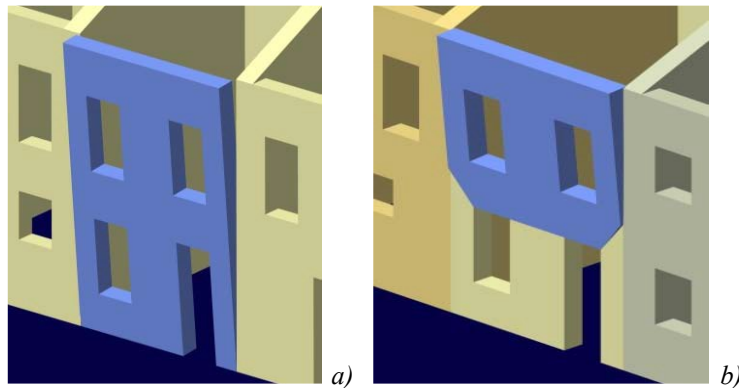
**Figure 6:** global overturning and upper overturning local collapse mechanism

For each possible significant local mechanism, a part of the construction becomes a labile system (kinematic chain), through the identification of rigid bodies able to rotate between them (mechanism of damage or collapse), usually defined on the basis of typically seismic induced shear surfaces (cracks). The seismic action is then schematized as an equivalent static force given by the product of the mass of the wall and of the vertical loads, times the seismic acceleration, regarded as constant along the height of the wall. The procedure continues with the evaluation of the multiplier of loads (ratio of horizontal forces applied and weight of the masses) which activates the mechanism, that is to say that equals the stabilizing (loads of structural elements) and unstabilizing (inertial seismic) forces. Out-of-plane mechanisms relative to vertical strips of masonry were studied, involving the overturning of the whole wall (Figure 6a) and of the upper level/s of the same wall (Figure 6b).

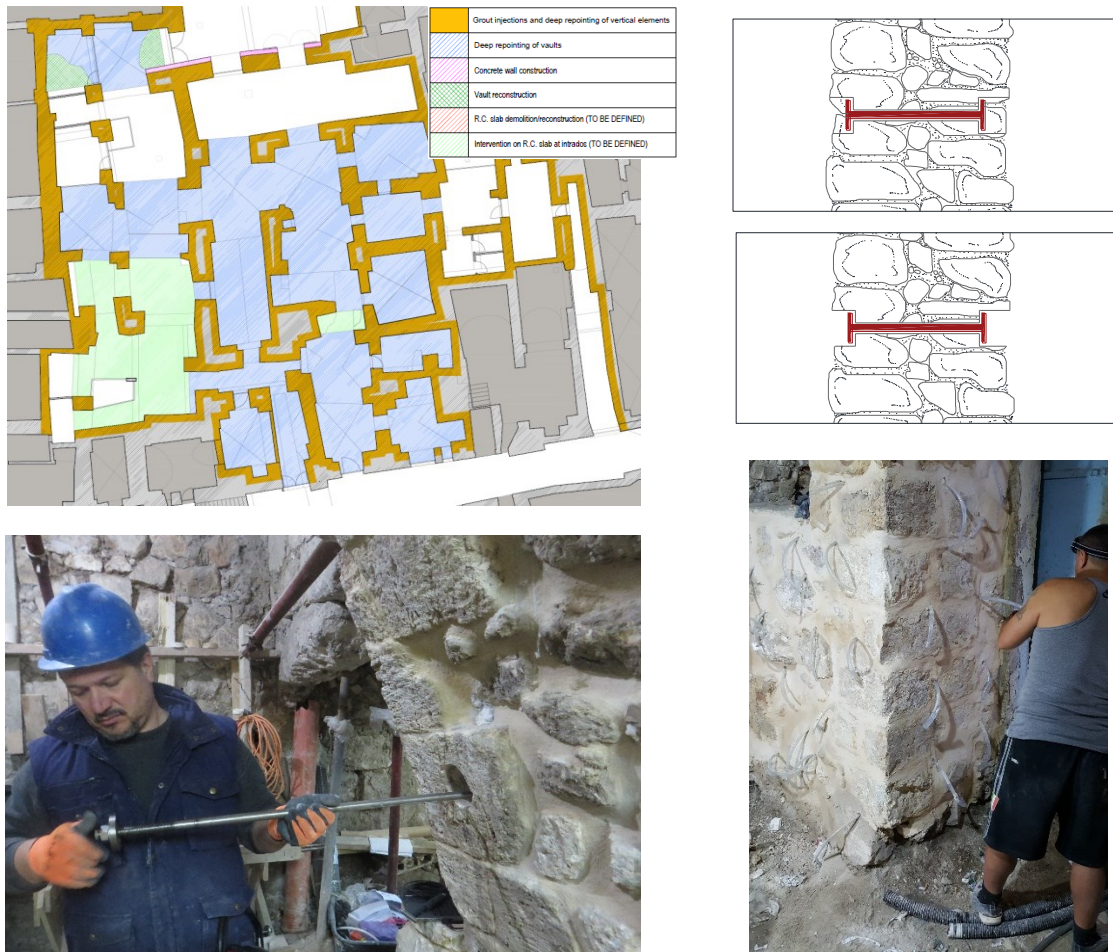
**Figure 8:** general layout of the interventions in the basement structures, strengthening intervention on pillars

It is noted a generalized lack of structural consistency in several areas of the basement resisting structures, for intrinsic reasons and for lack of maintenance interventions for relevant periods. The encountered masonry typology of the basement corresponds to irregular stone masonry, thus indicative of a structural vulnerability, worsened by the poor mortar quality. The results of the structural analysis indicated furthermore relevant stress values in the basement, especially in some vertical elements, where previous strengthening interventions were already introduced. For this reason it was considered critical – besides providing a generalized improvement of the mechanical characteristics of the stone masonry structures (hydraulic lime grout injections, deep repointing), to locally intervene to strengthen the most heavily loaded pillars, subjected to excessive compressive values with reference to the actual masonry capacity. Interventions such as “confinement” or “stitching” were designed and applied – together with the overall interventions of hydraulic lime grout injections and deep repointing – to provide an increased strength to such structures, consequently increasing their “safety” conditions.

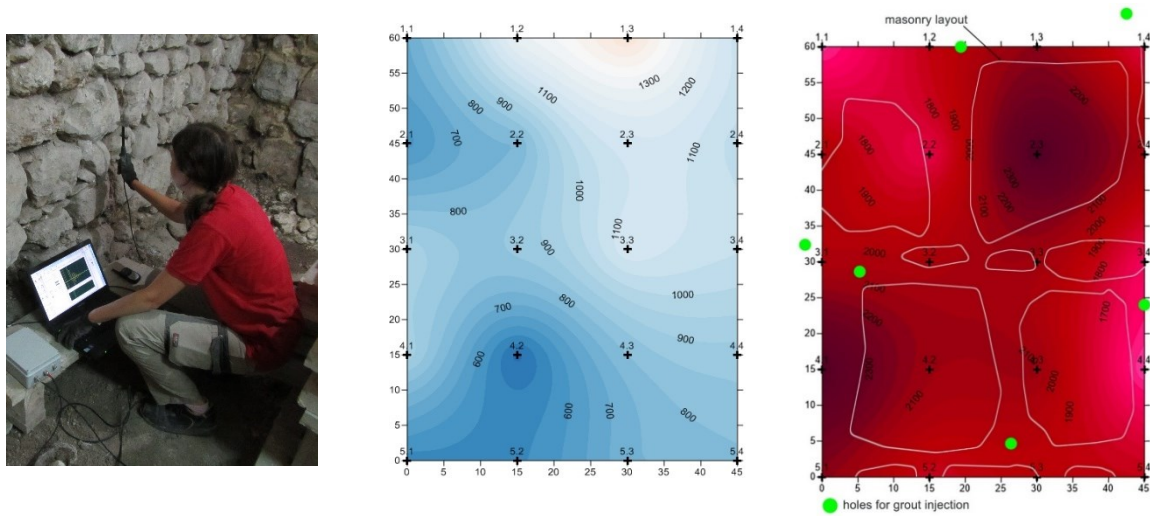
**Figure 9:** sonic test SON4/SON4i, comparison of velocity before (avg. 800 m/s) and after (avg. 2000 m/s) the injection intervention, graphic representation between sonic velocities (face view of the acquisition grid)

“Traditional” intervention methods were hence employed, always employing compatible materials as hydraulic lime mortar, as deep repointing in masonry walls and pillars, together with more recent techniques which proved their effectiveness, specifically in case of low resistance stone masonry elements. Between these, grout injections in masonry walls and pillars, executed with a high absorption ratio and validated through further investigation activities (direct sonic tests, **Figure 9**), since an overall increase of the velocities measured was widely found (in case of test SON4, an increase of 220% was recorded). Other methods employed were the confinement of masonry pillars and walls transverse tying, in areas of stress concentration, as emerged from the structural modelling. In cases in which there was lack of material, stone integration/reconstruction was considered, highlighting the newly introduced from the original material.

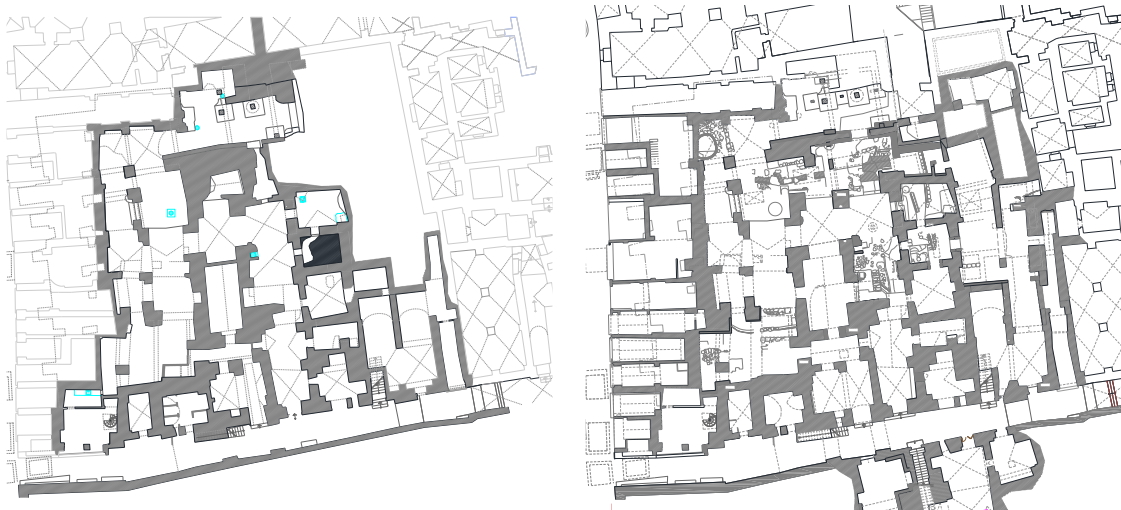
**Figure 10:** geometrical survey of the basement in 2014 (left) and today (right), with a relevant increase in area and excavations depth

A relevant part of the activities finally corresponded to the excavations in the basement soil, which, year after year, gave the possibility to reach lower levels and find buried structures, also with relevant historical and archaeological findings (e.g. tombs, roman era shops), see **Figure 10**. From an engineering point of view, it was, and it still is a challenge to support the superstructures with uncertain soil conditions, given the difficult execution of geotechnical investigations, the diffuse presence of cisterns in the bedrock and the chaotic stratification of the historical layers of the underground Jerusalem.
