## FLEXURAL RESISTANCE OF MASONRY WALL RETROFITTED WITH TIMBER PANEL UNDER OUT-OF-PLANE LOADING

ORNELLA IUORIO<sup>1\*</sup>, JAMIU A. DAUDA<sup>1</sup> AND PAULO B. LOURENCO<sup>2</sup>

**Abstract.** *Retrofit of unreinforced masonry (URM) structures is incessantly attracting interests of masonry professionals. Because there are enormous URM structure stocks in different parts of the world that have shown vulnerability to damage against out-of-plane actions due to having limited flexural strength and deformation capacity [1]. As such, there is a global trend of promoting the development of sustainable retrofit techniques for URM structures. The authors' previous study [2] has introduced the application of oriented strand board type 3 (OSB/3) as a prospective sustainable retrofit material for URM wall with evidence of improving the flexural performances. This paper presents, for the first time, experimental works on 1115 x 1115 x 215 mm double wythe single leaf URM walls. Specifically, quasi-static out-of-plane loading tests were carried out on two plain specimens, two single-sided retrofitted walls and two double-sided retrofitted walls. The flexural and displacement capacities

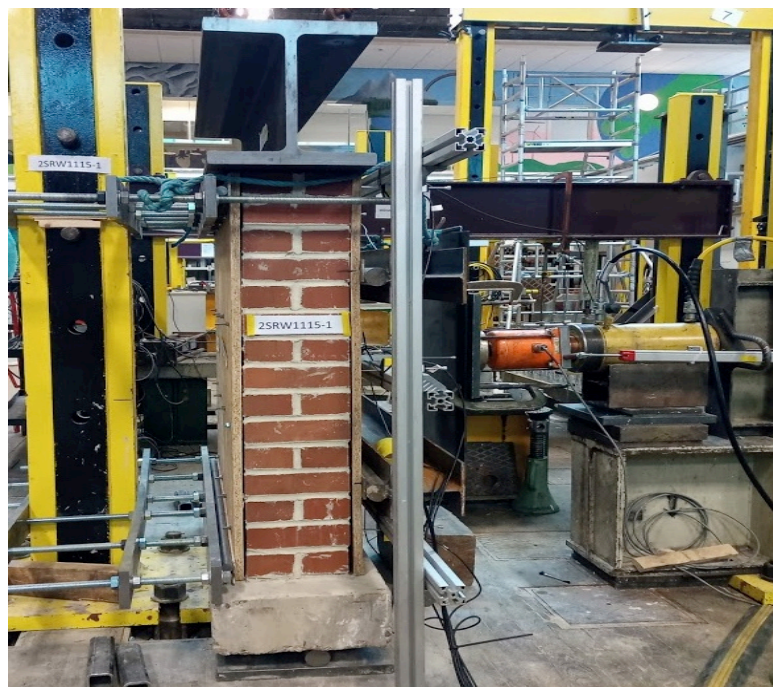
The specimens were tested under four-point loading test arrangement [12] to assess their flexural behaviour. The test was load controlled, and the load was applied to each tested specimen using a hydraulic ram and was distributed through a steel spreader arrangement in the central area of the wall (Fig. 1). All specimens were tested with simply supported boundary condition and a vertical pre-compression load (305 x 305 x 240 UC section amounting to 3 kN load) on top of the wall. The specimen constructed on reinforced concrete footing was rested on 50 mm diameter cylindrical roller with the axis of the roller parallel to the face of the specimen. At the back of the wall, 5mm thick metal plate was fixed across the middle of the top and bottom course of the wall to provide contacts for the simply supports. Similarly, 5mm thick metal plate was fixed at 1/4th and 3/4th of the specimen height at the front side to provide contacts for which the loading rollers rest.

Figure 1: Test set up

The loading scheme was such that an initial load was applied continuously at a rate of 1kN/min for up to 5kN and then maintained for 5mins period. The purpose of maintaining the applied load was to allow the wall assembly to come to substantial rest before taking the next set of reading [11]. Also, this helped to observe any time-dependent deformation and load redistribution. The load steps were repeated continuously for 10kN, 15kN, 20kN, 25kN, and 30kN load and maintained for 5mins period at each load step. After that, the load was increased continuously to the failure of the specimens. In order to obtain the maximum capacity of the retrofitted walls, the applied load was increased continually after the first crack until additional cracks were formed in the retrofitted specimens and ultimately the timber at the back of the masonry walls were broken. During testing, the applied load on the wall were monitored using a 200kN capacity ring load cell. Also, 8 LVDTs were used to record the deflections of the test specimen along the wall centre, mid-top and the bottom.

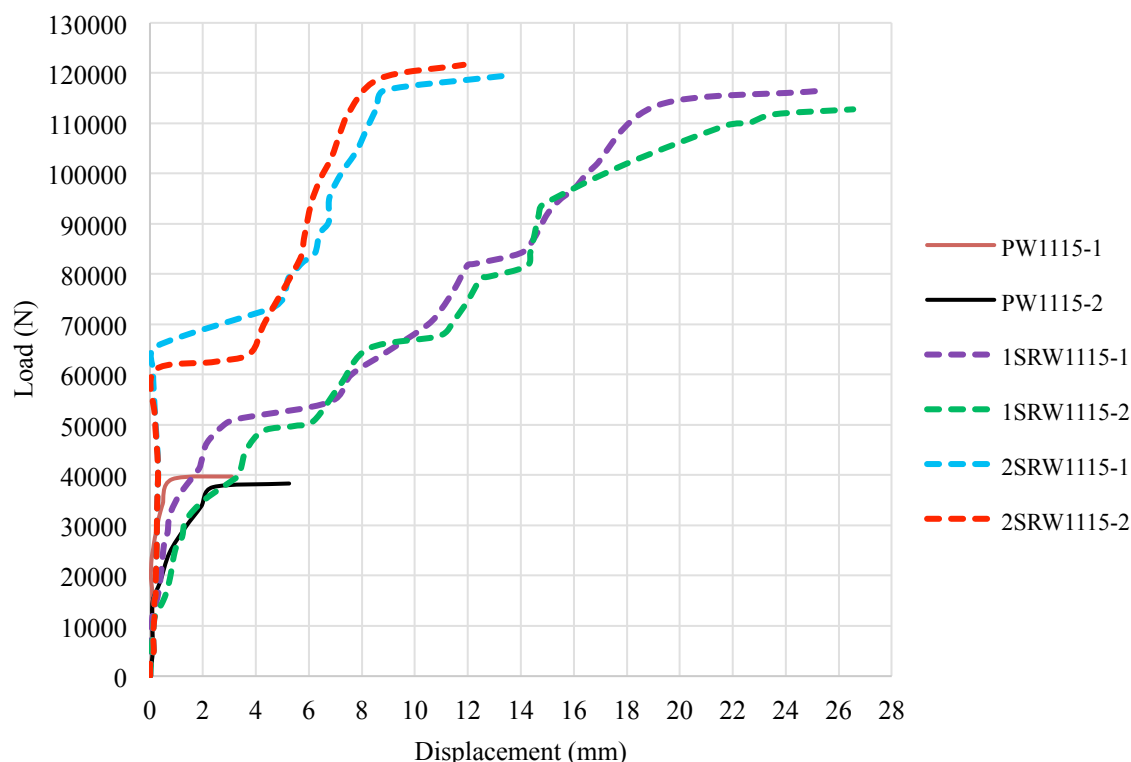
The net out of plane displacement in the mid-height of the wall was estimated by deducting the mean displacement recorded at the top and bottom of the specimens from the average mid-height displacement. This deduction accounted for the unexpected displacement at the top and bottom of the wall. Figure 2 shows the load-displacement curves obtained from the experiment. The inference from figure 2 shows that the plain specimens PW1115-1 & PW1115-2 have a quasi-linear behaviour up to about 15000 N loads, which corresponds to the onset of crack formation in the plain wall. After that, the load continuously increased with small increments in the out-of-plane displacement before the specimen failed. At the failure point, the displacement suddenly increased. This increment is due to the brittle nature of the failure pattern. The maximum load attained by PW1115-1 and PW1115-2 is 38330 N and 39720 N respectively. The average of these two value (39025 N) was chosen as a baseline to evaluate the effectiveness of the proposed timber-retrofit technique in both single-sided and double-sided retrofitted walls. For the retrofitted wall specimens, the first crack appeared at an average load of 52750 N and 68714 N for 1SRW1115 and 2SRW1115 respectively. Finally, the average peak load and out-of-plane displacement at the specimens mid-height were estimated as (114622 N, 25.88 mm) and (120559 N, 12.61 mm) for 1SRW1115 and 2SRW1115, respectively. Figure 2 reveals that the proposed retrofit technique has substantially increased the out-of-plane load capacity of retrofitted walls by almost three times when compared to the plain wall.

Figure 2: Load vs Displacement curve for specimens

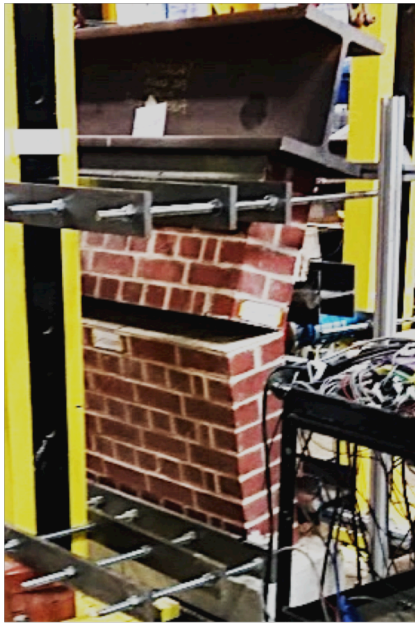
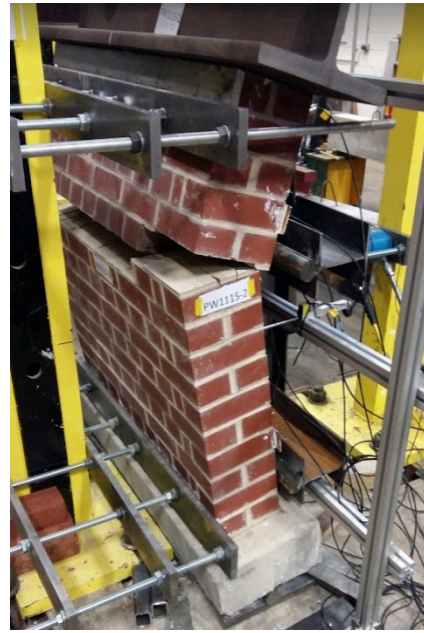
The observed failure pattern in the plain walls is characterised by the sudden formation and rapid opening of the crack in the unit/mortar joint interface throughout the whole wall specimen thickness. The failure of the plain masonry wall is quasi-brittle and always started with the formation of a crack opening in one bed joint at the tensile face of the specimen (i.e. the side opposing the loading face). Subsequently, the crack occurred in the bed joint was propagated through the perpend joint to the next bed joint. The crack occurred throughout the whole thickness of the wall so that the unit-mortar interface was completely separated (Fig 3).

a) PW1115-1

PW1115-2

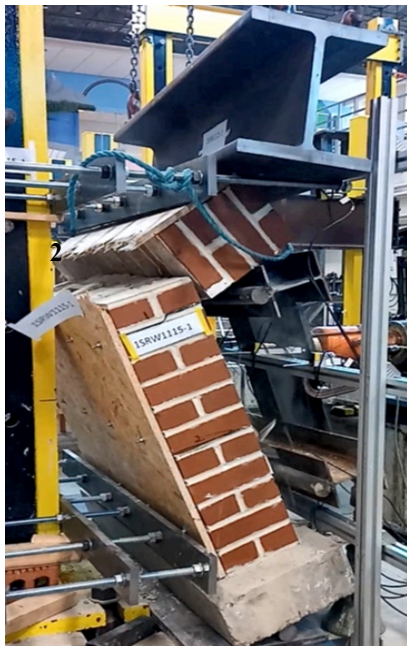
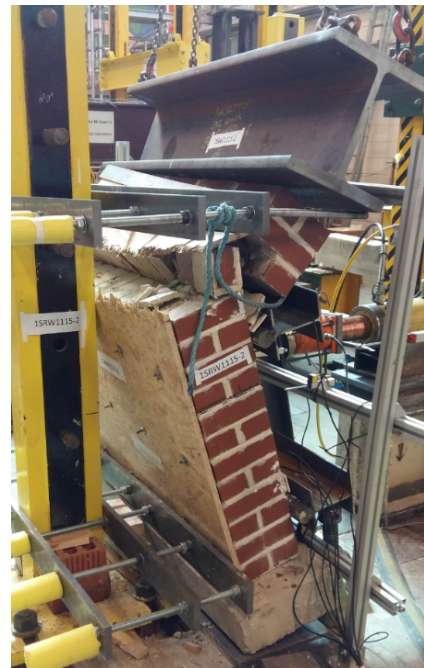
The behaviour of single-sided retrofitted masonry wall (1SRW) shows that the net out-of-plane displacement of the specimens increased with the applied out-of-plane load from the beginning. This behaviour indicates that 1SRW specimens started to deflect while remaining undamaged. The failure of 1SRW began from the tensile face with the first crack occurred in the unit-mortar interface at 54600 N and 50900 N for 1SRW1115-1 and 1SRW1115-2 respectively. But the application of the OSB timber panel at the back of the wall specimens kept the specimens un-separated after the first crack. Therefore the loading increased continuously until other cracks appeared in the bed joints parallel to the first crack still within the inner bearing for 1SRW and 2SRW (Fig. 3b & 3c).

b) 1SRW1115-1

1SRW1115-2

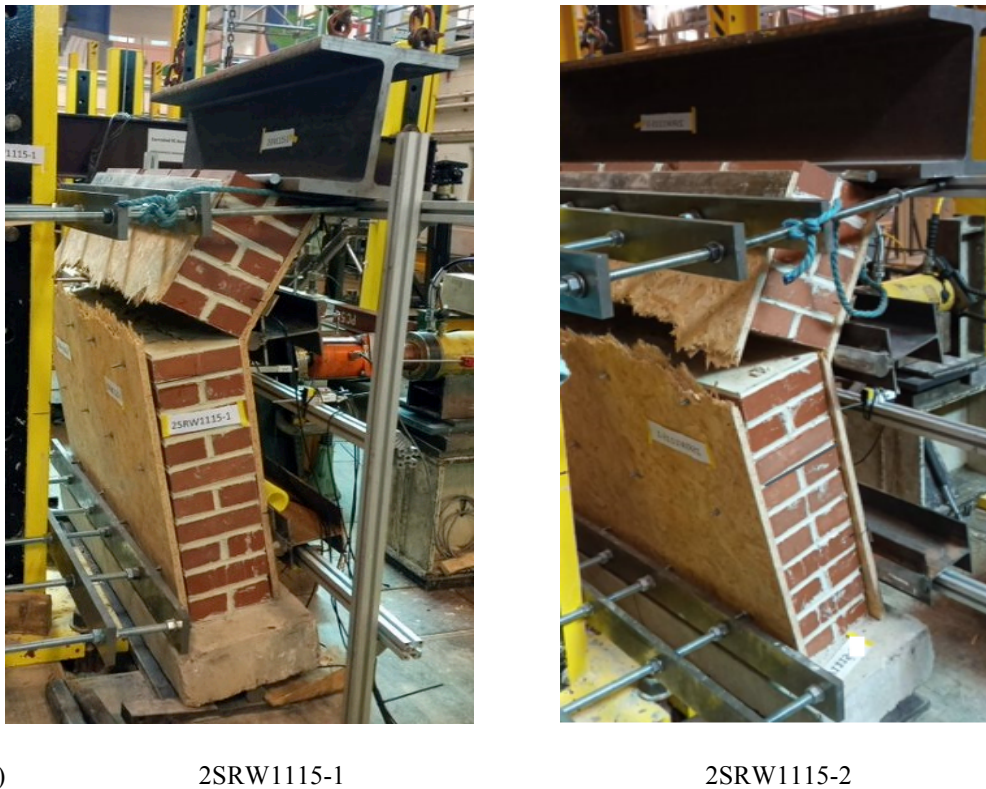
Meanwhile, the double-sided retrofitted wall (2SRW) shows approximately no displacement (0.25 mm) before the first crack occurred in the masonry part at an average load of 68714 N. This implies that the addition of the timber panel on the compression face (i.e. the face where the load was applied) in 2SRW improved the lateral resistance of the 2SRW specimens. So, double-sided application means that the specimen remained undamaged before the first crack occurred at an average load and displacement of 68714 N and 4.18 mm respectively.

**Figure 3.** Failure pattern of retrofitted masonry wall
