INTEGRATED CONSERVATION STRATEGIES IN THE NETHERLANDS

Abstract. *In the Netherlands a program for the enhancement of quality in the restoration of monumental buildings is presently carried out, stimulated by national authorities and coordinated by the foundation ERM. Guidelines are issued by the branches involved, from architects to masons, under guidance of an experts' committee, to perform interventions on monuments and assess them. The aim of this paper is to discuss the contributions to the program offered by different actors active in the field of conservation, the existing synergies and the potential of using a common language and approach. These are needed to facilitate communication and exchange knowledge. The use of the terminology of MDCS (Monument Diagnosis and Conservation System) can help create a community of stakeholders. Sharing the damage terminology and methodology can help achieving a clear and systematic assessment of damage and its causes. It can further improve the communication among all stakeholders, including owners and laymen, stimulating cooperation, and can allow monitoring of damage and interventions.*

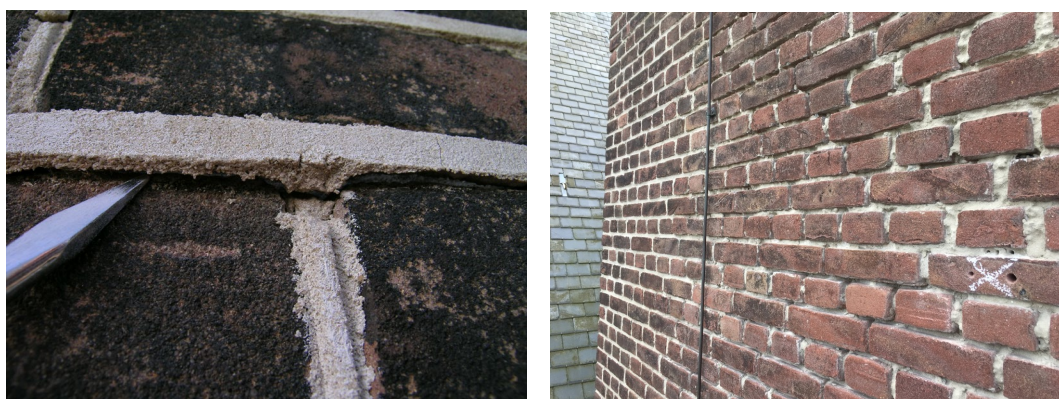
A passage of a MW report made before the adoption of the new terminology has been selected to show a description of damaged pointing. No reference to the source is given for privacy reasons. The description of the type of damage rises questions: ‘especially in the higher part (of the masonry) the pointing is damaged, cracked, has lost adhesion, is detached or washed out’. It is clear for the reader that the pointing is damaged and gone, but in which way? In one piece or through e.g. erosion? It is fundamental to identify the phenomenon in order to better understand the mechanism behind it: for example, in the case of push out, the pointing maintains its cohesion and is indeed pushed by e.g. the formation of a swelling compound or frost action; in the case of erosion the pointing loses particles [figures 3].

Figure 3 Examples of push out of pointing(l) and erosion (r)

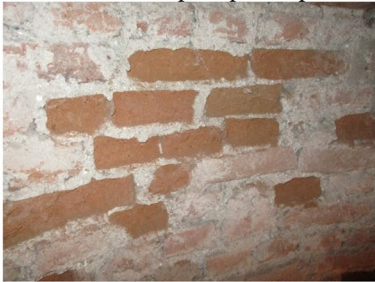
Figure 4: Passage of a MW report. The masonry is in a good state (G), with the exception of some moisture penetration and powdering of the stones. (No reference to the source is given for privacy reasons).

In the first example the state of conservation of the masonry of a staircase is described as ‘good’, with the exception of some moisture penetration and powdering of the bricks. In the following report, MDCS terminology and methodology presented in the course (Monumentenwacht moves) are implemented. The identification of damage and its context is more complete and clear. Although the general state of conservation is rated as good, locally

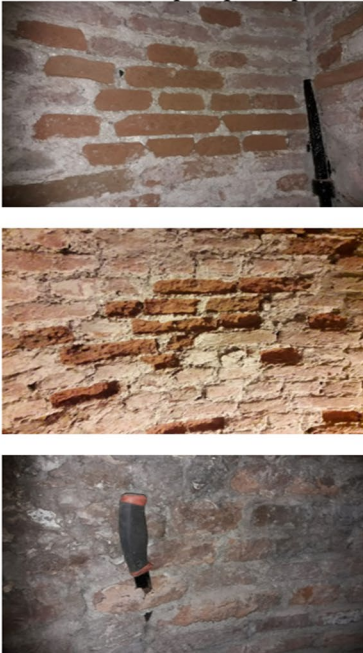
Figure 5: Passage of a MW report concerning the same masonry as in fig. 4, but written on the basis of the MDCS terminology and methodology. The damage is better identified and the damage mechanism explained. (No reference to the source is given for privacy reasons).

occurring damage is reported at the west side. The damage is identified as powdering, and moisture penetration is assessed. The mechanism is also explained: due to the moisture penetrated in the wall (soluble) salt is transported and deposited at the surface of the masonry, where it crystallizes causing damage to the ‘softer’ bricks in the first place. The specific damage found at different locations is disintegration → powdering (second picture) or layering and spalling (third picture). This way of reporting and explaining damage - based on visual assessment, which is inherent to the way of operating of MW – provides the inspector with a basis for planning further investigations (e.g. moisture and salt distribution) or else monitoring the extension and severity of the damage. MW Gelderland is presently developing a tool facilitating the storage of the information on the damage types and interventions. Such a tool would be easy to manage and could be used during (MW) inspections; it is deemed important for recording data, which are presently not always traceable, i.e. data concerning interventions.
