## TESTING CALIBRATION ISSUES IN RESISTANCE DRILLING APPLIED TO TIMBER ELEMENTS

*Resistance drilling devices are commonly used for the onsite inspection of wood and timber structural components in existing buildings. Although they provide a measure related to the density variation along a section of an element, results are used mainly qualitatively, due to several parameters that affect the computed values.*

*In this paper, several new and old timber elements, taken from the dismantling of original roofs from a large existing historical building in northern Italy, are tested through a series of ND (non-destructive), SD (semi-destructive) and destructive testing procedures. Various wood species (spruce, fir, larch, oak, elm, pine) are taken into consideration.*

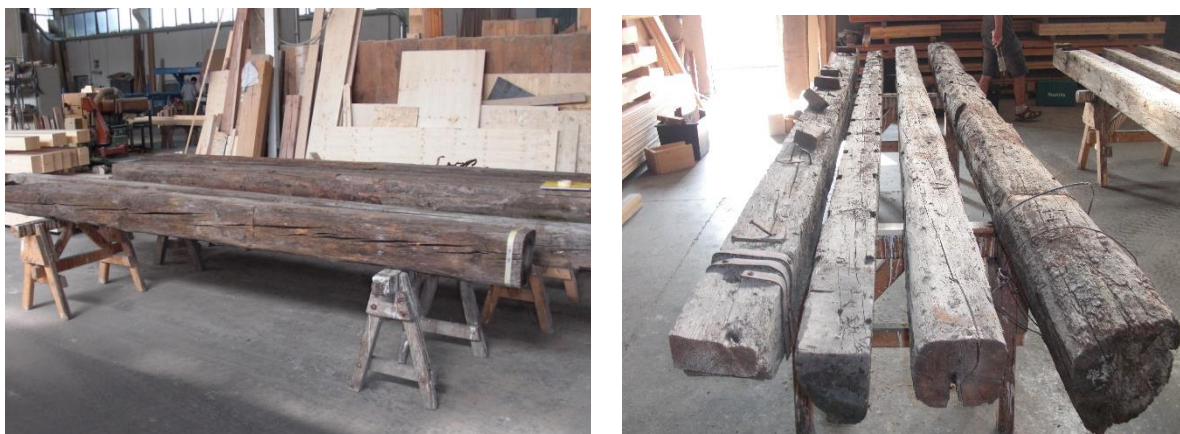
Figure 1: Timber beams ready to be tested at Bozza Legnami premises

- 21 “old” beams of different species, recovered from the dismantling of the roof of the Moncucco farmhouse in Milan (now a student house of IULM University of Milan), having different dimensions and cross sections (Figure 1).
- 12 new beams (6 spruce and 6 larch beams), having a cross section of 160x160 mm and different lengths. The new beams are classified as C24 (spruce) and C22 (larch) according to the resistance classes of UNI EN 338 [5].

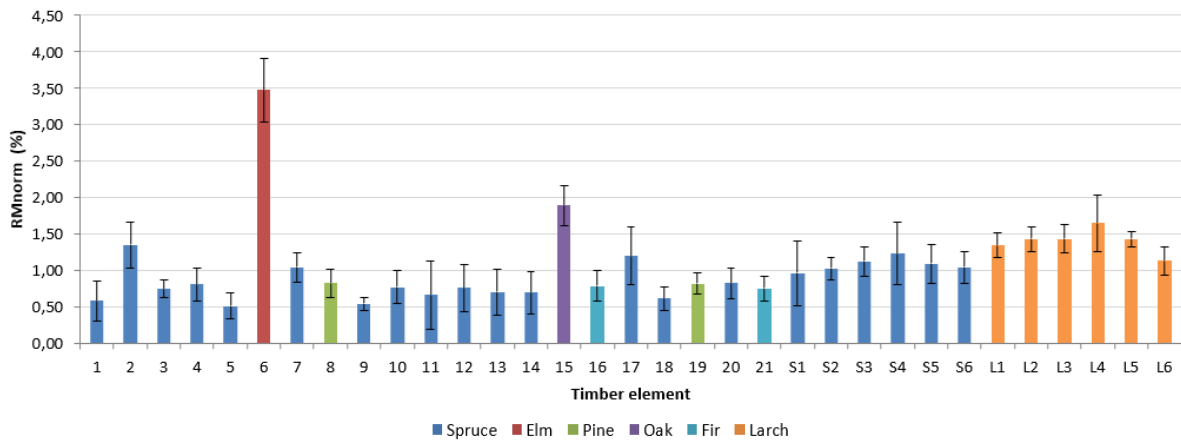
**Figure 4:**  $RM_{norm}$  values for all the tested timber elements, corresponding nr. 1-21 to old elements and acronyms S1-S6 / L1-L6 to spruce C24 and larch C22 new elements

The reference parameter was then  $RM_{norm}$ , intended as the ratio between RM calculated from a test position on the timber element and  $RM_{C24}$ , i.e. the RM value calculated only for the first 27 mm of known spruce; in both cases, the parameters were determined considering the "feed curve" of the used device [7]. The aggregate  $RM_{norm}$  values for all tests per each beam are shown in Figure 4. The C24 sample element applied on the timber surface of the investigated beams to compute normalized values of RM proposes indeed more informative data on the evaluation of the actual state of wood, for allowing immediate test results comparison among different cases and conditions. The use of the C24 spruce element allowed also to evaluate the trend of the RM value over time, observing how this increase with the number of the measurements. The use of a normalization element is therefore necessary as measurements performed on the same element at different times lead to different (increased) RM values (Figure 5).

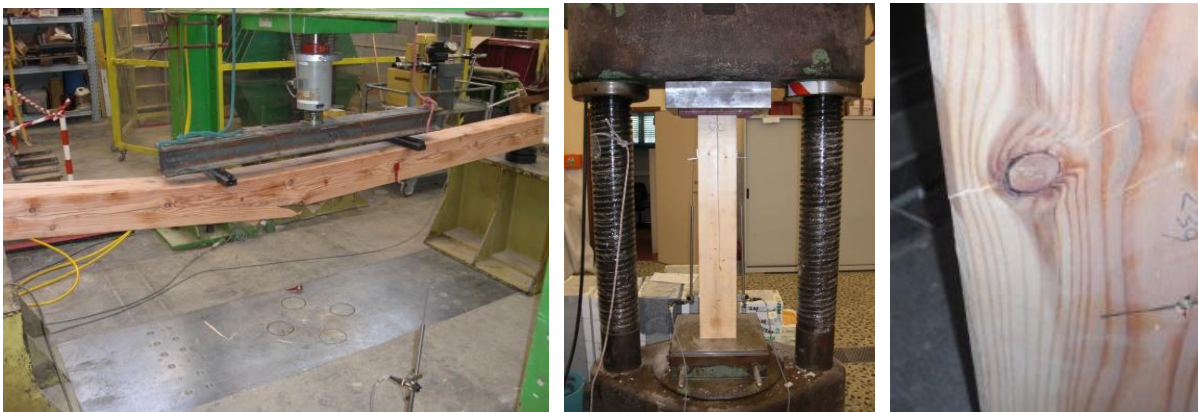
**Figure 7:** Execution of mechanical tests at DICEA laboratory, according to EN 408 (compression/bending)

Experimental laboratory tests were carried out with the aim of obtaining the mechanical parameters that can be correlated with the results of the non-destructive and semi-destructive tests carried out on the same timber elements. The tests carried out were bending and compression tests on real-scale elements (Figure 7).

Both types of test refer to the requirements indicated in UNI EN 408 [8], which specify the test methods and the dimensions of the samples. Tests involved 9 reused and 6 new timber elements.

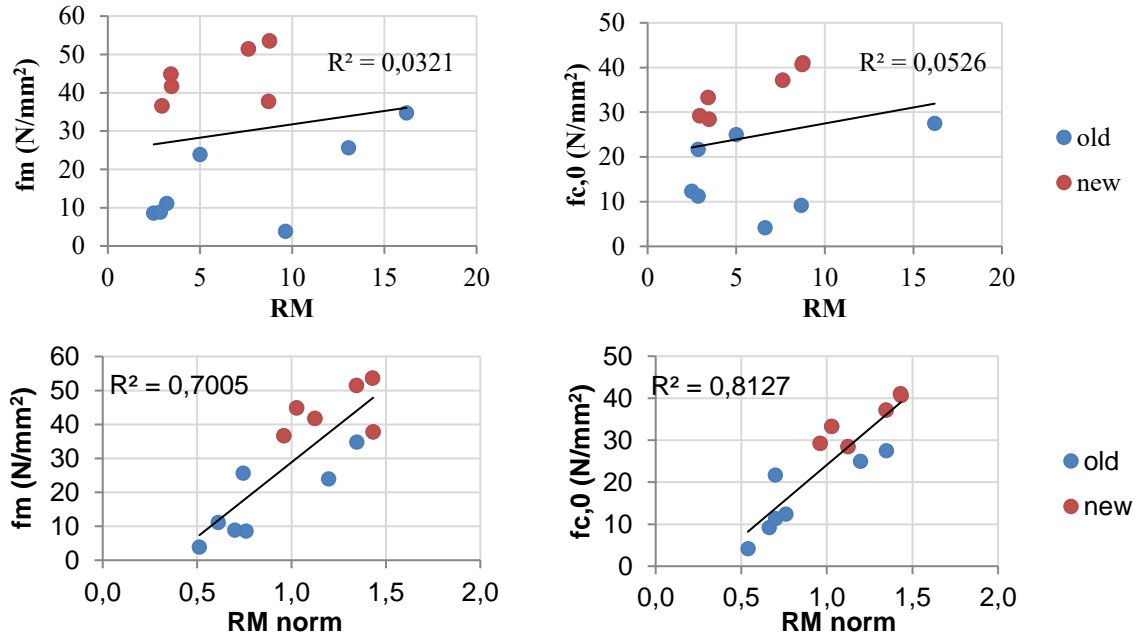
**Figure 8:** Correlation of mechanical characteristics of old and new timber elements in terms of compressive and flexural strength, versus the parameter RM (above) and  $RM_{norm}$  (below)

A comparison between the resistance drill averaged values RM and the mechanical characteristics emerged from the laboratory tests are given in Figure 8. As it can be seen, the correlation coefficient between  $f_m/f_{c,0}$  vs. RM (charts above) is very low and almost no relationship can be established between the laboratory and onsite results. On the contrary, very interesting results emerge when plotting the mechanical results versus the parameter  $RM_{norm}$ , i.e., normalizing the average value on the sample element of known characteristics. This allowed to balance the overall densiometric profiles on a well characterized sample, depending from parameters (i.e., pin consumption) which are uncontrollable on site.
