THE DAMAGE SURVEY OF CULTURAL BUILT HERITAGE BETWEEN SIMPLIFIED PROCEDURES AND NEEDS FOR IMPLEMENTATION: THE CASE STUDY OF EMILIA- ROMAGNA CEMETERIES

Keywords: “Emilia 2012” earthquake, Specialised type, Morpho-typological characters, Recurring Collapse Mechanisms

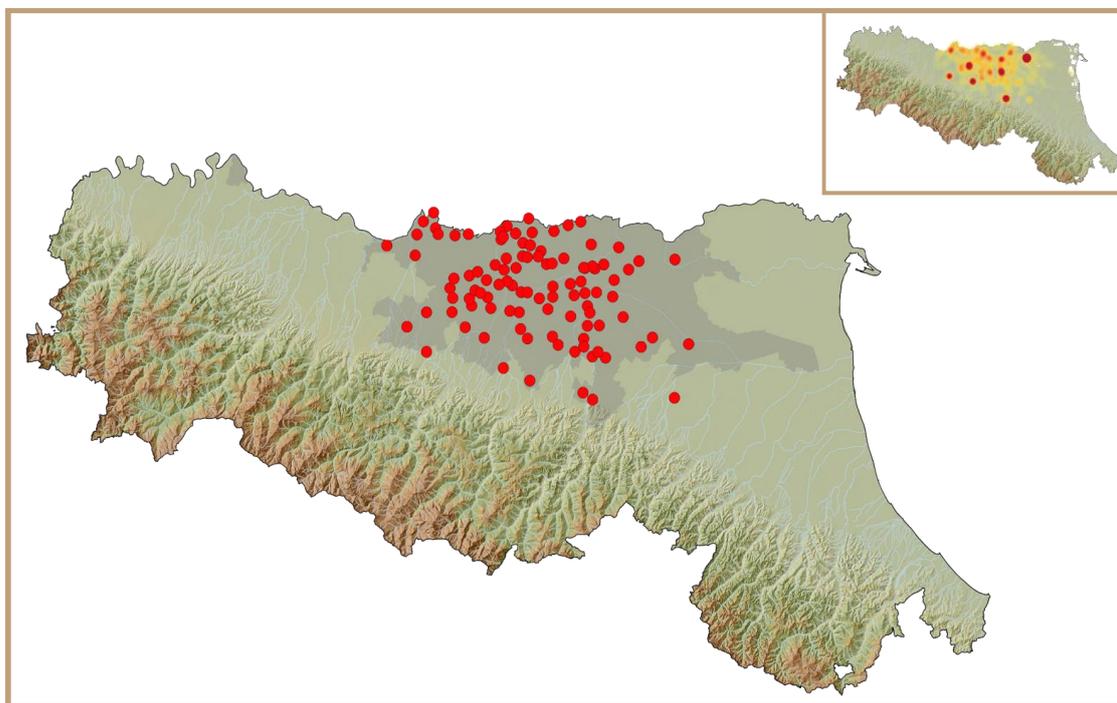
Figure 1: Heatmap of the all Architectural Heritage damaged by the earthquake (top right image) and distribution of the damaged cemetery in the “*crater*” area of Emilia-Romagna.

One of the most challenging type of buildings is the cemetery, especially from an economic point of view and for a lack of efficacy in the survey tools (Figure 1).

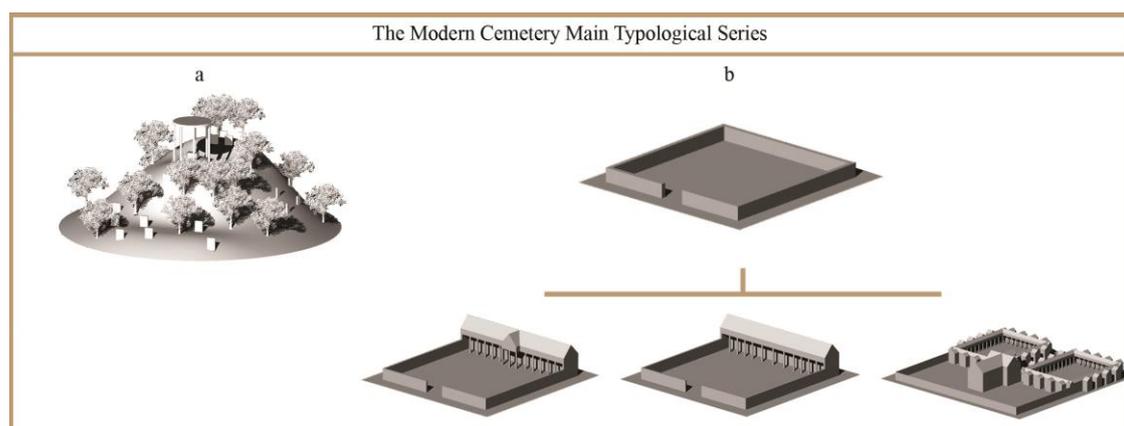
Figure 2: The main *typological series* of modern cemetery. The garden cemetery (a) and the architectural cemetery (b) with its three *variants* presented in Emilia-Romagna

Based on this model, we can identify three different *variants*: a cemetery delimited by porticoes and with a central chapel, a cemetery delimited by porticoes without a central chapel and the reuse and/or renovation of huge buildings outside the city (Figure 2).

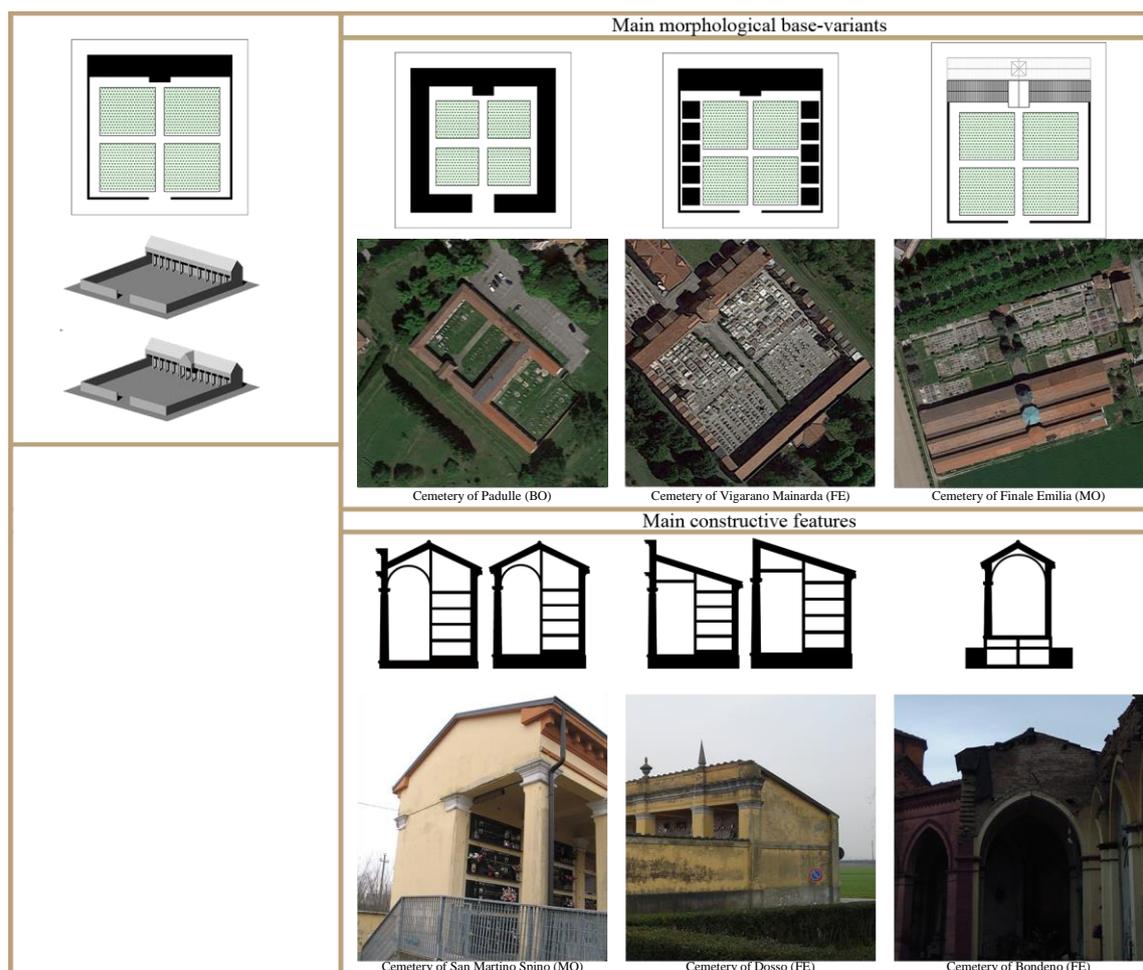
Figure 3: Main morphological and constructive features of the cemeteries in Emilia-Romagna

In conclusion cemetery is a complex *building type*, where *morphological variants* are combined with a variety of building techniques and materials came up in the next enlargement processes (Figure 3). Both of these aspects are essential features to better understand the structure and the seismic response of an area.

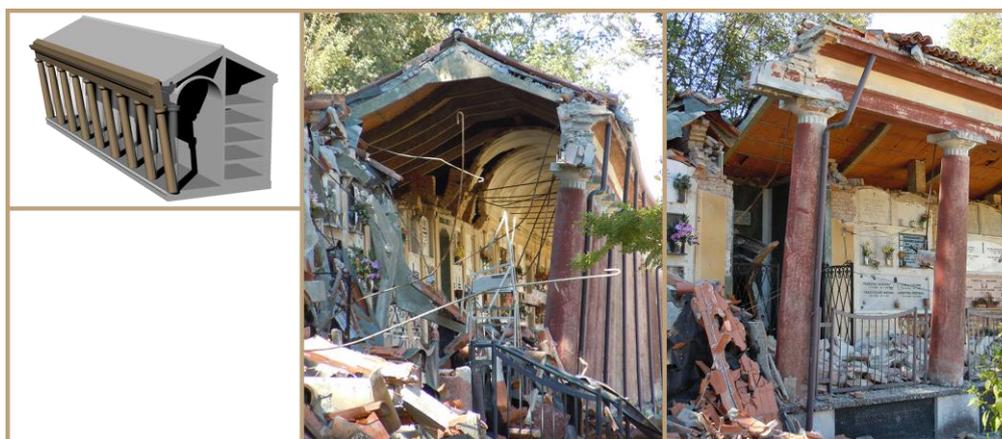
- Tipping over away from the colonnade floor (Figure 4). It represents the main collapse mechanism of the porticoed wings of the cemeteries, activated for most of the damaged units. This is a result of the summation of the seismic action to that of the thrust roof on the point feature of the portico. Furthermore, the presence of large replaced parts has almost always aggravated the situation, which in some cases led to collapse.

Figure 4: Cemetery of Mirandola - Tipping over away from the colonnade floor. It is worth mentioning the use of reinforced concrete beams and elements in steel in the structures.

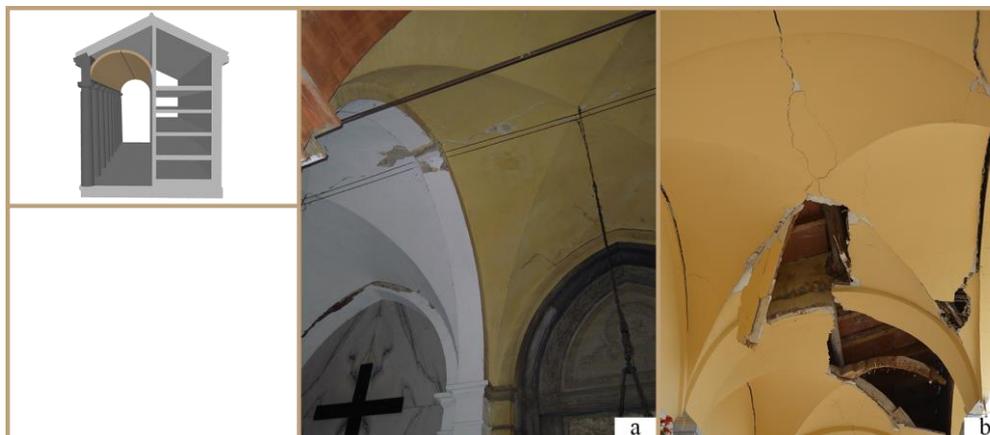
- Collapse and/or damage to the vaults and suspended ceilings (Figure 5). Secondary mechanism with respect to that of the portico generally activated for the rotation of the plinths due to the tipping over of the colonnade.

Figure 5: Cemetery of Bondeno (a) and cemetery of Mirabello - damage to the vaults

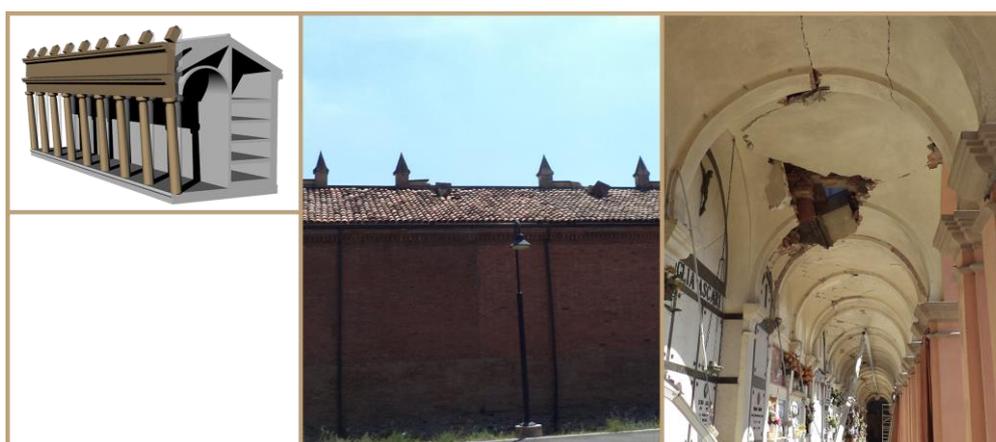
- Damage by interaction of the structures. The heterogeneous set of buildings that develop by successive additions (see the arms of the columbaria which are completed in the extensions with the preparation of the walls for a new construction) is conducive to triggering interaction mechanisms among the structures (see, for example the interaction between the columbaria and the single central compartment, or when they are inserted in the same building).
- Tipping over of the projecting elements away from the floors (Figure 6). Although it does not trigger a structural collapse mechanism, the presence of attic solutions, point and/or linear architectural elements aimed at hiding the pitches of the roof constitutes a serious vulnerability in the structure. The tipping over of these elements can take place externally or inwards.

Figure 6: Monumental cemetery of Concordia Sulla Secchia -Tipping over of the projecting elements away. In this case the projecting elements are collapsed inside the structures

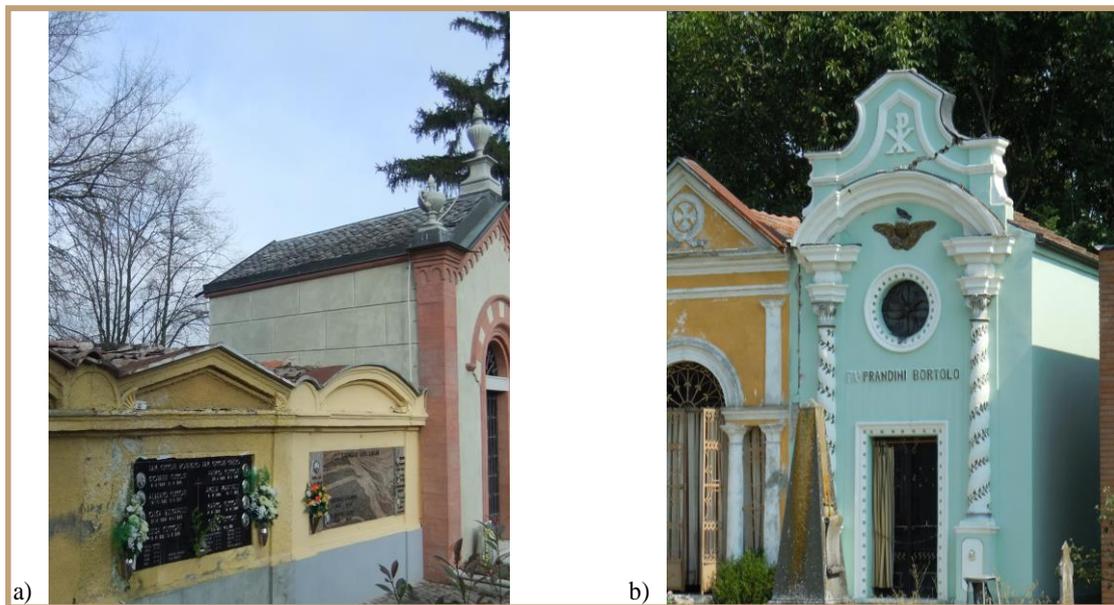
Figure 7: Different types of family chapels: a) chapels connected at columbaria and at the structures of the cemetery; b) chapels as separated units.

Furthermore, the breakdown of the cemetery into multiple micro-units is an additional problem. The use of multiple forms is in fact allowed in relation to the identification of a structurally separate unit. Although this criterion seems to have been respected for some cemeteries, where the subdivision follows the scan in separate blocks of the columbarium, in other cases the unit is considered as unified giving up the compilation of separate forms for each block and, in others, it is still divided into several parts (for example by construction period), without which they can necessarily be considered structurally independent. In the first case, there is a summary description of the damage. In the second case, there is also a detailed description for each unit that does not necessarily take into account the probable interaction between the different parts.

In the margin, a necessary reflection is added on whether family chapels are to be considered as annexed bodies (on the same form) or else should they be considered as structurally separate units (a new form)(Figure 7) ? On wall and/or statuary headstones, and on other characteristics related to the *cemeterial type*. It is easy to understand how the tools existing today are insufficient in damage detection operations.
