LA-14285-T

Thesis

# Pipeline Structural Health Monitoring Using Macro-fiber Composite Active Sensors

LA-14285-T  
Thesis  
Issued: March 2006

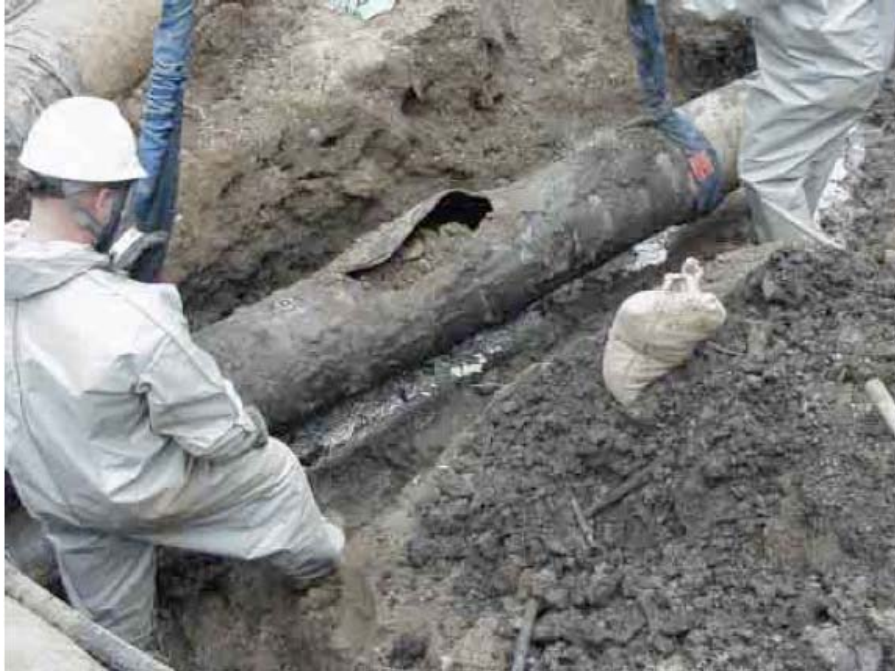
**Figure 1.2: Actual rupture in the pipeline (NTSB, 2002)**

property damage was \$45 million. A photograph of the ruptured pipeline can be seen in Figure 1.2.

According to the NTSB, the primary cause of the rupture was excavation damage to the gasoline pipeline. This damage occurred in 1994 during a nearby modification project which was unrelated to the gasoline pipeline. (NTSB, 2002) A secondary cause of the rupture was the inability of the operator to accurately evaluate the results from a magnetic flux inspection, which was performed at regular intervals every five years for this pipeline. Therefore, the rupture and ensuing explosion could have been prevented if a reliable damage detection system had been implemented with the pipeline to continuously monitor its structural integrity.

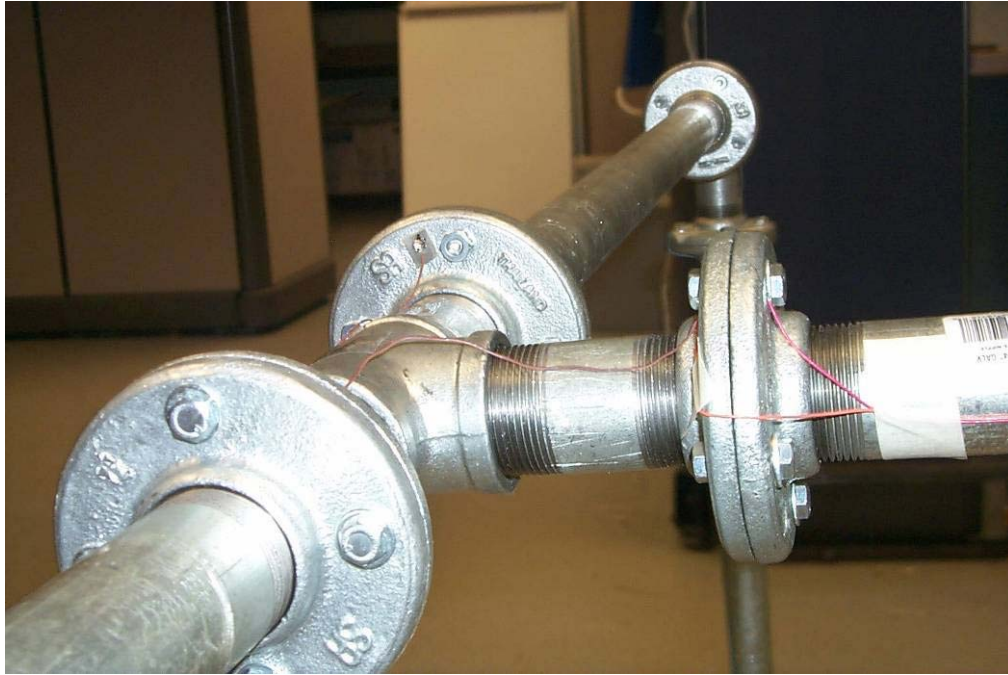
**Figure 2.5: Application of impedance methods to a simple pipeline structure (Park, et al. 2001)**

this research can easily be integrated into a SHM system. Because the piezoelectric patches were mounted to the flanges of the pipeline system, however, these methods can not efficiently detect damage in the pipeline's main body.

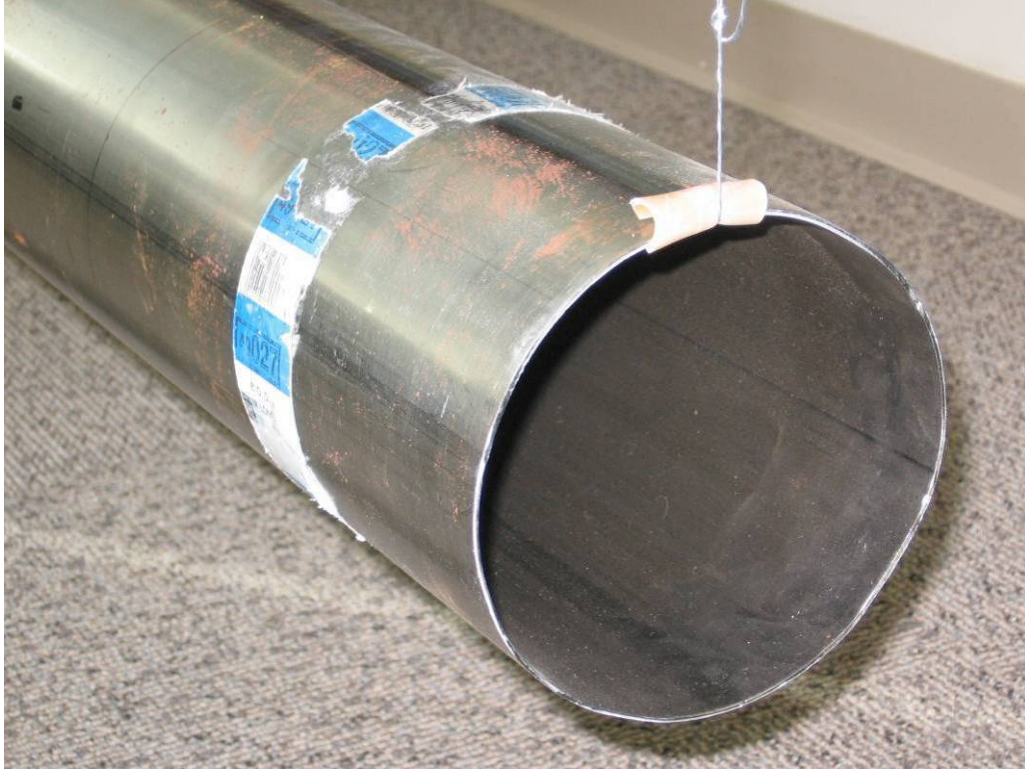
**Figure 3.2: Suspension method**

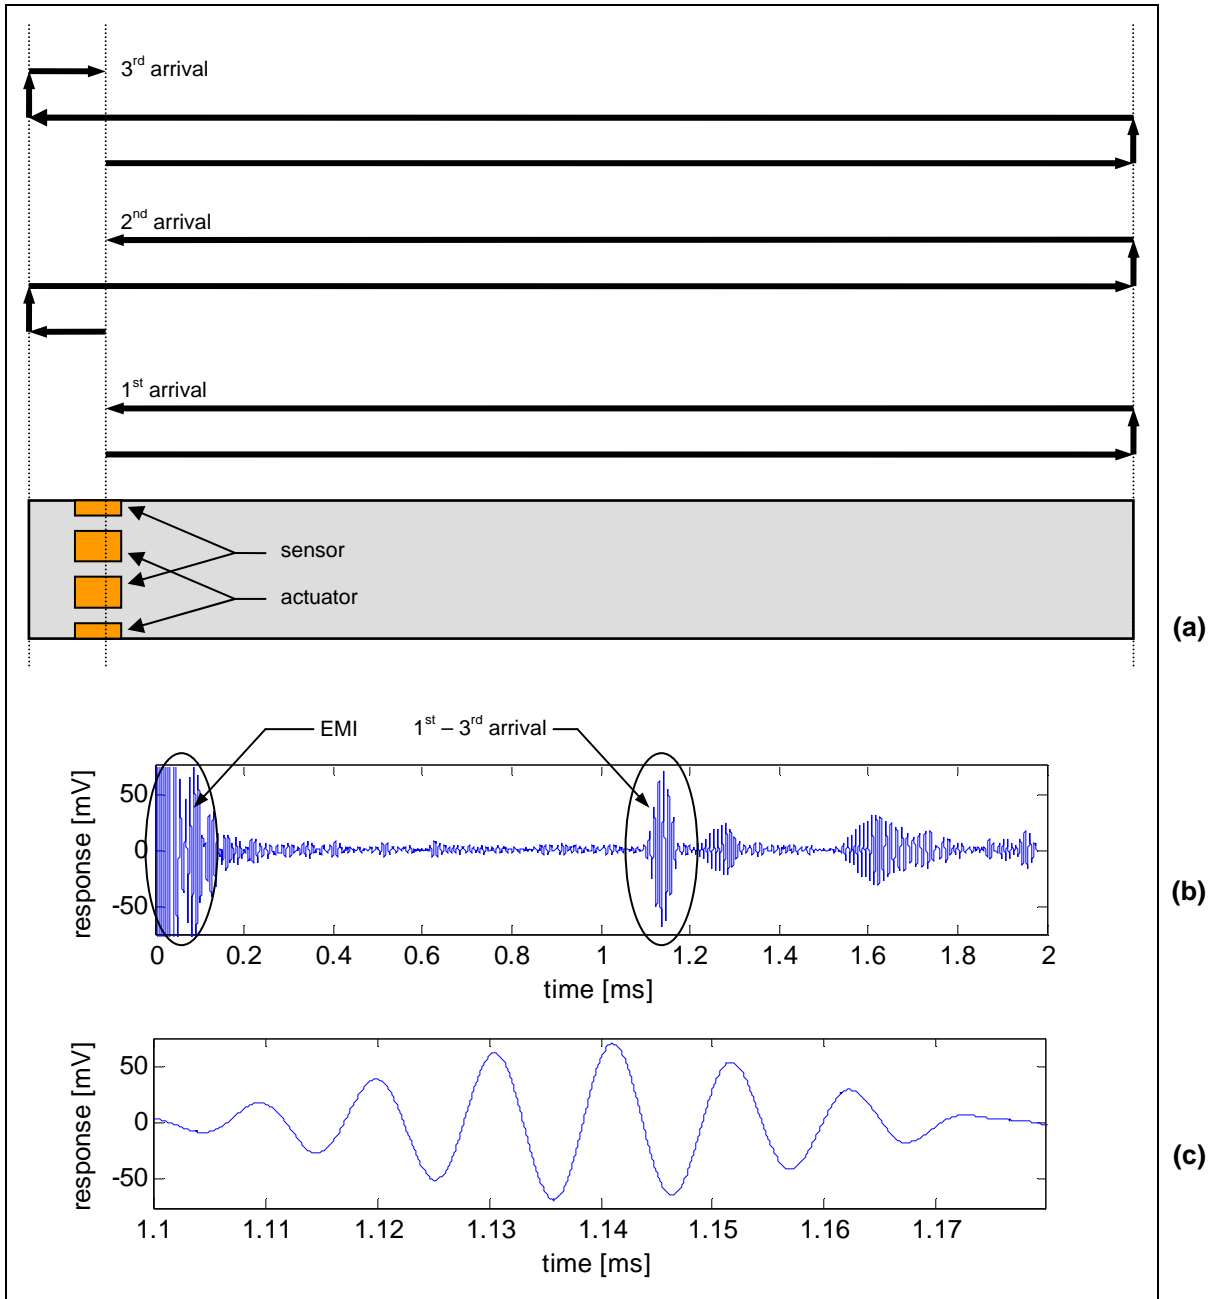
**Figure 3.9: Example of a pulse-echo measurement – (a) Diagram of paths traveled by the first three arrivals, including reflections, (b) Full time history for 0 to 2.0-ms with first two arrivals labeled, (c) Close-up view of 1st and 2nd arrivals**

excitation signal contained only five peaks, the interference between the first three arrivals caused the response shown here to have seven peaks. A more detailed discussion of experimental results is in the following chapters.

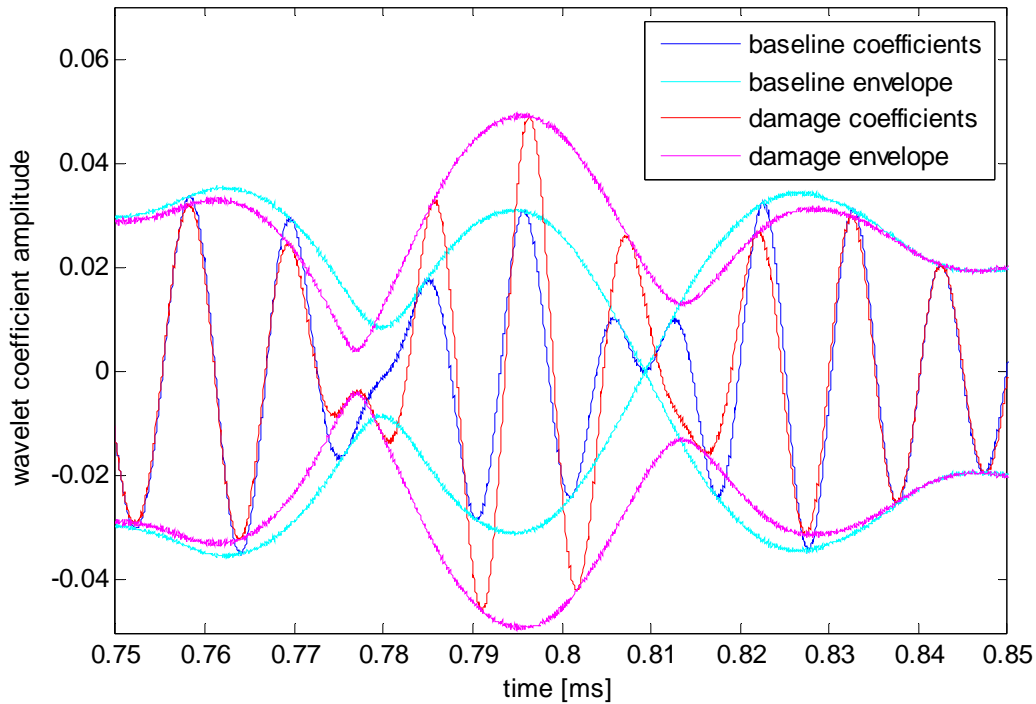
**Figure 4.5: Comparison of wavelet coefficients and signal envelopes for a damage-case and a baseline measurement**

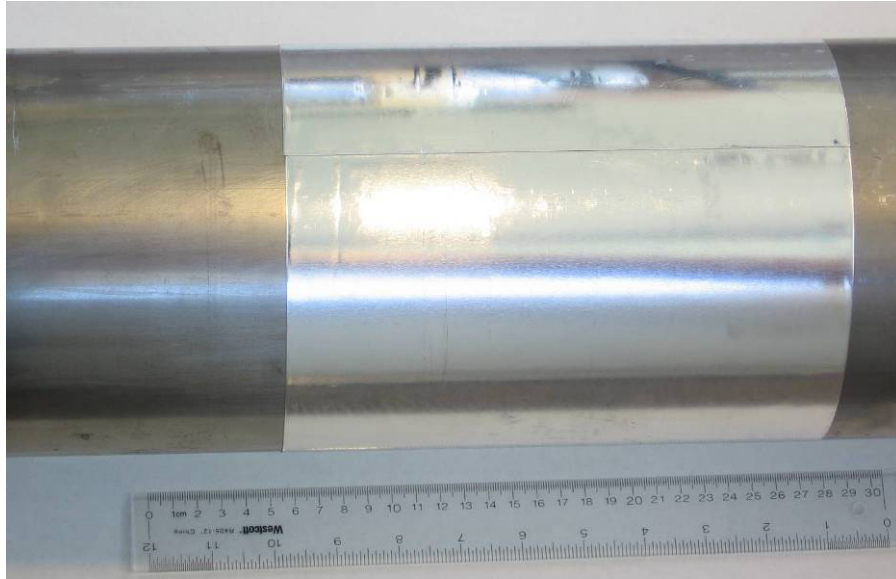
**Figure 4.14: Constrained damping layer as mounted to pipe**

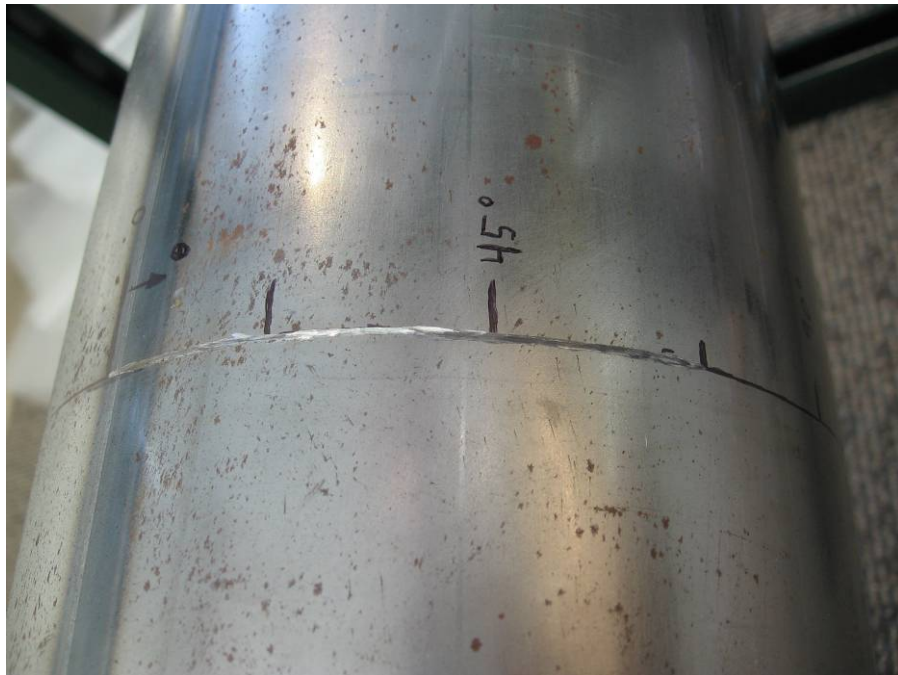
**Figure 5.3: Circumferential notch, 50% through thickness,  $0.0^\circ$  to  $67.5^\circ$**

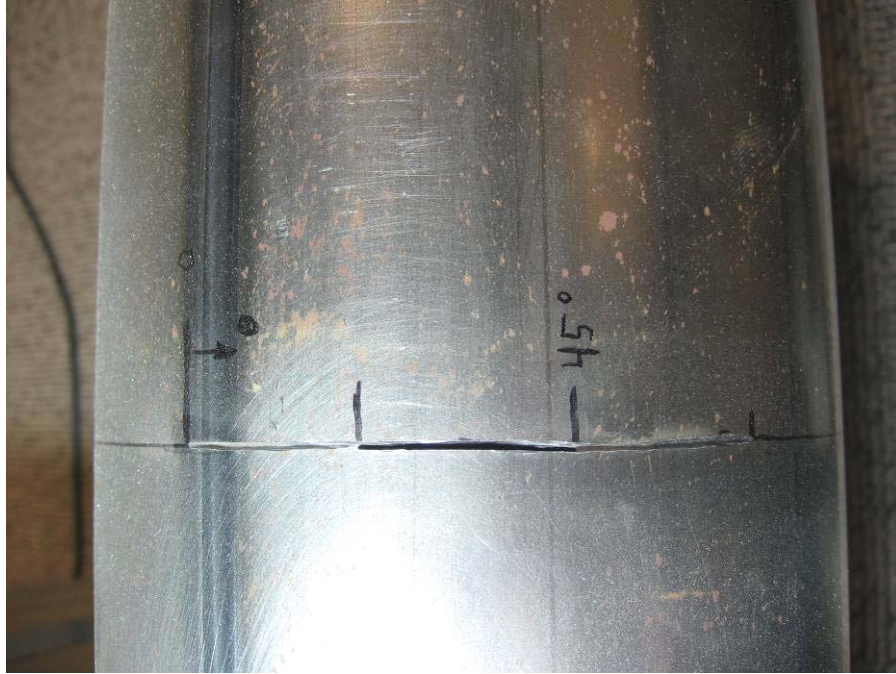
**Figure 5.5: Circumferential notch, 100% through thickness, 22.5° to 45.0°**

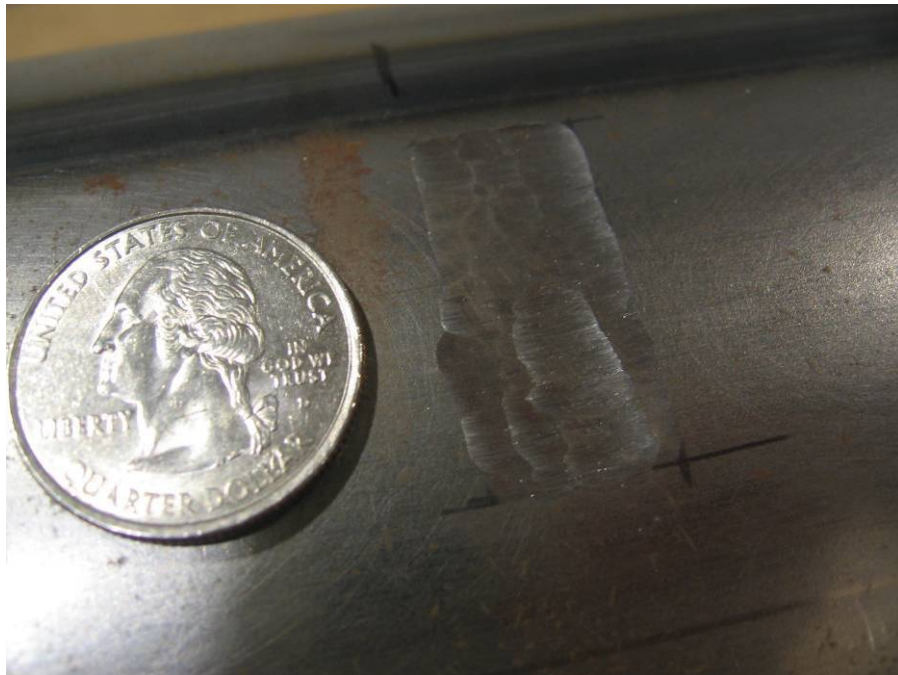
**Figure 5.9: Surface grinding, 0.0° to 22.5° long, 0.50-in (12.7-mm) wide**

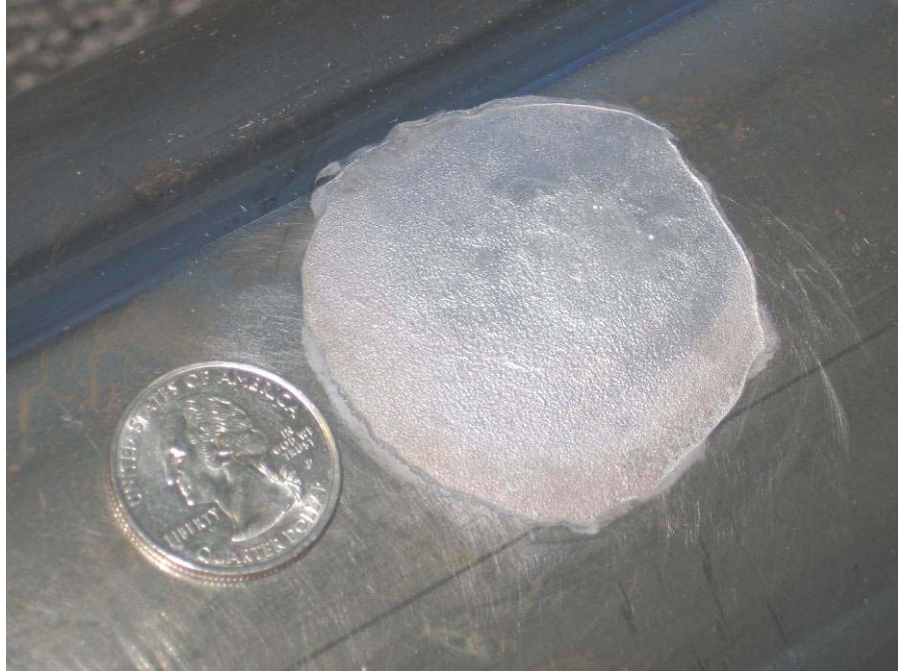
**Figure 5.12: Top view of accelerated corrosion, 10% through thickness**

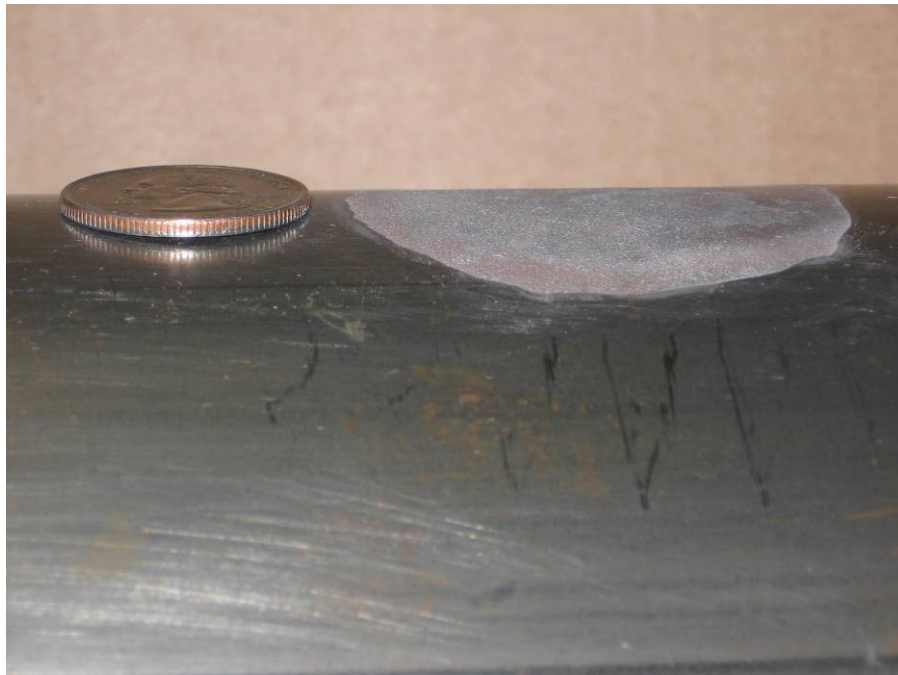
**Figure 5.13: Side view of accelerated corrosion, 10% through thickness**

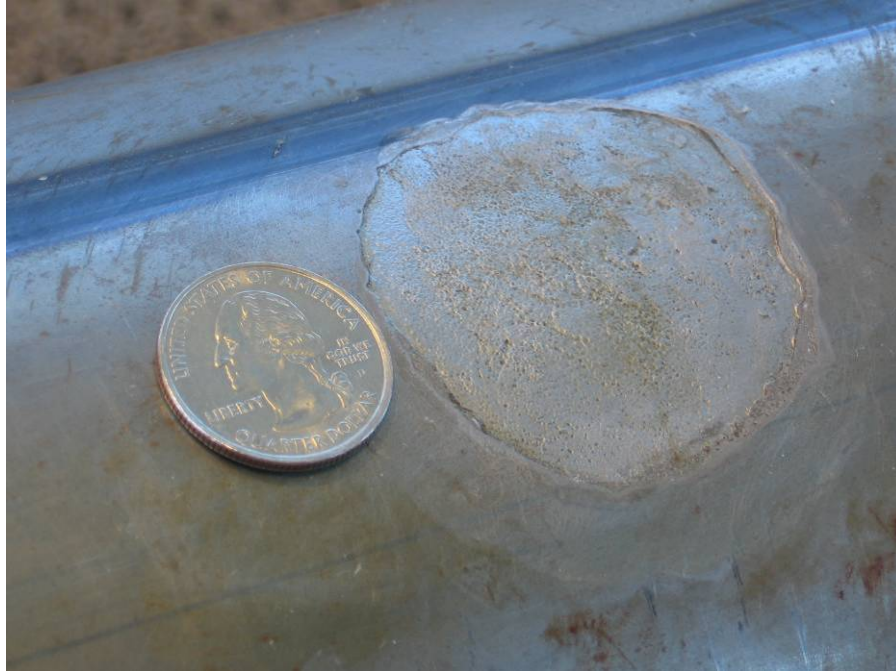
**Figure 5.14: Top view of accelerated corrosion, 20% through thickness**

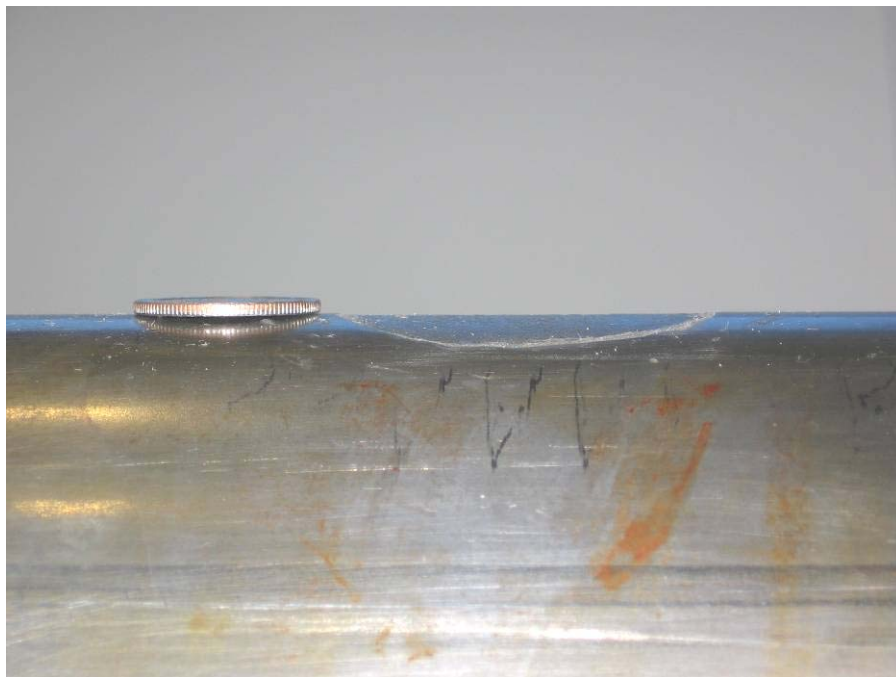
**Figure 5.15: Side view of accelerated corrosion, 20% through thickness**

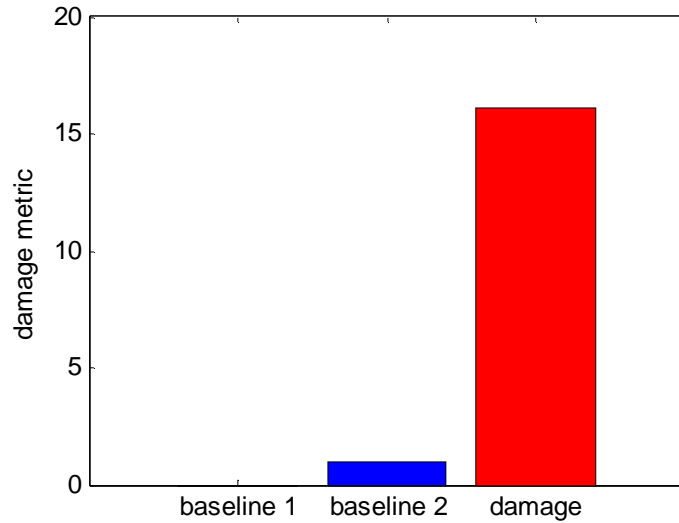
**Figure 6.5: Example of the damage metric for typical baseline measurements and a damage case measurement**

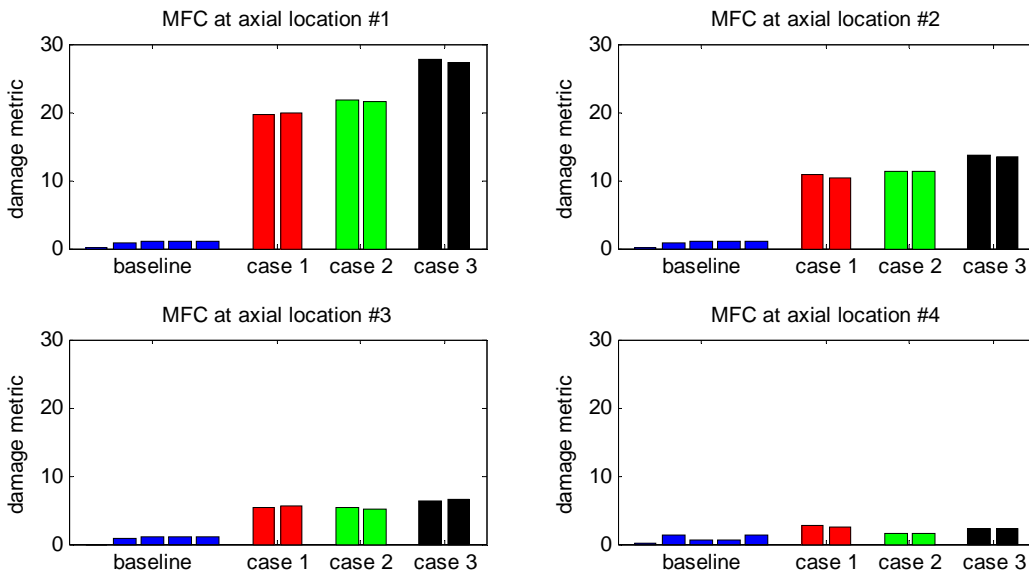
**Figure 6.8: Damage metric for damage to flange A (110 to 120 kHz)**

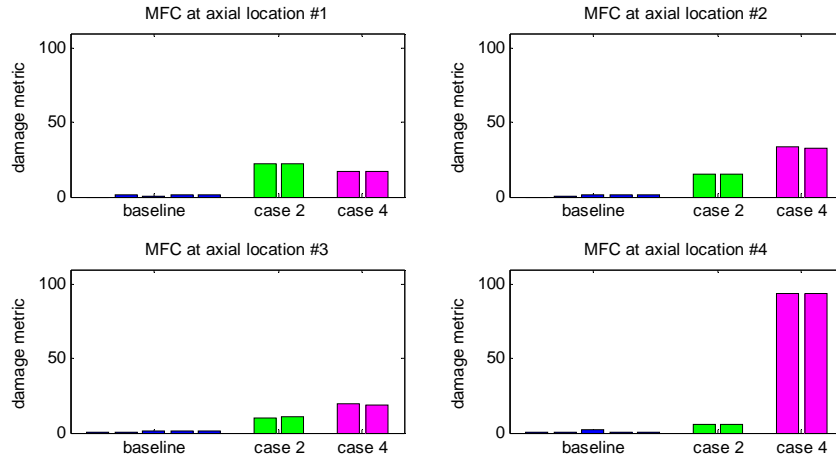
**Figure 6.9: Damage metric for damage to flange B (50 to 60-kHz)**

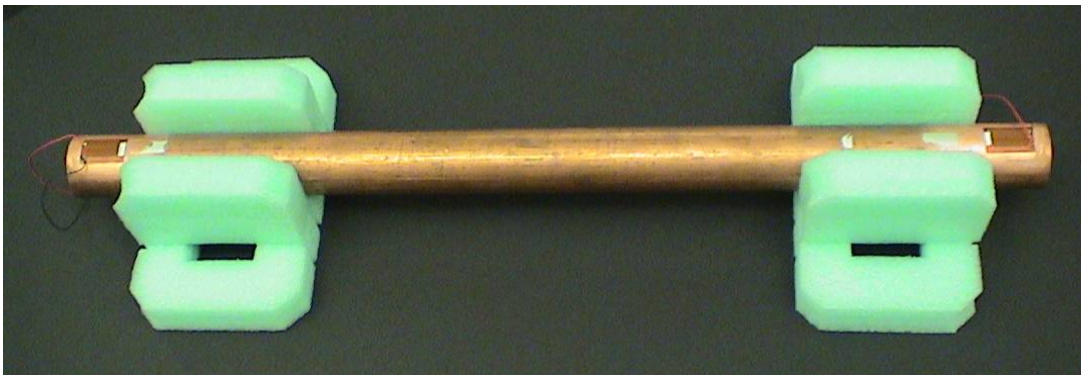
**Figure 7.1: Copper tube used as test structure**

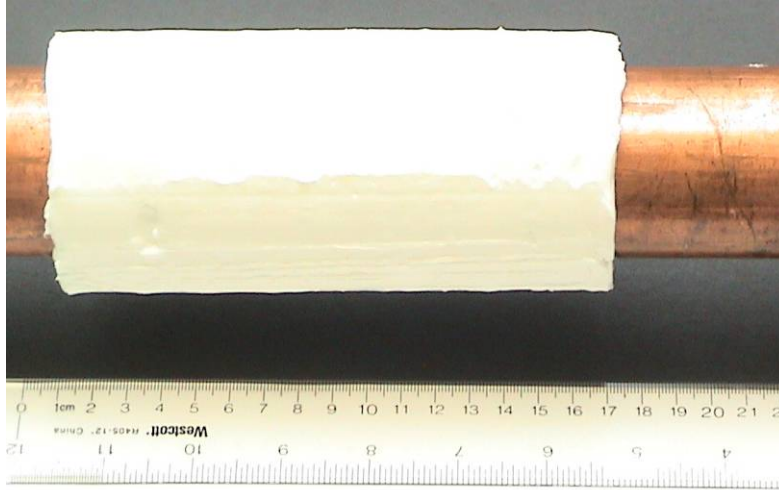
**Figure 7.3: Layer of vegetable shortening for damage case 3**

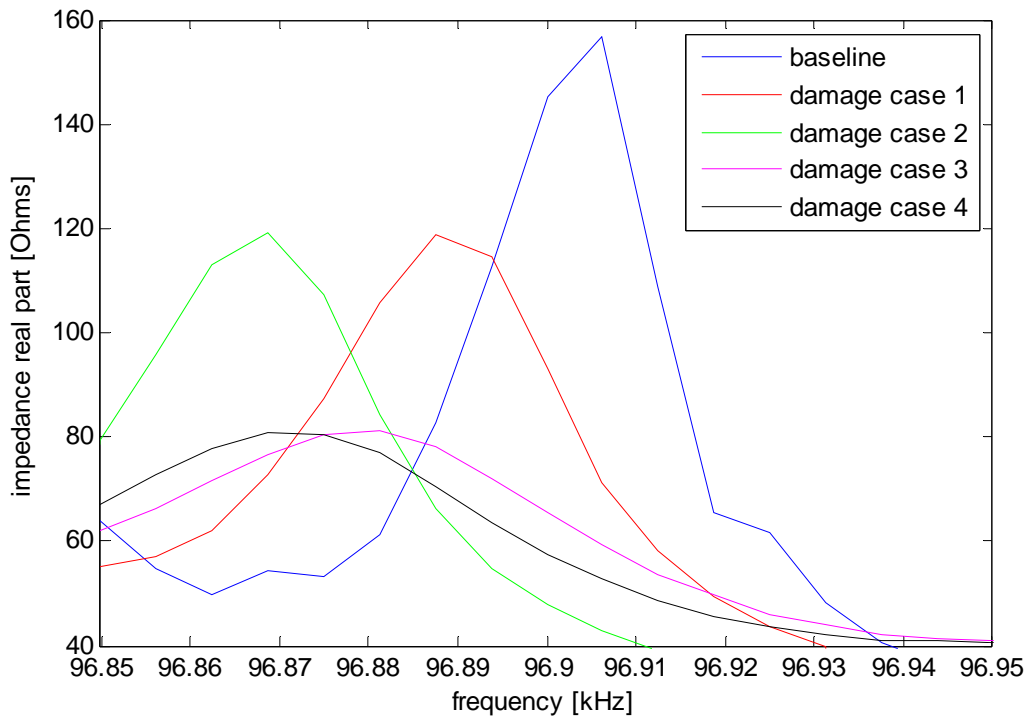
**Figure 7.6: Detailed view of impedance measurements near resonance at 96.9-kHz**

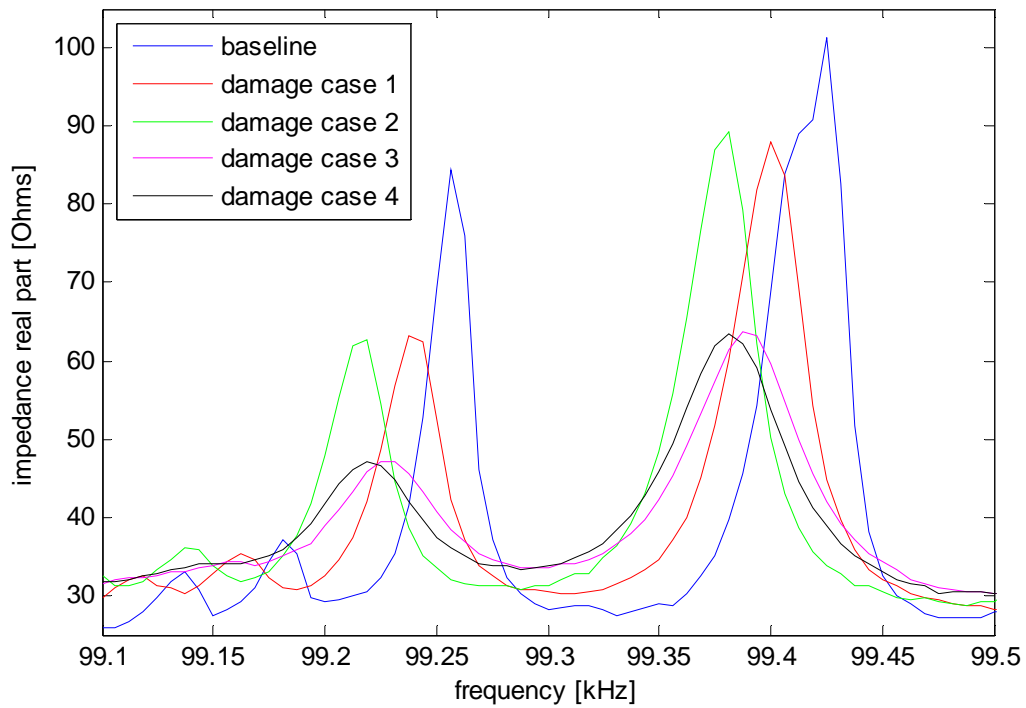
**Figure 7.7: Detailed view of impedance measurements near resonance at 99.4-kHz**

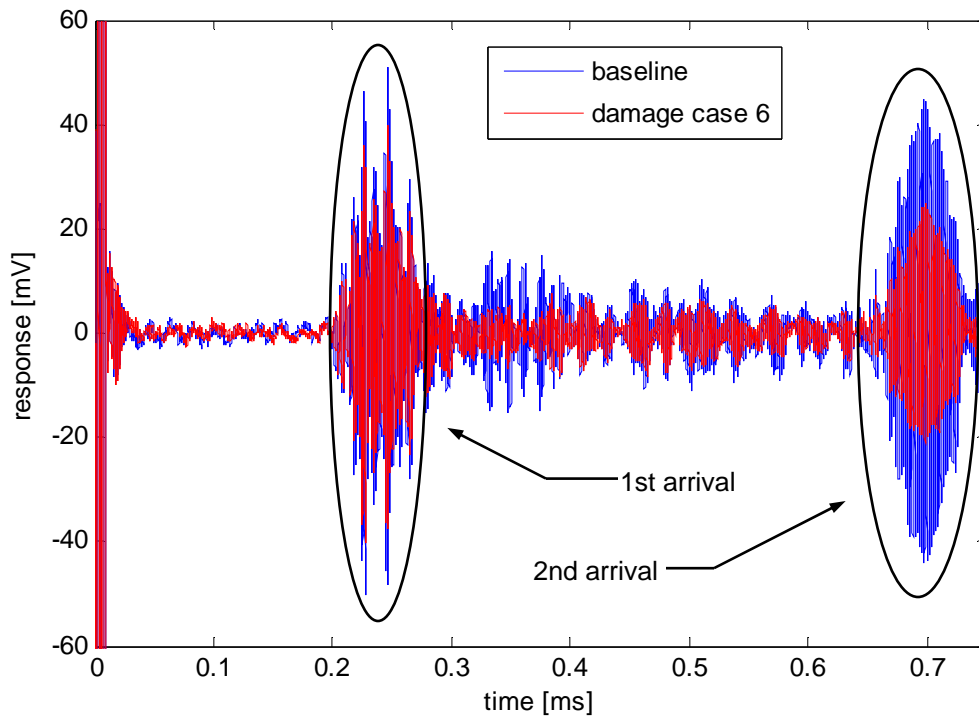
**Figure 7.9: First and second arrivals for 500-kHz excitation**

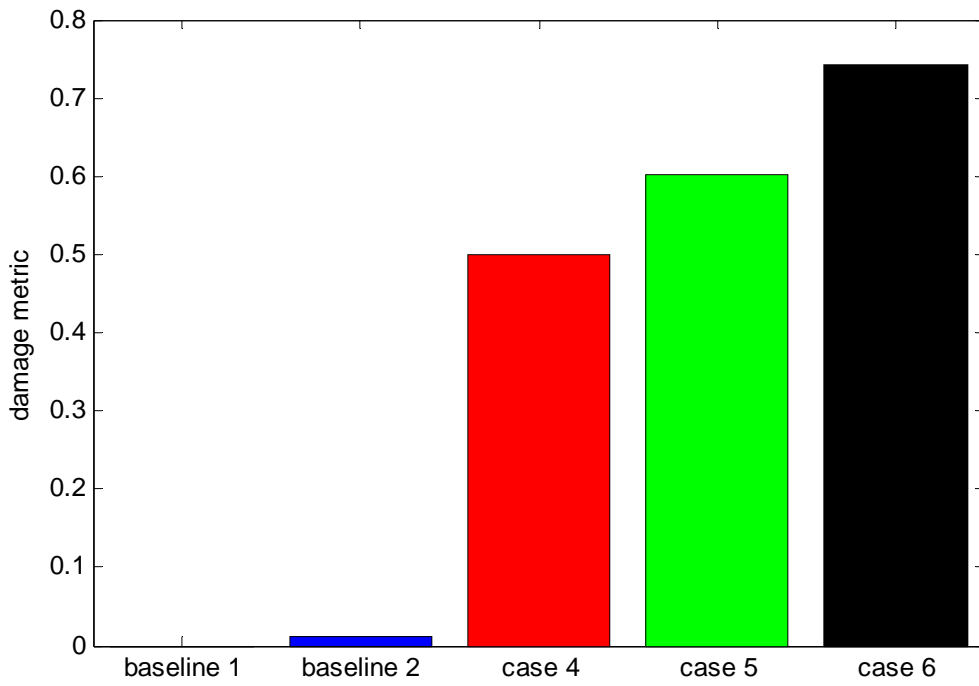
**Figure 7.13: Damage metric for 500-kHz Lamb wave measurements**

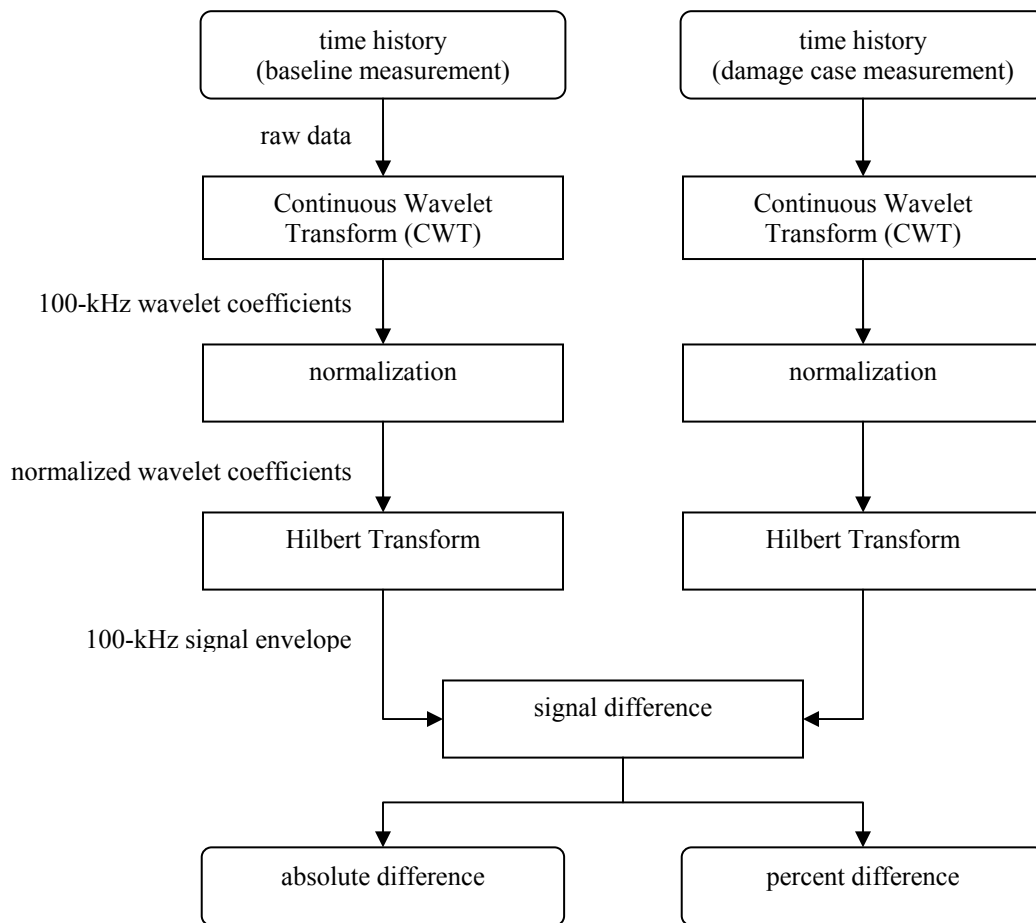
**Figure A.1: Flow chart for damage detection algorithm**
