## CONSERVATION BEYOND CONSOLIDATION FOR PREHISTORIC MONUMENTS: FINDING NARRATIVES FROM ARCHAEOLOGY TO ARCHITECTURE FOR SCOTTISH BROCHS

**Abstract.** *The sophisticated drystone Iron-Age brochs of Northern Scotland, called Complex Atlantic Roundhouses by archaeologists, have shown a relatively high technological culture. Their architectural conservation should strike a balance in presenting their key features (structure, materials, building use and architectural elements) in a concept of wholeness that integrates its major phases rather than design unity of a hypothetical original form. However, currently there is uncertainty due to the lack of agreement for a standard broch scheme and the need for more archaeological research. As most brochs in Scotland are fragile ruins and only a few of them have been scientifically explored, they have been conserved through basic consolidation for safety reasons in very localized methods, primarily by archaeologists. All of them are open to the public but only a few are developed as tourist sites. In both situations, none has shown the complete features of anything close to a standard typology as a narrative of their origin and a few have inte

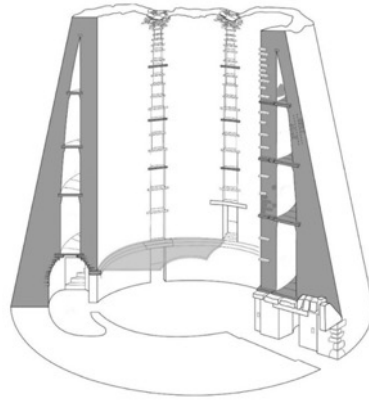
**Figure 1:** The configuration of Revised Standard Model for Brochs [6]

These remarkable stone-built roundhouses contain some elaborate architectural features. Their dry-stone walls were about 3m to 6m thick and internal diameters range between 5m and 20m. These dimensions could easily have supported tall structures and five out of more than 500 still survive to 9m or higher [5]. Presently, some diagrams of the original image of brochs are widely known among the public, but they are conjecture due to the lack of supporting evidence. Barber [6] studied several cases and suggested a revised model of a standard broch, aiming to show they were all built to a standard canonical plan and their apparent diversity is a product of modifications and natural decay (Figure 1).

Compared to Figure 1, the curved ‘possible scarcement’ in Figure 8 in the inner wall circle in Carn Liath is sort of misleading, which is different from brochs nearby, like Ousdale and Dunbeath. The site was proved to be occupied in the Bronze Age before a broch was built [12]. As it was suggested as scarcement by Mackie [13], however, John Barber [6] found the scale errors in drawings which failed to find the proper position of the inner wall face. He proved that the curved scarcement was either caused by the structural failure, or by the reconstruction of the tower at and above that level which was returned. Therefore, the origin of scarcement is either lost or covered in the ‘possible scarcement’ which is actually an inner lining wall face built attached to the real inner wall face. Therefore, the dimensions and scarcement features of the conserved broch Carn Liath offer wrong images of this type.

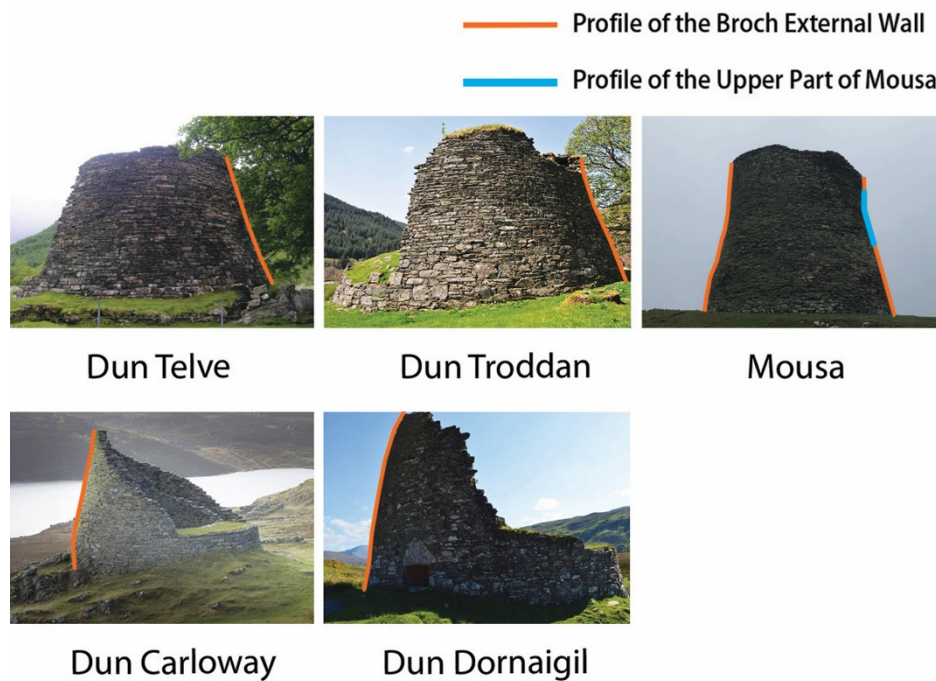
**Figure 2:** The profile study of Dun Telve, Dun Troddan, Dun Carloway and Dun Dornaigil.

Even earlier changes in brochs are evident but these can be identified as essential modifications of the original design during the archaeological study. For example, Mousa, known as the tallest and most complete broch in Scotland, is assumed to have been modified by a Norseman who completed the staircase up to the parapet [8]. This created a slightly overhanging upper part of the tower, which does not appear in the other four tall brochs as Dun Telve, Dun Troddan, Dun Carloway, and Dun Dornaigil (Fig. 2). Since Mousa is the most complete surviving monument, it set a stereotype for the general public

Besides the five taller brochs mentioned in Figure 2, other brochs with lower height are obviously different in the original form they convey. There have been some proper surveys on brochs done by professional archaeologists and this research is looking at a collection of such broch plans as collected on Canmore, the book ‘The complex roundhouses of the Scottish Iron Age: an architectural analysis of complex Atlantic roundhouses (brochs and galleried duns), with reference to wheelhouses and timber roundhouses’ written by Tanja Romankiewicz [5] and the survey “The roundhouses, brochs, and wheelhouses of Atlantic Scotland c.700 BC-AD 500: architecture and material culture” written by Euan W. MacKie [4]. Also, archaeological reports published in the recent 10 years offered surveys of Thrumster and Nybster which are included in the data pool.

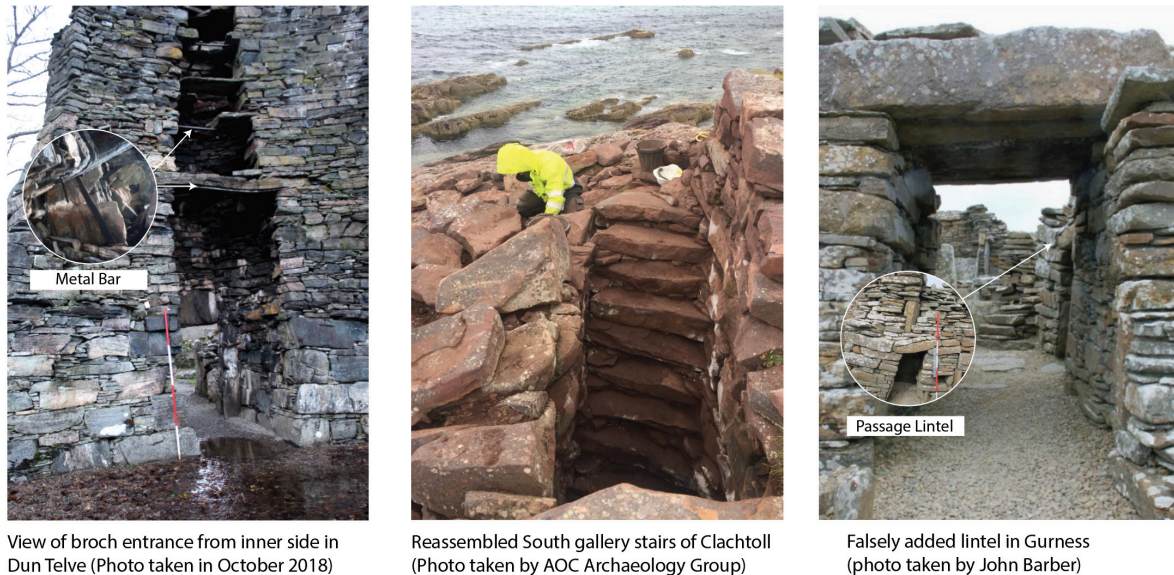
**Figure 3:** The consolidation in broch Dun Telve, Clach toll and Gurness

As seen in Figure 3, an example of the recent practice is Clach toll, where the entrance was consolidated firstly and after archaeological excavation in 2018 the staircase was dismantled and reassembled and all rubble at the interior was removed. The best-preserved tall brochs, like dun Telve, though have been strengthened in undocumented campaigns so the extent of repairs is difficult to ascertain. Gurness is a case where dating was misinterpreted or ignored (phases that never co-existed were presented together) while Midhowe restoration actually brought back features that the earlier clearing of the ruins had cancelled (edge-set slabs applied as external buttresses against the N face of the broch wall) [6].

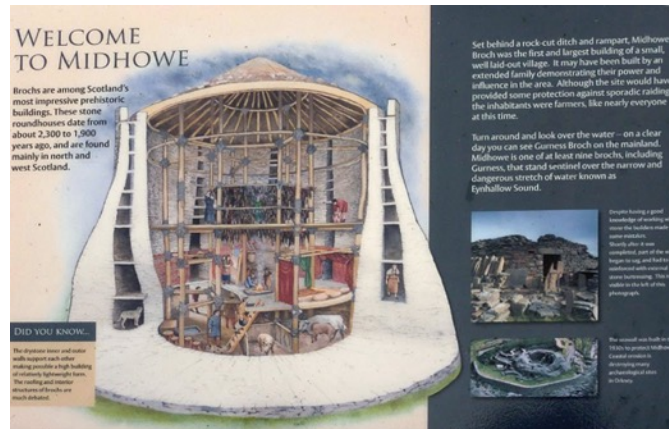
**Figure 4.** The schematic board for Midhowe broch in Orkney.

The image of how a broch looks like has been spread to social media nowadays, but it cannot represent all the brochs. For example, Figure 4 is one of the general images found on websites or TV programs speculating on human life in brochs. Most of the images like this are based on basic concepts like perfectly circular brochs built on even ground with constant galleries at several levels which enabled cohabitation [1] where the animals live on the ground floor and people in the upper floors. An immediate observation is that in reality there is a huge amount of them built on a slope where the galleries are not perfectly horizontal. Moreover, the roof form is only a conjecture as there is no evidence for shapes and materials.

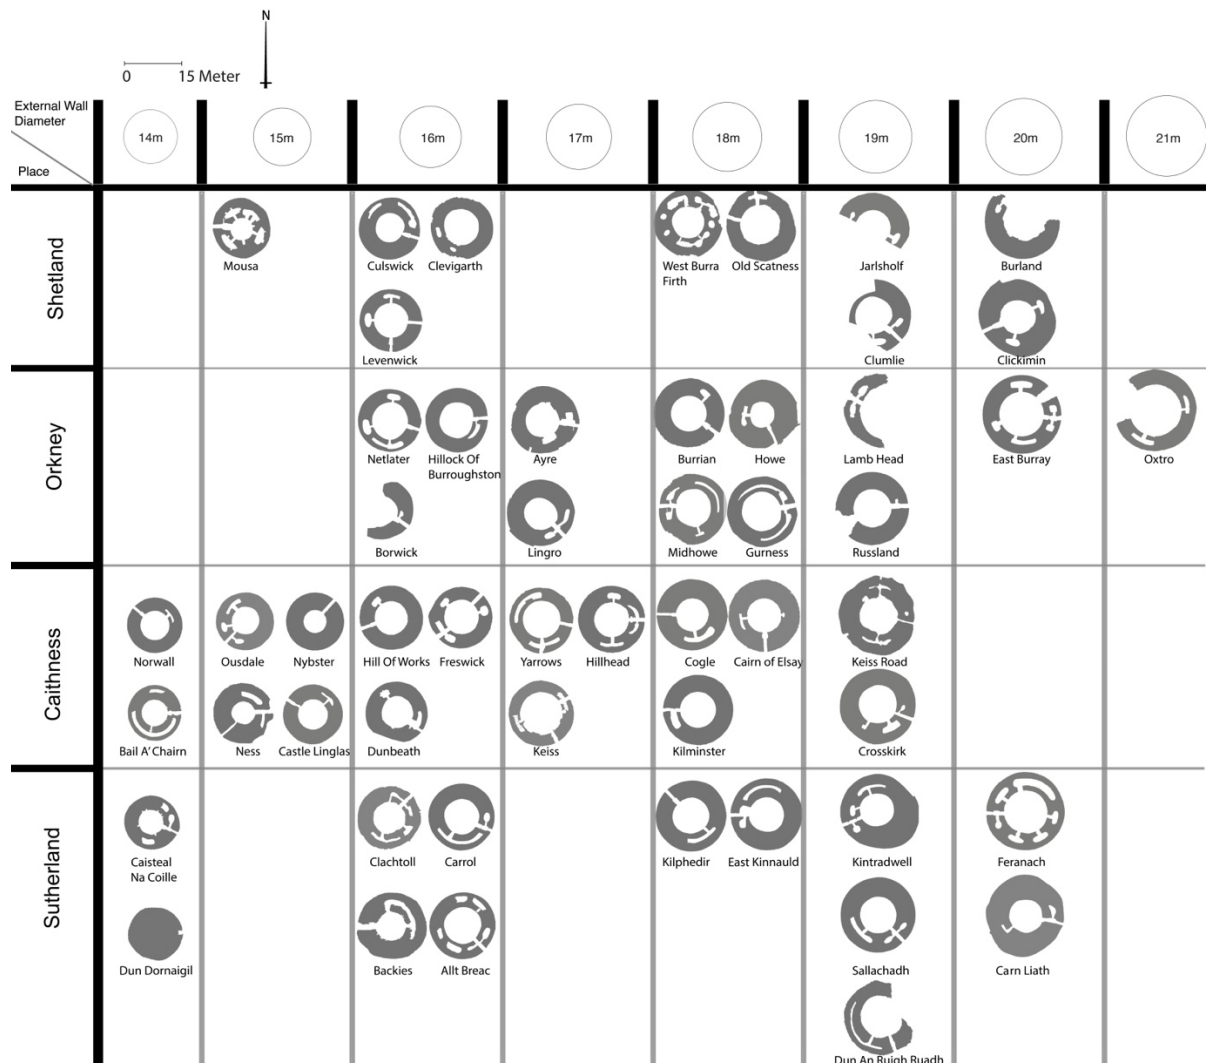
**Figure 5:** The broch plan study of 51 brochs in Shetland, Orkney, Caithness and Sutherland

The plans of 51 brochs, which were professionally surveyed, are selected and divided into groups based on their locations to study their design concept in multiple manifestations and adaptations as seen in Figure 5. The building parameters are mainly overall sizes, the external wall diameters of these brochs vary from 13m to 22m. The largest one, as Thrumster in Caithness, is almost double the size of the smallest one (Norwall). The other important parameter is circularity. The brochs in Caithness are much more circular-shaped except Keiss Road and Thrumster due to their incomplete survived shapes, while there are ellipse-shaped brochs like Backies and Carn Liath. Also, in terms of broch entrance, unlike other Iron age monuments which would normally face the East, the point of the day where sun is rising from, or south for the most sunlight, brochs' entrances are quite diverse. Even in some location group, brochs do not share a dominant direction. It indicates the ancient builders did not respond to the four cardinal directions, representing sunlight and shadows. Also, some brochs had two entrances, possible due to reuse in later times (like Yarrows),

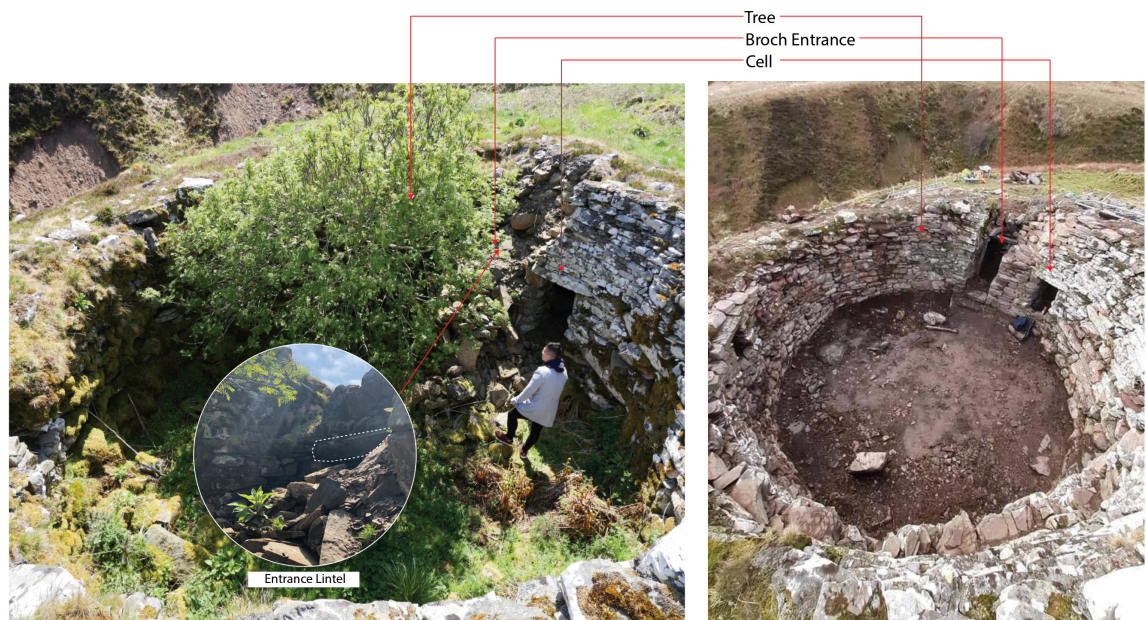
Ousdale broch before consolidation (Photo taken in April 2018)

Ousdale broch after consolidation (Photo taken in April 2020)

**Figure 7:** The consolidation of broch Ousdale

In broch Ousdale which is an unusual broch embedded in the ground that has been heavily damaged (Figure 7), the tree growing at the wellhead collapse was removed to clear the entrance and the stones on the ground were reused to rebuild a part of the inner wall. The consolidation work is definitely needed, where partial collapse happens and causes structural problems. Even steel structures could be used to stabilize tilted walls after the stones repined.

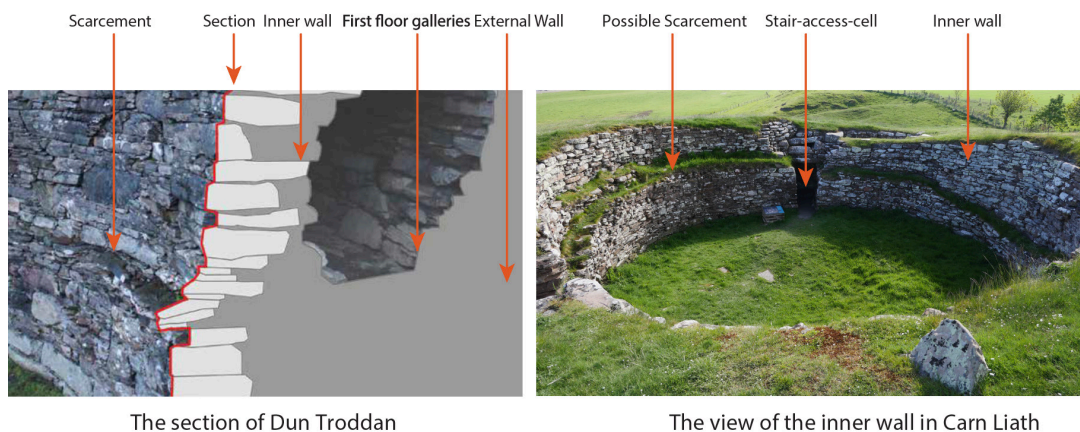
**Figure 8.** The section of Dun Troddan and the view of inner wall in Carn Liath

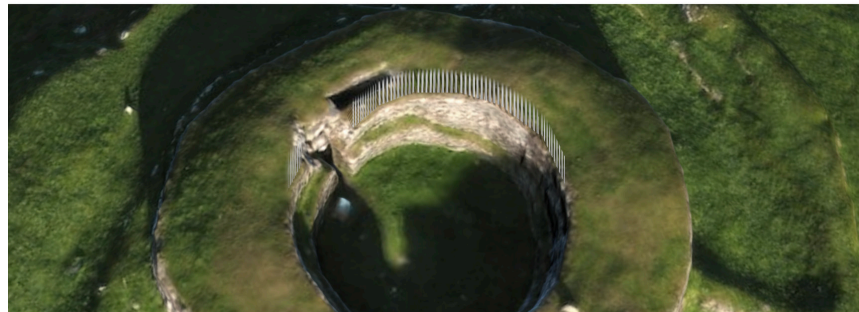
**Figure 9.** Steel bars highlight the original inner wall face in Carn Liath

If more evidence or findings are needed to confirm the changes in the conserved sits, a mark on the wrong parts of brochs should be possible. Removable structures, like steel bars as seen in Figure 9, could be used to make up the collapsed parts and the original wall head of inner wall, which could offer the impression of the function of the building elements and the sense of building scale without damaging the archaeological site. However, under the concept of being interpretive, there would be a question about what level of impact should this approach reach. In Article 9 of the Venice Charter, it stated that ‘any extra work which is indispensable must be distinct from the architectural composition and must bear a contemporary stamp’ [14], which stressed the importance of respect for original material and authentic documents. For brochs here, the authenticity lies in the ruins and the archaeological values should have priority to be considered. The interpretive conservation for brochs should not repair them with the same sandstones as being confusing or fake. Importantly, the added materials should always be removable to get rid of damages caused by improper conservation decisions.
