CHARACTERIZATION OF CRACKS IN HISTORICAL BUILDINGS USING IMAGE-PROCESSING TECHNIQUES

P. L. PÓRCEL^{1*}, B. CASTAÑEDA¹, R. AGUILAR¹

¹ Engineering Department, Civil Engineering Division
Pontificia Universidad Católica del Perú
Av. Universitaria 1801, Lima, Perú
e-mail: {pporcel, raguilar}@pucp.pe, castaneda.b@pucp.edu.pe
(*corresponding author)

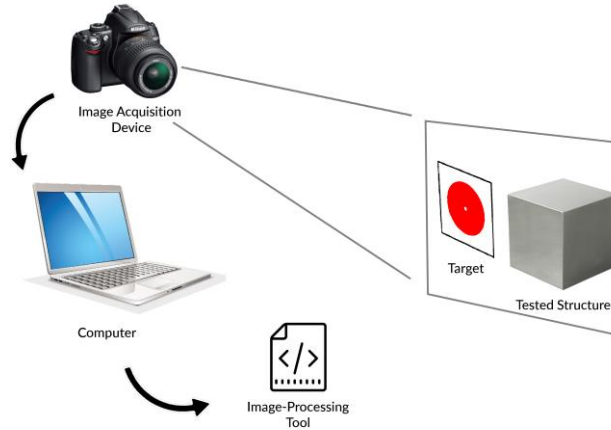
Figure 1: Machine vision methodologies most used measurement system.

Machine vision techniques have come as the technological approach for crack detection and monitoring, given that the conventional methods are usually performed by experienced human inspectors who identify and manually draw the crack patterns [5]. Machine vision methodologies mostly use a configuration as shown in Figure 1. This set up consists of the tested structure and targets, the Image Acquisition Device that captures and stores the information in a computer where it is processed with an Image-Processing Tool that is tailored to the specific purpose of the study [4].

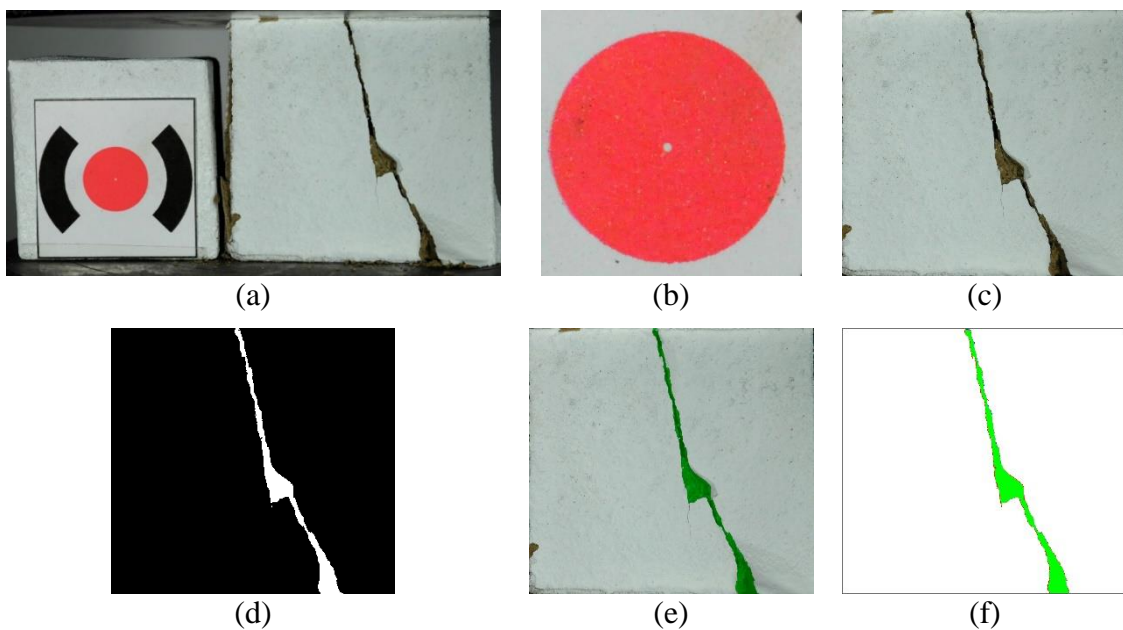
Figure 2: Process that the acquired images follows (a) image acquired (b) target region (c) ROI of the image (d) image after the binarization algorithms (e) final binarization in green over the original ROI in RGB and (f) the comparison between the ground truth and the final binarization.

Initially, a sparse detection of the pixels belonging to the crack is performed by analyzing the overall variation in color between the crack and the background. After that, stick voting is applied to the previously detected pixels to analyze the interaction between them. Finally, the tensor voting algorithm is applied to establish which pixels are proximate enough to others to be part of the crack. On the other hand, the region where the target is contained is processed to detect the red target and extract its measurements. The real measurements of the target are known; therefore, they were compared to the metrics extracted from the previous step. This process allows the tool to obtain a resolution in pixels/meters. Due to human error introduction, the images taken are not entirely parallel to the surface of the specimen, thus, the measure in pixels of the target will not be exactly the same horizontally and vertically, as it should be, given the shape of the target. The final step, consists of calculating the area of the crack in pixels and converting it to meters with the previously calculated resolution.

Finally, in order to scale and get an approximately measurement of the cracks area a target was introduced into the tests. The target is shown in Figure 2.a, the red circle in the middle has 12.7mm of diameter. This would be later detected and used to scale the image in order to have the resolution in pixels/m, the target was positioned parallel to the surface of the tested specimen.

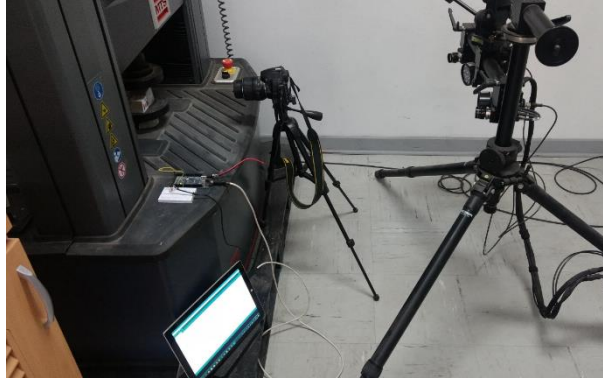
Figure 3: Data acquisition system layout.

The acquisition system used in this process is consistent with the machine vision methodologies used in recent years. In Figure 3, there is a representation of the layout configuration for the compression tests that were performed in the specimens to generate the cracks that would be evaluated later. In this layout, a set of two stereo lights was used to enhance the illumination inside the compression machine as its structure introduced shadows that would pollute the acquisition of data. The camera captures the images with a resolution of 12MP

(4288x2848), it was set at a distance of 45cm from the specimen with the lenses approximately parallel to the surface of the specimen. A separate program was created in Arduino for the acquisition of data to obtain the pictures automatically while running the compression test. Therefore, we obtained a different number of images per specimen, because the time of rupture was moderately different. The Arduino was connected to a Surface tablet in order to stop the acquisition when the compression test finished. After that, all the images were introduced in a computer where each data base went through an automatic organization process, that would help later with the image processing tool developed in this work.

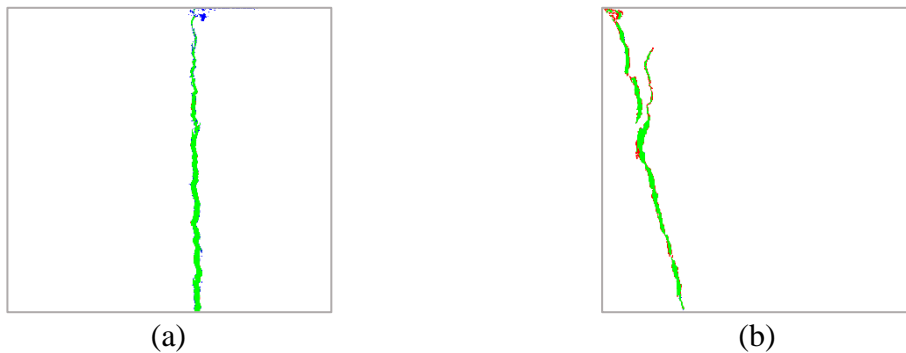
Figure 4: (a) Comparison of the proposed segmentation with the ground truth in the last frame of specimen 3 and (b) Comparison of the proposed segmentation with the ground truth in the last frame of specimen 5.

In Figure 5, it is shown the result of the comparison between the Ground Truth segmentation to the one realized by the tool in two specimens. The color green represents the accurate segmentation of the crack, the color red provides information about the false negative pixels and lastly the color blue displays the false positive pixels. For each test, four ground truth images were created in order to validate the monitoring of the cracks through time, this manual segmentation was performed with the Image Labeler belonging to the Computer Vision toolbox and was done pixel by pixel

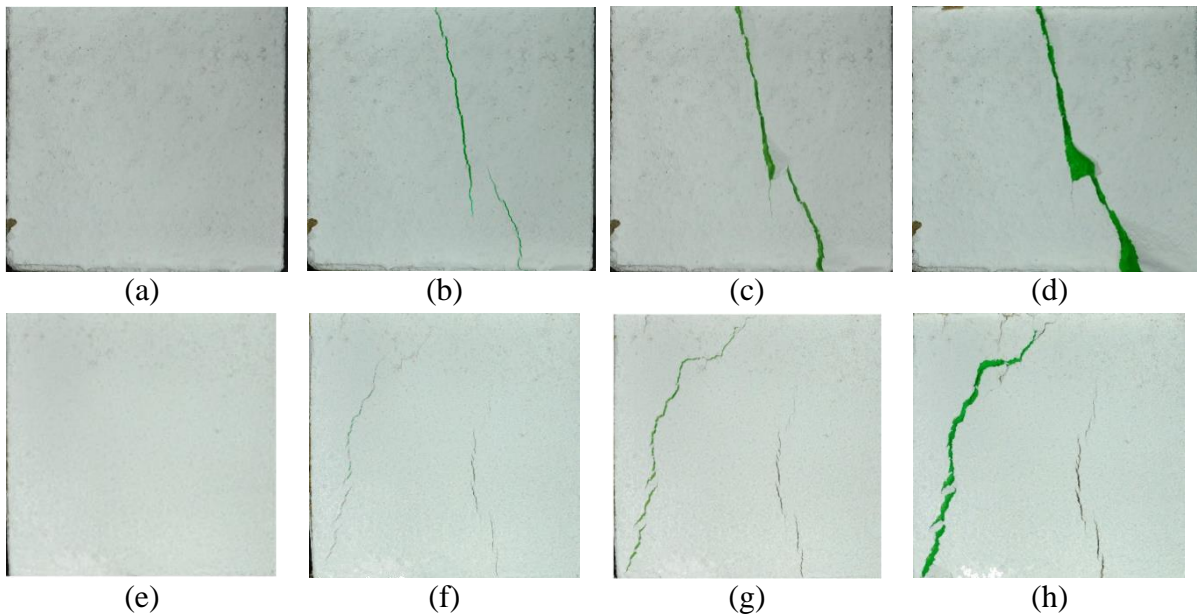
Figure 5: Images that represent how does the crack changes (a) first image of specimen 1, (b) image 150 of specimen 1, (c) image 293 of specimen 1, (d) last image of specimen 1, (e) first image of specimen 2, (f) image 150 of specimen 2, (g) image 273 of specimen 2 and (h) last image of specimen 2.

The quantitative results of the tool are provided by the change in the crack's area produced through time. Thus, each row in Figure 5, represent different frames in time while the crack in each specimen starts to grow. The first column represents the first frame where no crack was previously formed. The next column corresponds to the 150th image for each specimen in this part both adobe cubes where still on the elastic deformation region. Specimen 2 shows cracks but little segmentation, this is because the cracks in that image are thinner than 1mm which is the minimum thickness that the tool perceives. The third column shows the image in the elastic limit point where the adobe cubes enter the plastic deformation region and the crack starts growing faster. The last column the last frames of each test.

The results of the first 5 specimens are shown in Figure 6, which is a graphic corresponding to the change of the area versus the time of duration in each test. It is correlated to Figure 5, the letter indices correspond to the frame they belong to. Thus, Figure 5a and 5e are the first frames of the tests for Specimen 1 and 2, and so on. The graphic shows that two specimens were more resistant and the growth in their cracks area is moderately constant, it also compares how in some specimens the area of the crack is substantially bigger. The points “c” and “g” correspond to the limit where the behavior of the adobe cubes stops representing a constant growth, the crack’s area starts to change rapidly and reaching faster the rupture point.

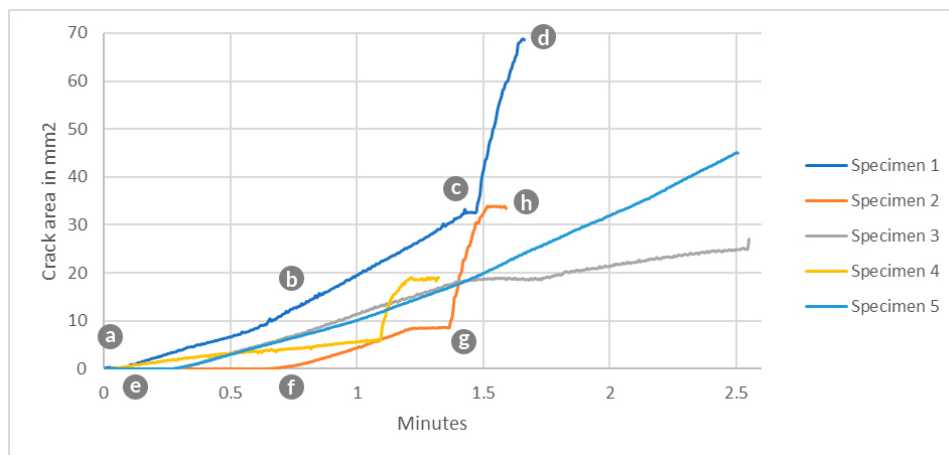
Figure 6: Graphic of the change in area of the cracks in the first 5 specimens through the duration of the tests.

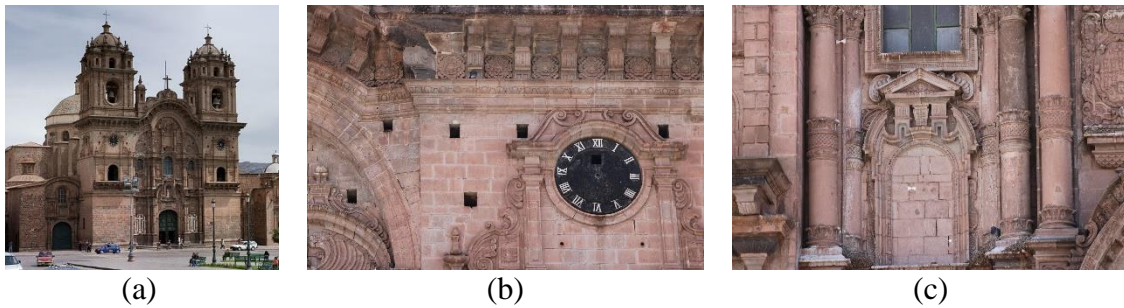
Figure 7: (a) The church of the Society of Jesus, (b) right bell tower and (c) left side of the façade.

The case study evaluated in this paper is focused on an important heritage building, which is part of the Andean Baroque Route, composed of four representative churches of Cusco, Peru. The Church of the Society of Jesus, was built in 1576 over the Inca temple called Amaru Cancha, however, it suffered the consequences of the 1650 earthquake and had to be re-built in 1651. In this occasion, it was contemplated with three doors facing the main square; the main vault was finished and closed in august of 1653. In 1950, another earthquake caused damage mainly in the structures of the façade and choir. The structure was rebuilt in a Latin cross shape, its façade, shown in Figure 7.a, is made of profusely decorated stone and it has two bell towers and two external chapels.

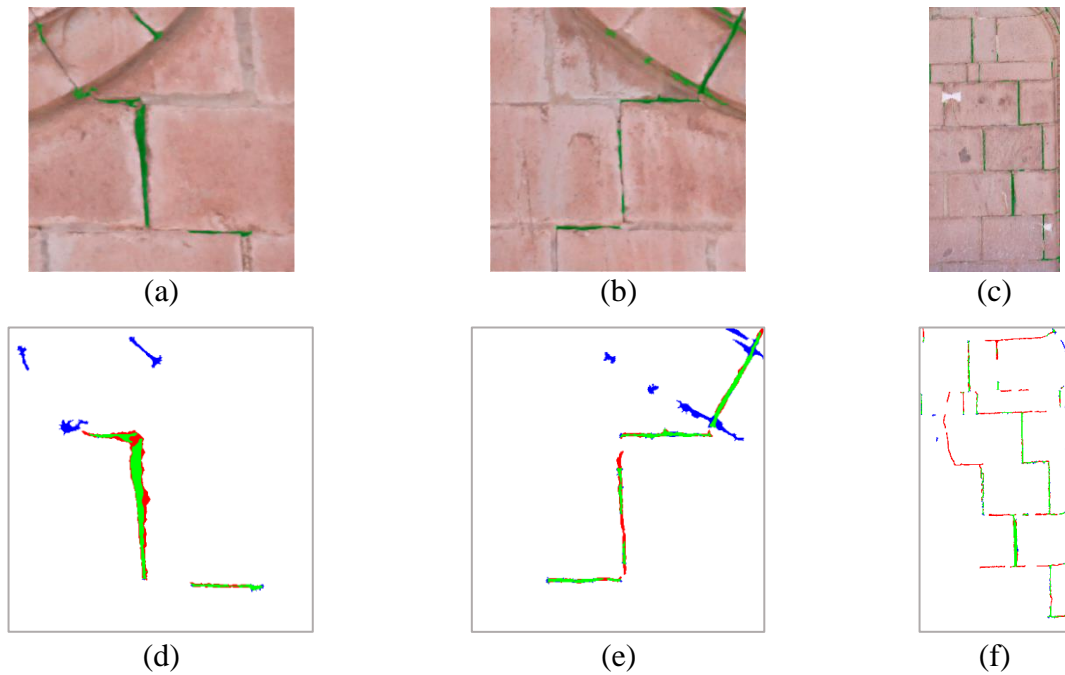
Figure 8: (a),(c) and (e) are the segmentation in green over the ROI, (b),(d) and (f) are the qualitative result of the tool from different cracks on the façade of the Society of Jesus.

The qualitative results are shown in Table 1, which confirm that the great variations in contrast that the façade has play against the capabilities of the presented tool. However, the results do not correspond to a poor segmentation, it is also seen in Figure 8 how some junctions are not detected as cracks.

In Figure 8, the results of the tool being used are shown in the images obtained of the representing cracks of the façade of the church. Due to, the large variation in color in the façade

the use of the tool was performed in parts as its shown in Figure 8, the first two columns represent parts of the same image, in this case the full image is presented in Figure 9.b. The third column of Figure 8 represents another part of the façade, in this case only one section had visible cracks, the full image is presented in Figure 9.b. In the second column belonging to Figure 8, it is shown how some parts of the borders and shadows introduced become false positives for the tool being represented in blue. Moreover, in Figure 8.f, some cracks that were not detected represent cracks of a thickness below the proportional minimum, given that these images represent a bigger surface than the adobe cubes previously tested.

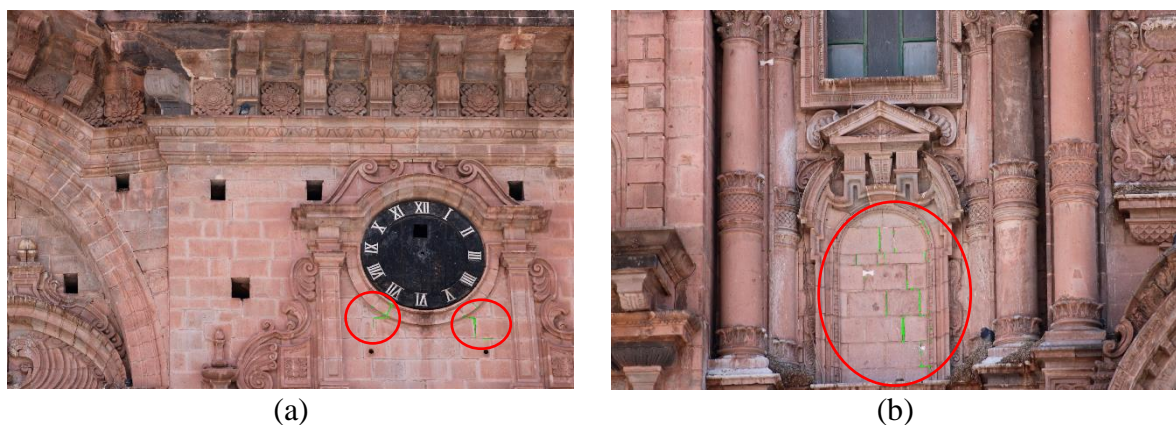
Figure 9: (a) Image 1 of the top part of the façade, (b) Image 2 of the middle part of the façade.
