## DYNAMIC IDENTIFICATION OF DAMAGE IN BRICK MASONRY WALLS

**Keywords:** OMA, Masonry, Monitoring, Non-Destructive Inspection

**Abstract.** *This paper shows the experimental and numerical analysis developed on a brick masonry wall of 3x2.5x0.2 m to understand the changes on its dynamic behaviour with different stiffness situations: (i) original, (ii) loaded with different load levels, (iii) damaged by horizontal in plane loads, (iv) retrofitted with Textile Reinforced Mortars (TRM) and (v) retrofitted and damaged by horizontal in plane loads. This analysis has been developed at the Civil Engineering Lab at the University of Alicante. On this masonry wall a matrix of 8 seismic accelerometers have been installed to evaluate, in plane and out of plane, changes in the main frequencies, modal damping ratios and modal shapes. By the use of Operational Modal Analysis techniques the results shows that the changes on the stiffness have important influence on the main frequencies and in the modal damping ratios. Very low influence have been detected on the modal shapes due to the low level of external vibrations generated during the tests. Due to the low level of vibrations inside the lab

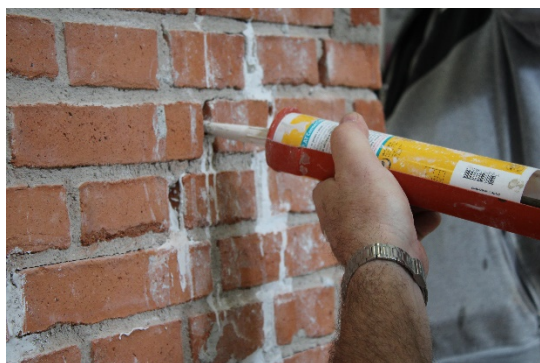
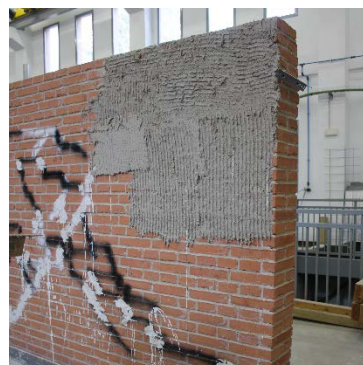
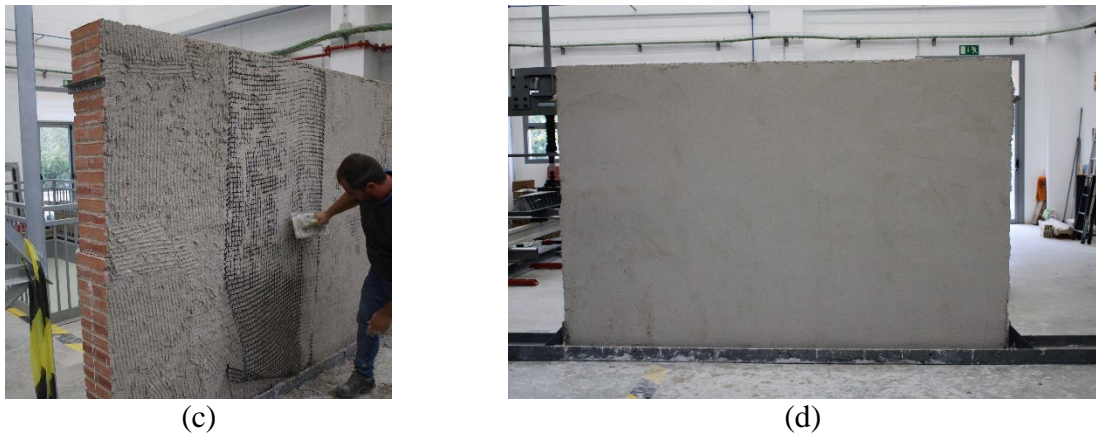
**Figure 2.** (a)- Injection the wider cracks. (b)- 5 mm thick cementitious laye applied on the outer face. (c)- Application of the glass fiber mesh. (d)- Reinforced masonry wall.

cementitious-based strengthening to: (i) improve the seismic behavior of masonry structures, and (ii) avoid a seismic-induced premature failure of poor-quality masonries. The adopted TRM retrofitting technique comprised a 25x25 mm glass textile grid embedded into a 10 mm thick cementitious layer applied along the outer face of the overall building (Figure 2). Table 2 shows the mechanical properties of the reinforced material used in this research.

When this kind of reinforcement is applied on damaged structures, it comprises different steps. Indeed, the masonry support was preliminarily treated injecting the wider cracks (Figure 2.a) to restore the original load bearing capacity of the damaged masonries. Then, a 5 mm thick cementitious layer was applied on the outer face of the walls (Figure 2.b). This layer is necessary to allow the bond between the masonry support and the glass textile grid (Figure 2.c). It is worth mentioning that, conversely to FRP composites, TRM materials allow to comply with the current requirements of compatibility and reversibility of the retrofitting with respect to brittle supports due to the presence of a mortar matrix instead of an epoxy one [6]. Finally, the glass grid was covered with a second 5 mm thick layer of the cementitious binder (Figure 2.d). The layers composing the TRM composite adopted in the present investigation are showed in Figure 2.

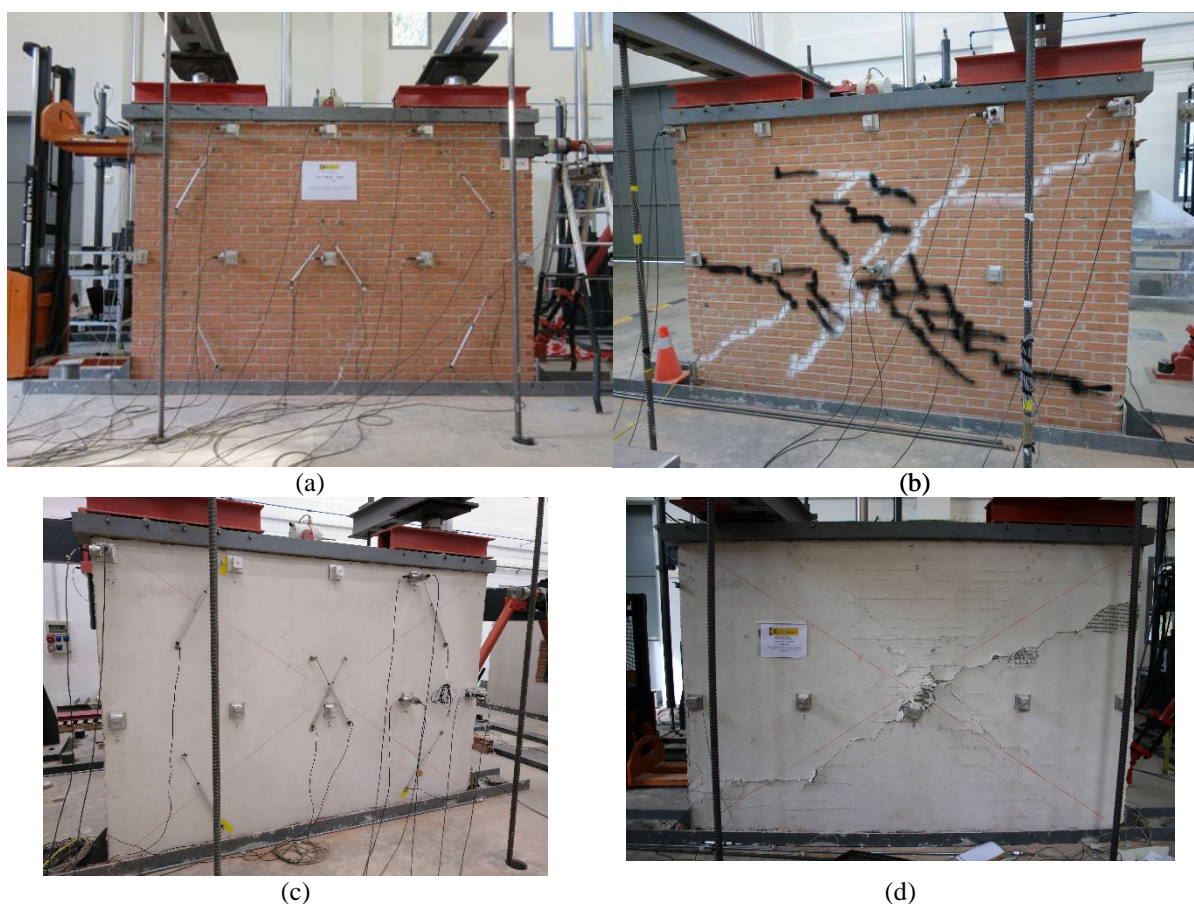
**Figure 2.** General view of sensors location; (a) Undamaged (b) Damaged (c) Retrofitted with TRM (d) Retrofitted with TRM – Damaged.

In case of the unreinforced wall, a classical crack pattern (Figure 2) arose with increasing damage. In particular, a well-defined diagonal crack (white crack) and some diffused cracks (black cracks) appeared. As it can be seen in Figure 2, the cracks mainly follow mortar joints, except in some points where it cross one or more bricks.

Figure 2 shows the crack distribution for the reinforced wall. The damage configuration appears very similar with the unreinforced case, but less severe.

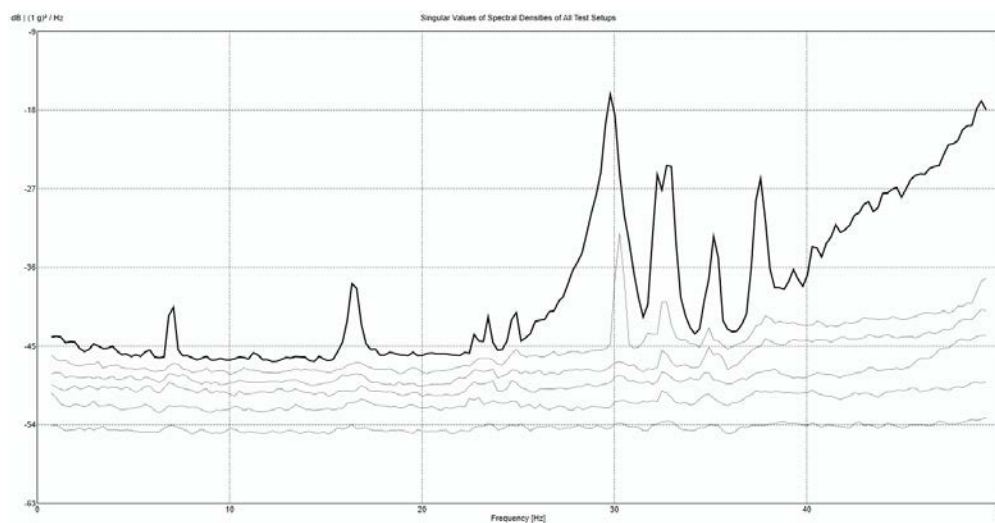
**Figure 3.** Typical Singular Value Plot obtained by processing acceleration data of the wall through the EFDD technique.

Regarding operational modal analysis, the first three vibration modes have been identified. The Figure 3 shows a typical Singular Value Plot, in a value range from 0 to 50 Hz, obtained through the EFDD technique. The estimated natural frequencies and damping ratios are shown in Table 3 and the mode shapes are represented in Figure 4. The first two vibration modes are out-of-plane modes, the third is an in-plane mode. For each identified vibration mode, the natural frequency decrease and the damping ratio increase due to damage. In particular, a reduction of natural frequency equal to 21.14%, 22.04% and 57.15% and an increase of damping ratio equal to 10.11%, 69.94% and 12.04% have been evaluated respectively for the first, the second and the third mode. Finally, in order to evaluate the changes in mode shapes due to damage, the Modal Assurance Criterion (MAC) has been used.

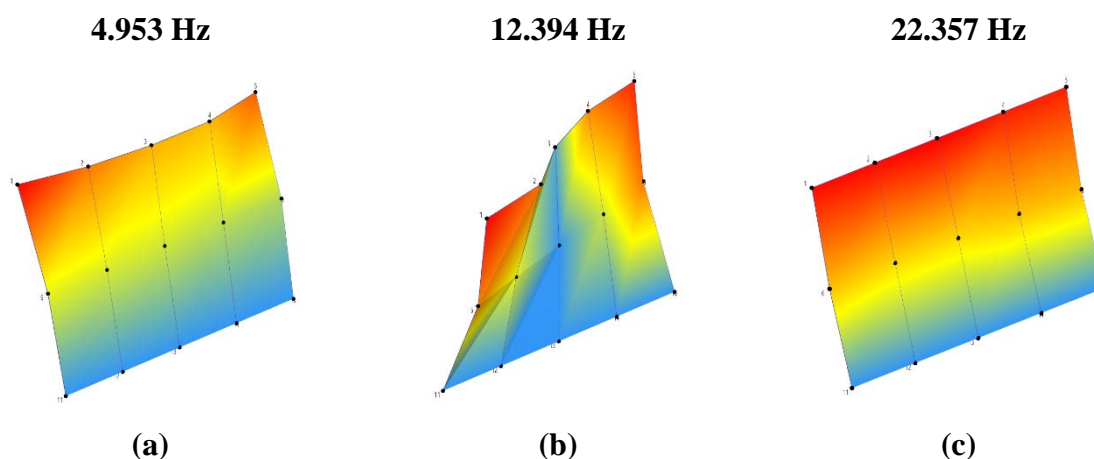
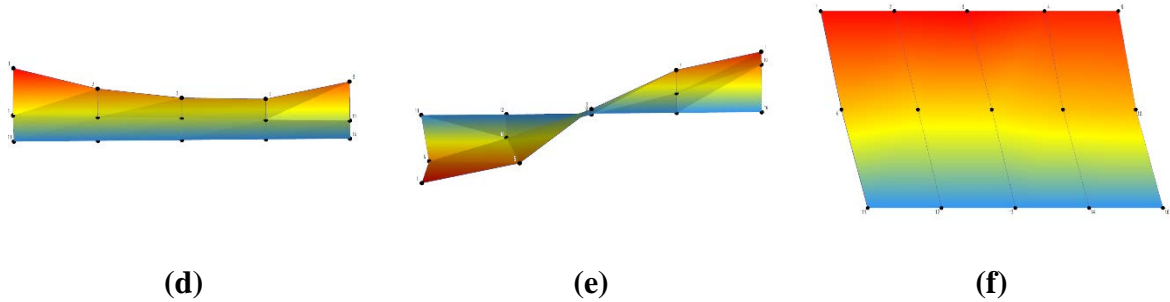
**Figure 4.** Frequencies and mode shapes for the unreinforced pre-damage wall. General view: (a), (b), (c), (d). Plan view: (e), (f), (g). Front view: (h).

The reduction of natural frequency due to damage indicates a reduction of wall stiffness. Moreover, the increase of damping ratio suggests an increase of energy dissipation due to material friction along the cracks. It is worth noting that, since the greatest frequency reduction corresponds to the third mode, the damage has mainly affected the in-plane stiffness. Moreover, the MAC values reported in Table 4 suggest that the damage mainly affects the mode shape of the second vibration mode.
