# Comparative study on shotcrete repair solutions of buried steel pipelines

**Abstract.** The research aims to optimize the rehabilitation works of steel buried pipes after their lifespan is reached. It is based on objective real situations met in the Romanian agricultural irrigation system. The study proposes an analytical approach to predict the behavior of the rehabilitated pipelines initially subjected to various corrosion rates, from low to high agressivity of the environment. Besides traditional lining with reinforced concrete, a new trend given by the relative modern structural repair mortars is considered. The time behavior of the shotcrete lining is estimated based on information given by the appropriate European norm. The results question the design philosophy, still not clarified in the field, and emphasize the superior performance of modern cementitious materials, both in terms of technical performance and economical efficiency. Future research perspectives are also underlined with regard to the new materials meeting sprayed concrete technology requirements, and design philosophy.

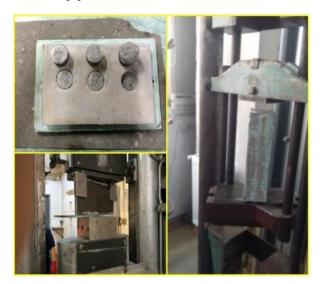
Fig. 3. Specimens and tests.

The results of the mechanical tests (Figure 3) made on the concrete C 30/37 and repair mortar R4 mixes at the age of 28 days are summarized in Table 4.
