HOLISTIC APPROACH TO CLEANING AND PROTECTION OF STONE FAÇADES OF 20TH CENTURY ARCHITECTURAL HERITAGE

Keywords: Architectural heritage, Stone cleaning, Self-cleaning, In situ examination, Case study

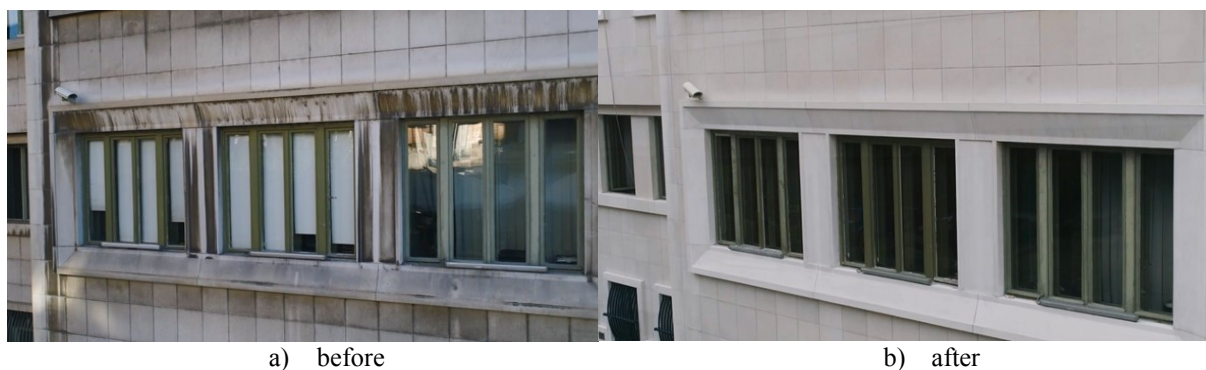
Figure 5: Cleaning and protection - before (a) and after (b)

The involvement of the Laboratory on the sight in continual scientific monitoring of cleaning and protection works at Banovina Palace, from May to November 2019, Figure 5, was beneficial from multiple points of view. The most important, it proved that no significant visual damage (change of colour or surface roughness) was caused by the treatments. What is even more important, the regular presence of the Laboratory team at the building enabled solving unexpected issues promptly. Finally, regular monitoring and reporting after each cleaning stage with portable digital microscope and mobile spectrophotometer, together with regular XRF, FTIR and microbiological measurements, enabled some procedures to be repeated if necessary, and ensured that each phase (cleaning, repair and protection) is documented and approved when the satisfying results are achieved, Figure 5.
