Monitoring Steel Rebar Corrosion-induced Cracking in ECC Cover by DOFS

E Chen¹, H. Ye¹ and S.S. Zhang¹

Abstract. *Steel corrosion is the main threat to the durability of concrete structures, and the cracking or spalling of concrete cover caused by the expansion of corroded steel can largely accelerate the deterioration process. Engineered cementitious composites (ECCs), as one type of high-performance fiber-reinforced cementitious composites with high tensile ductility and excellent ability of crack width control, have a great potential to be able to improve the durability of structures under corrosive environment. Nevertheless, corrosion of steel rebar may still happen in ECC if aggressive agents de-passivate the rebar; therefore, the relationship between the corrosion level and cracking degree in ECC cover is essential for accurately estimating the corrosion condition as well as service life of steel reinforced ECC structures. This study investigates the cracking process of ECC under accelerated steel corrosion implemented by impressed current, during which the distributed optical fiber sensors (DOFS) were employed both on the steel rebar surface and surface of ECC specimens to

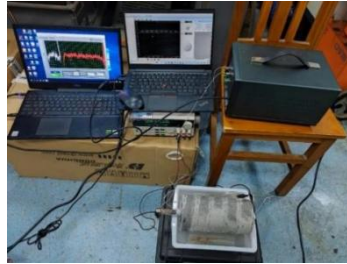
Figure 4. Accelerated corrosion test set-up and DOFS system.

To accelerate the corrosion process, impressed current method was used. Before applying the current, the specimens were immersed in water for 12 hours. The corrosion test set-up is shown in Fig. 4. The positive electrode of the power supply was connected to the steel bar, and the

negative electrode was connected to the stainless-steel mesh. A constant current applied to the specimen was set as 0.03 A. This corresponding to the corrosion current density of $373\mu\text{A}/\text{cm}^2$ for the specimens in this study. The specimen ribbed-R/ECC was impressed current at the age of 29 days for about 25 hours, and then was placed in a natural state due to the Covid-19. The formal corrosion test was started at the age of 89 days. The specimen smooth-R/ECC was impressed current at the age of 120 days. After the accelerated corrosion test, the specimen was cut into thin slices for observing the internal crack pattern and corrosion distribution.

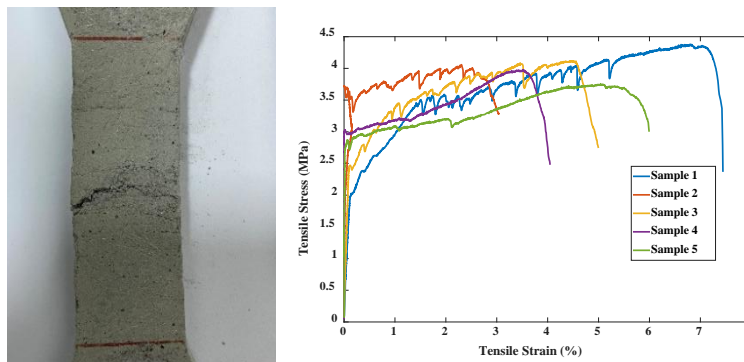
Figure 5. (a) Multiple-cracking in ECC under tension; (b) Tensile stress-strain curve of ECC.

All the dumbbell specimens exhibited multiple cracking during the tensile loading, as shown in Fig. 5a. The stress-strain curves of the five ECC specimens are shown in Fig. 5b. Good ductility was obtained in these specimens.

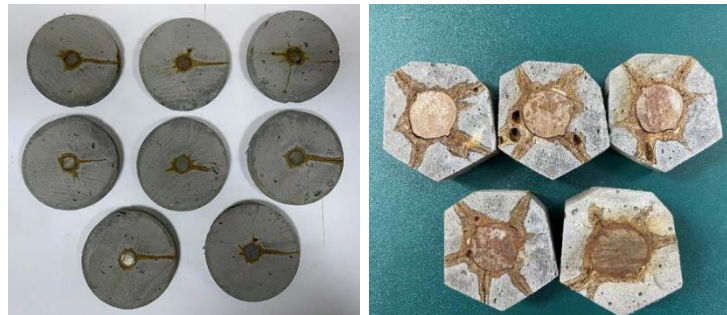
Figure 10. Crack pattern in the smooth-R/ECC (left) and ribbed-R/ECC (right).

The two specimens were cut into several slices to observe the internal crack pattern and corrosion distribution. The smooth-R/ECC specimen was cut by a thick cutter at first. It was found that the surface of the slices was not well flat and the edges of the steel surface was damaged a little. Therefore, a more precise and thinner cutter was used to cut the ribbed-R/ECC specimen. Before cutting on the precise cutter, the out portion of the ribbed-R/ECC specimen was cut off by the thick cutter first so that it can be placed on the thinner cutter set-up. Figure 10 shows that several corrosion-induced cracks were produced under the corrosion expansion. In normal concrete, the corrosion-induced cracks is usually localized into fewer major cracks.

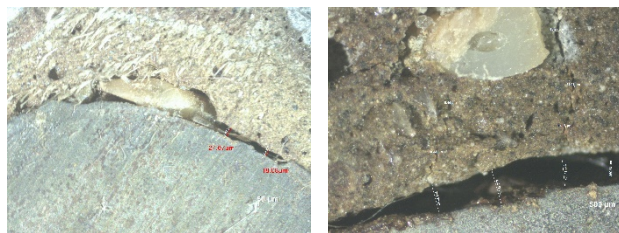
Figure 11. Fiber sensor at the smooth bar surface (left) and at the ribbed bar surface (right).

Through the microscope observation, it was found that the fiber sensor was adhered on the smooth surface tightly while the fiber sensor was not directly attached on the rebar surface at some locations due to the transverse ribs, see Fig. 11. Therefore, the strain measured by the DOFS attached on the ribbed rebar may be a little different with the theoretical strain calculated right on the rebar surface from the classical corrosion expansion cylinder model. Further quantification analysis of the correlation between the corrosion-induced strain measured by DOFS and corrosion level should account for this.
