STATIC AND DYNAMIC LOAD TESTS OF LIBEŇ BRIDGE OVER VLTAVA RIVER IN PRAGUE AND CONCEPT OF REPAIR

Keywords: Concrete, arch bridge, historical structure, load tests, reconstruction

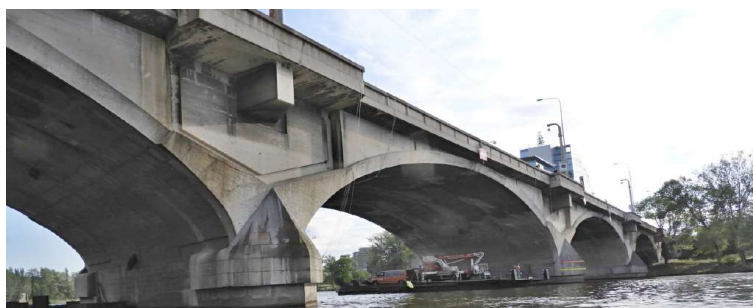
Figure 1: Libeň bridge

The Libeň Bridge (Figure 1) was built between 1924-1928 according to the design by architect Pavel Janák. The structure was designed by Ing. František Mencl, who was the author of the arch part of the. The bridge was opened to the public on 29 October 1928 on the 10th anniversary of the Czechoslovak Republic with the participation of President Tomas G. Masaryk. Arched spans of three joints from plain concrete are considered to be the highest value of the construction.

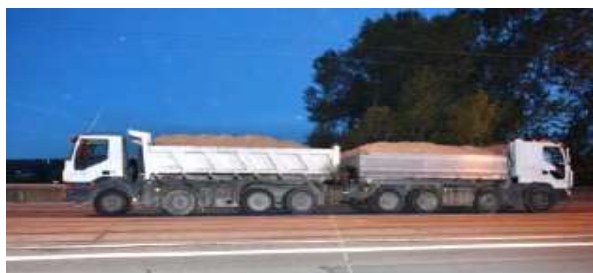
Figure 2: Vehicles during static load test – static

During the load states the vehicles were in the position as shown in Figure 2, 3 No.1 vehicle (mass 37 t), the vehicle No. 2 (mass 41 t) always points in the same direction - ending towards each other and facing to one end of the bridge. For vehicle crossings, both vehicles were used, alternating in the rides individually.

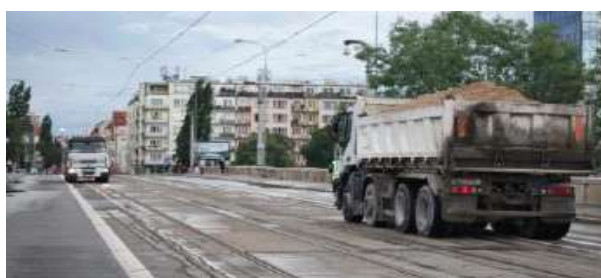
Figure 3: Vehicles during static load test – crossing

Two freight four-axle vehicles with a weight of 40 t have been designed as a test load. The vehicles were placed according to symmetrical load bridge by two lorries at the top of the arcs. Load 2 x 40 t in the middle of the span in each arc for all 5 arrays x 4 passes, i.e. 20 load cases. In addition, crossings with a vehicle weighing 40 tons were made, in each of the vault strips 3x back and forth, i.e. 120 crossings.

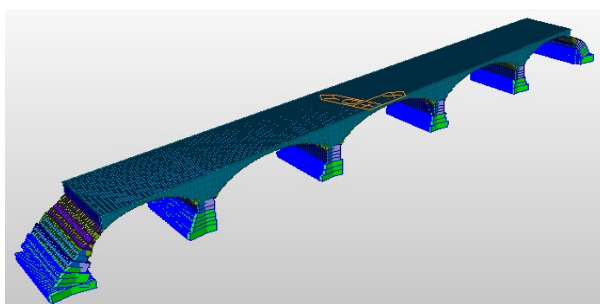
Figure 4: The overall model before dividing into individual parts

The computational models were developed in Midas software (Figure 4). The model for assessing the load carrying capacity of vault strips is created using rod, flat, and bulk elements so as to simulate the behavior and dimensions of the structure as close as possible. Due to the complexity of the bridge construction, the overall model is divided into individual vaults, which are then independently assessed.

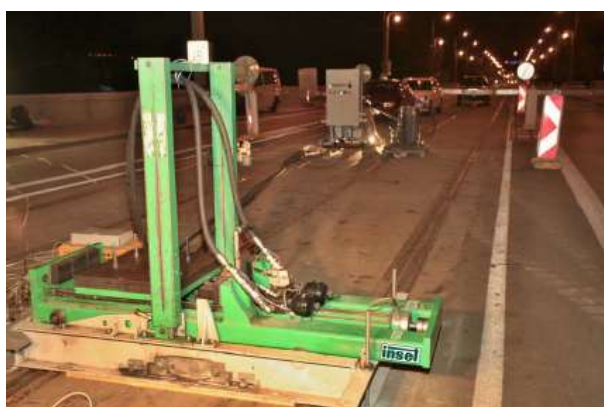
Figure 7: The vibration exciter installed on the tramline

To excite the forced oscillation of the bridge structure in shapes close to the theoretical oscillation mode shapes (mode shapes cannot be excited, it is a dimensionless mathematical fictitious shape), a hydraulic INSET vibration exciter (Figure 7) was used in the harmonic excitation mode. During the tests, the exciter was placed on the bridge (or on the tramway) in three positions. These positions were designed for measurements on individual vaults in spans 1, 2 and 5. The theoretical location of the exciter was half the span of the bridge in the longitudinal direction and on the tramline. At these locations, the excitation was in the position for horizontal transverse excitation (relative to the axis of the bridge) and for vertical excitation.

The measurements were made at all measuring points using electrodynamic sensors. Dynamic deflections (or vibration velocities) were measured using triaxial oscillator speed sensors. The measuring line also included two thermometers to monitor the surface temperature of the structure and the air temperature and the anemometer to monitor wind velocities and directions.

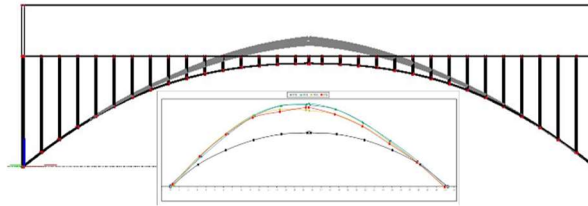
Figure 8: Measured and calculated oscillation shape for 7.23 Hz

Construction of the model is composed of individual vault strips of plain concrete C16 / 20 with a modulus of elasticity $E = 21$ GPa. These elements are modeled with sloping and variable thickness. The top and toe joints are simplified by a sloped line. A joint support is introduced at the heel of the vault. At the top, the joint is replaced with a low stiffness element ($E = 1$ GPa). The wall elements forming the front wall ($E = 19$ GPa) and the overhang ($E = 3$ GPa) are attached to these vault strips. Interaction of the individual strips is ensured by a slab simulating the road cover (according to the diagnostic conclusions it is a concrete slab with a thickness of 500 mm and bituminous cover with a thickness of 200 mm, $E = 10$ GPa). This slab is provided with boundary conditions ensuring the continuity of the structure (non-moving joints). In this model, where the upper slab behaves like a strained membrane that limits the oscillation of the structure, two identical oscillations have been found for measured frequencies of 7.23 and 11.92 Hz (Figure 8, 9).

Frequencies measured [Hz]	Frequencies calculated [Hz]	Deviation [%]
6,46	6,64	2,7
7,23	8,5	14,9
11,92	10,46	-13,9

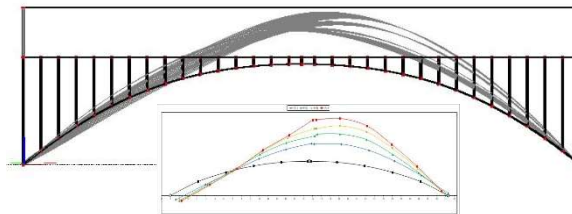
Figure 10: Measured and calculated oscillation shape for 6.46 Hz

In case we for this model partially release the boundary conditions for the top plate by inserting resilient supports with a stiffness of 100 MN / m^2 , the loosening of the wall linkage over the top joint vertically (flexible support with a stiffness of 100 MN / m^2) and by adjusting the stiffness of the left 19 GPa) and right (23 GPa) of the half of the arc to take into account the diversity of materials and possible discontinuities, we obtain another consistent shape of oscillation of the structure for the measured 6.46 Hz (Figure 10).
