Properties of Czech WW2 Concrete Fortifications after 80 Years

Abstract. *This paper deals with the investigation of properties of Czech fortification concrete bunkers built before Second World War (WWII). The Czech defense system consisted mainly of light bunkers type No. 37. The vast numbers of these bunkers have been preserved in various conditions to nowadays. The light bunkers type No. 37 were designed to last limited lifetime of decades. According to the preserved test protocols, strength of used concrete varied from 40 to 50 MPa, measured on cube specimens with dimensions 200×200×200 mm. There is an information, in general public, about high quality and strength of used concrete. The non-destructive analysis of compressive strength, determined by Schmidt hammer was performed. This method was used to maintain a historical value of the structures. Three were analyzed different bunkers type No. 37 located in Western Bohemia – Pilsner region. Tested bunkers are preserved in various conditions with various quality of concrete. The measurements by Schmidt hammer took place in several locations especially in the interior part. The exterior was also investigated but only in the loc

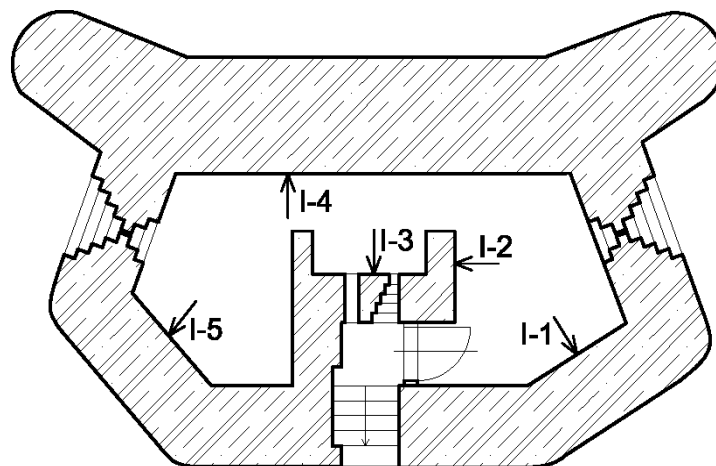
Figure 1. Schematic cross-section with marked places of performed measurements.

Testing by Schmidt hammer represents commonly used method for non-destructive testing of concrete’s mechanical properties. This method is standardized and allowed by standard systems of many countries. There have been cases where Schmidt hammer was used as representative of non-destructive method for measurement of compressive strength of masonry elements (Aliabdo *et al.*, 2012). However, the most widespread use still represent concrete, as a material usually supplemented by destructive testing if circumstances permit (Holčápek *et al.*, 2014). The standard Schmidt hammer type N was used, according to Czech standard (CSN EN 2013). Due to the preserved external plasters the investigation took place mainly in the interior part. The schematic cross-section of bunker No. 37 with marked location of performed measurements is shown on Figure 1. Minimum of 50 measurements were performed on each place (places in different heights). Also the quality of roof was investigated.

All results of performed measurements are summarized in Table 1. The first column describes the location according to Figure 1. Following three columns list the values of tentative

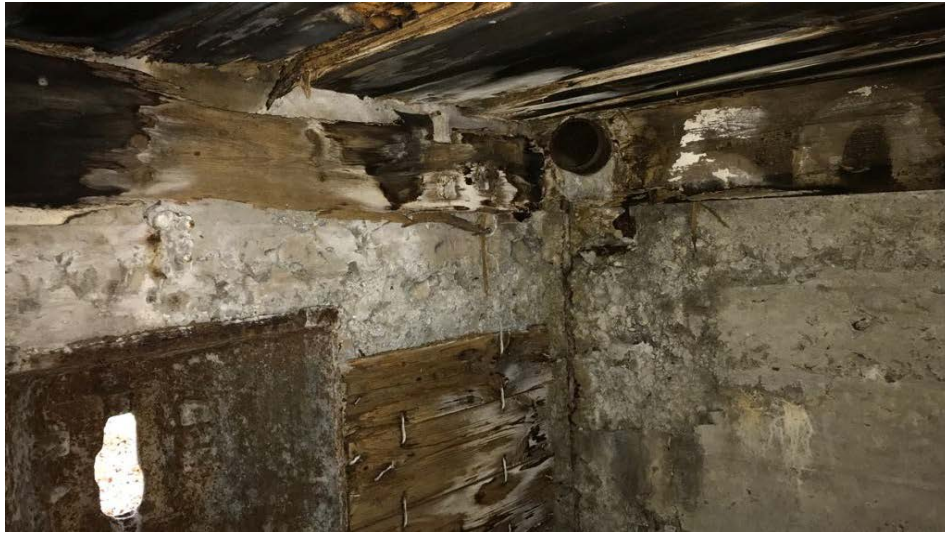
Analyzed bunkers are situated in one location and were built in approximately in the same period of second half of 1937. Their entrances are not locked, which means that the bunkers are not protected against vandalism. We can still observe the residua of original timber cladding in the interior part, as shown on Figure 2 and also on Figure 3. These timber elements were exposed to moisture and the effects of fungi and microorganisms. An important finding is that the quality of concrete within a single object is variable. We can observe excellent quality of surface layer, without any cracks or cluster of aggregate. There are places with very poor quality

Figure 2. Residuum of internal timber cladding, poor quality of surface layer of concrete.

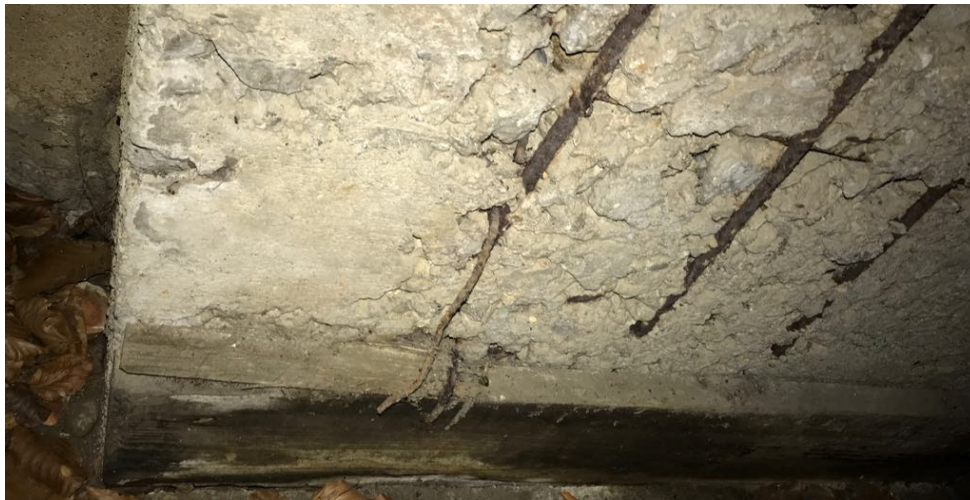
of compaction in the same bunker. We can see reinforcement uncoated by concrete, clusters of coarse aggregate and other imperfections. This surface was originally covered by timber cladding and the estimated designed lifetime was only about 20 years, but if we want to preserve these objects to future generations, we have to deal also with these problems.

Figure 3. Insufficient compaction with uncovered steel reinforcement.

- The quality of concrete from investigated bunkers shows very different properties. On one object, we can find areas with excellent surface quality and well compacted concrete. These locations alternate areas with exposed reinforcement and insufficiently compacted concrete with large gaps. This phenomenon is caused by the originally used method of compaction with rammer in 1930s. The exposed and uncovered reinforcement is not a result of concrete’s degradation.
