## **PRESERVING HISTORIC BEARING STRUCTURES BY PRUDENT INTEGRATION IN NEW STRUCTURES**

**Keywords:** Historical Structure, Preservation, Re-use, Consolidation

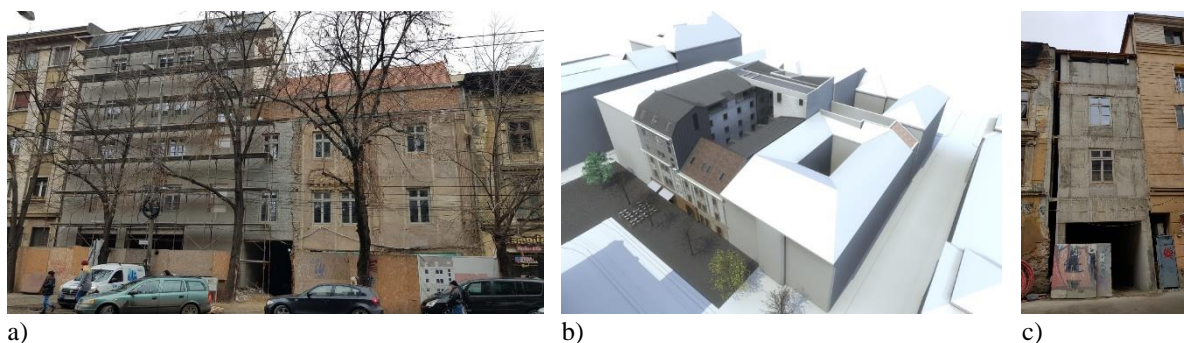
**Figure 1:** a) St. George square no. 2 and 3 buildings facades; b) proposed building – 3D model; c) St. George square no. 4 building facade

The historic buildings are located on 3 different plots (Figure 1) [1]. Located close to the St. George square, two of the buildings (no. 2 and 3), used to have a C-shaped plan while the neighbouring building (St. George square no. 4) is presenting an O-shape with an inner courtyard.

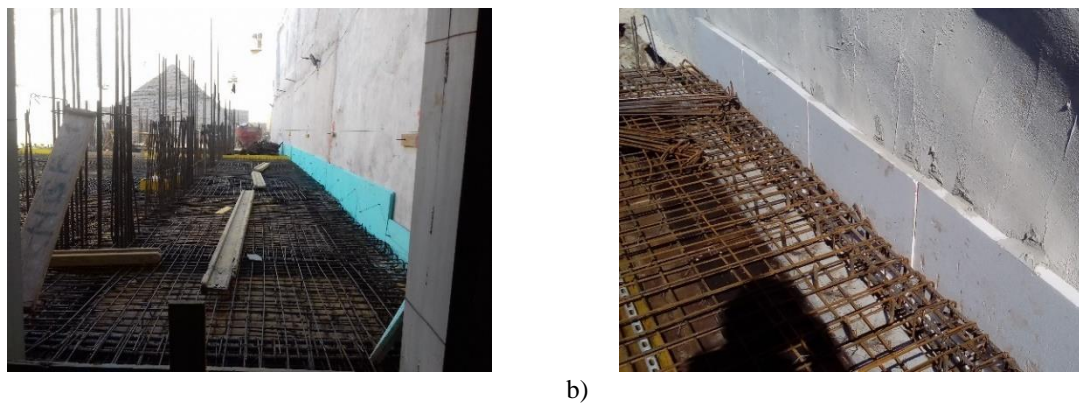
**Figure 3:** a) Perimetral columns withdrawn from the neighbouring buildings; b) 5 cm gap between the cantilevers and the neighbouring buildings

The new construction made in the courtyard of the buildings was designed using reinforced concrete, having a rigid central perforated core, two rigid concrete tubes in the access path area and columns near to the neighbouring buildings. These columns were placed at a minimum distance of 1.50 from the neighbouring buildings, in order not to transmit loads to the foundation ground of these buildings. From the perimeter columns, cantilevers were placed towards the neighbouring buildings and a gap between the old and new of 5 cm considered [13] (Figure 3).

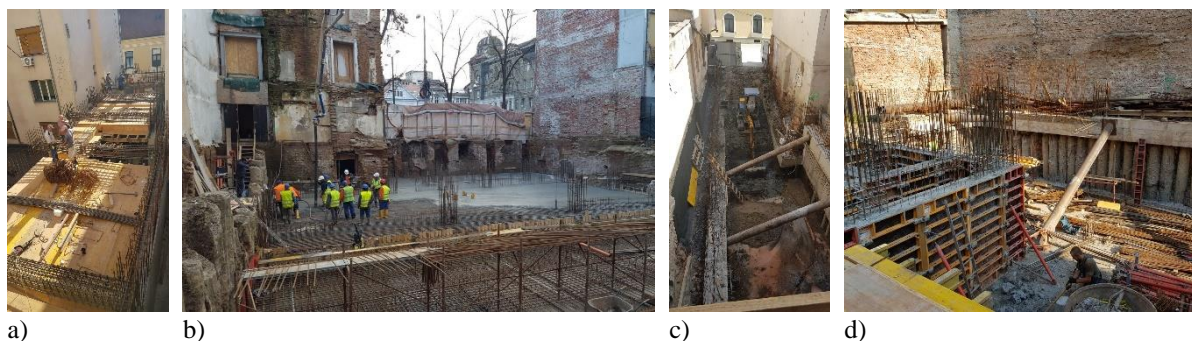
**Figure 4:** a) Reinforced concrete wall and floor of the new St. George square no. 4 building; b) raft slab in the area outside the St. George square no. 2 and 3 buildings; c) special foundations towards the old St. George square no. 4 building; d) special foundations of the St. George square no. 2 and 3 buildings.

The load-bearing structure of the St. George square no. 4 building was made out of concrete walls and reinforced concrete slabs (Figure 4a).

Because it was also necessary to include an underground parking lot, in the underground level area outside the historical buildings that were kept, a raft slab was designed (Figure 4b). In order to prevent the new construction from transmitting loads to the neighbouring buildings, it was considered to build piles towards the St. George square no. 4 building and partially towards the Mercy no. 1 building in the north (Figure 4c,d). The piles were designed by Soletanche Bachy Romania.

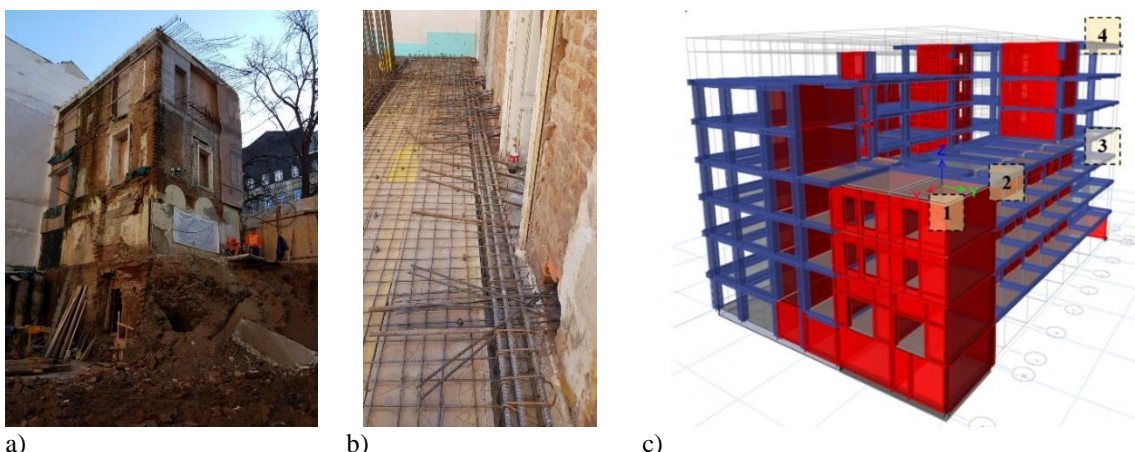
**Figure 5:** a) Preserved section of the historic masonry building; b) connection between the historic and new building; c) contact area between St. George square no. 3 and 4

1. Four rooms were kept from the St. George square no. 3 historical building in order to take over the loads from the St. George square no. 4 building (Figure 5a).

2. The historical building was connected to the very rigid reinforced concrete structure in the floors area (Figure 5b). This structural solution allowed the reduction of the internal forces and deformations of the historical structure and implicitly the reduction of the expenses.

Figure 5c shows the contact wall between the historic building and the neighbouring building. The wall is delimited at the top by points 1 and 2. The vibration modes and periods of the connected buildings are shown in Figure 6. In figure 7 and in table 1, it can be observed that the inter-story drift values do not exceed the allowed limits. On the last floor, these values increase because this level was designed as future meeting rooms of the hotel and therefore made using a steel structure.

By increasing the stiffness, consolidating the historic floors and connecting the historic building to the new reinforced concrete one, the bending moments in the wall in the contact area between the buildings were reduced. The values of the bending moments at the top of each wall at every level, on the corner of the building (Figure 5c – point 1) are presented in table 3.

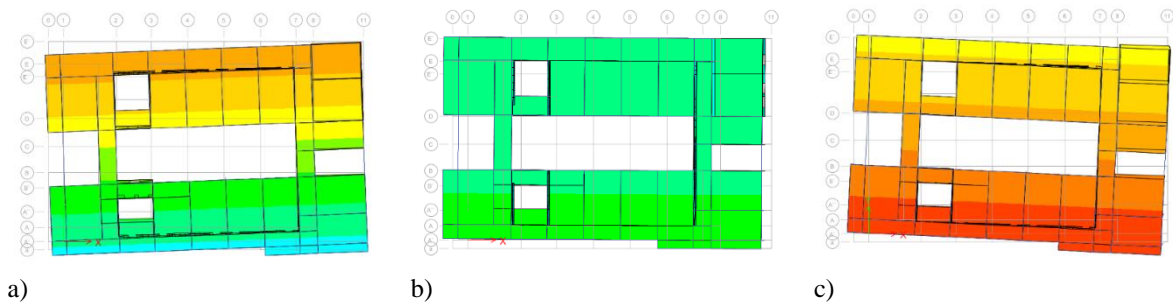
**Figure 6:** Vibration modes a) Vibration mode 1 –  $T_1=0.309$  sec; b) Vibration mode 2 –  $T_2=0.202$  sec; c) Vibration mode 3 –  $T_3=0.159$  sec

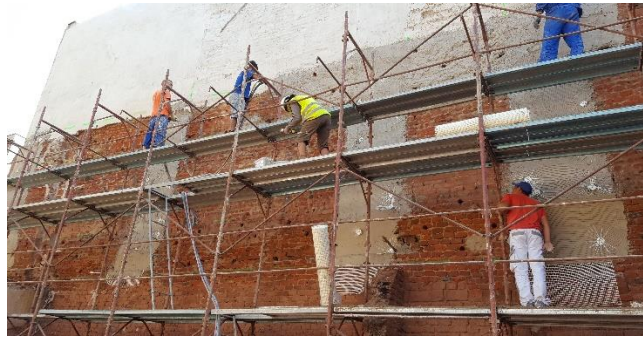
**Figure 9:** Consolidation of the St. George square no. 4 building wall which was not demolished using Kerakoll products

4. The original wall was kept the entire length of the St. George square no. 4 building. This wall was reinforced with FRP and is in contact with the reinforced concrete beams from the new building (Figure 9). On the upper floors, between the beams and the walls of the neighbouring buildings, a 5 cm gap was left. In this way, in the case of an earthquake, the new building could take over but not transmit the seismic loads to the St. George square no. 4 building.

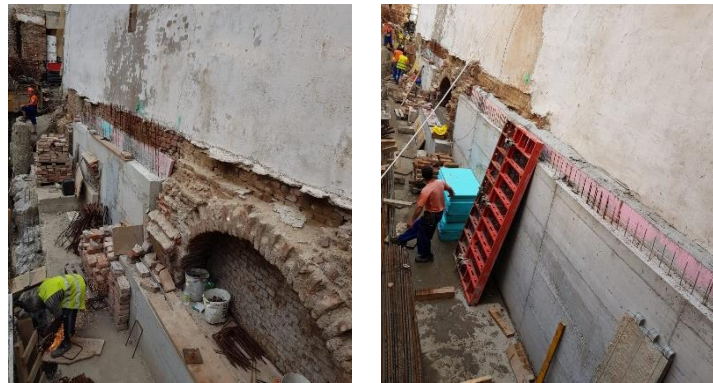
**Figure 10:** Reinforced concrete support walls made near the foundations of the St. George square no. 4 building

5. In order to prevent the earth discharge from beneath the foundations of the St. George square no. 4 building, reinforced concrete support walls were made, along its entire length (Figure 10).

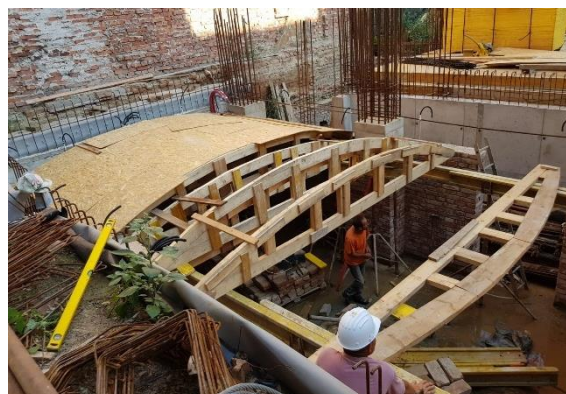
**Figure 11:** Reconstruction of the underground floor vaults of the St. George square no. 2 building

6. Due to the significant damage caused by settlements, the underground floor area of the St. George square no. 2 building was demolished. The vaults were rebuilt with the original bricks (Figure 11).
