THE COLUMN-LESS STAIR IN LORETTO CHAPEL IN SANTA FE, NEW MEXICO: STRENGTH ANALYSIS

Keywords: Historical Structure, Finite Element Analysis, Spiral Staircase

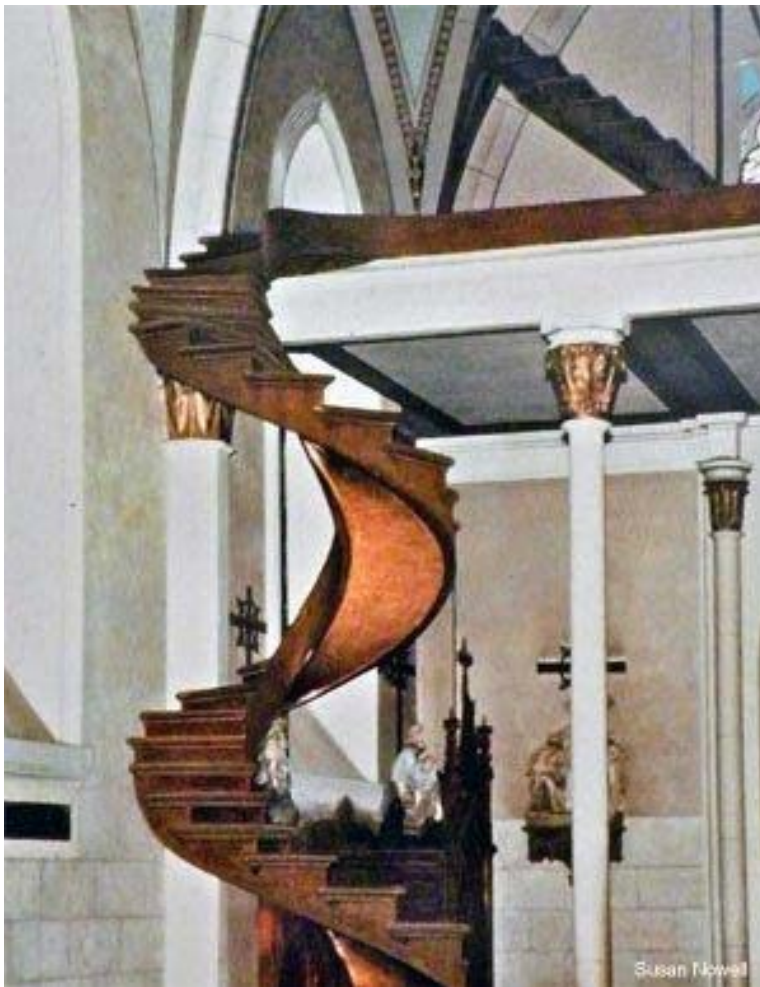
Figure 1 shows the structure of the stair. The figure is an artist's rendering; but the only difference between the figure and photographs of the actual stair is that the figure eliminates the railing to provide clear view of the structure of the stair. The strength analysis in this paper will include the railing as a load, not part of the load-bearing structure. For the first two years of its use, the stair had no railing (Black, 2014). Making two turns of 360-degree spirals, the stair has a total of 32 steps, the 33rd 'step' being the balcony floor. (The number 33 is said to be the age of Jesus Christ when he was crucified.) Table 1 shows data used in the strength analysis. Specific weight is used to calculate the loading of the stair structure due to its own weight. The ultimate strength and the shear strength of the material (assumed here to be Engelmann spruce) are used not in the calculation but instead compared to the maximum stress in the stair structure.

Figure 1: Staircase structure. (Black, 2014)

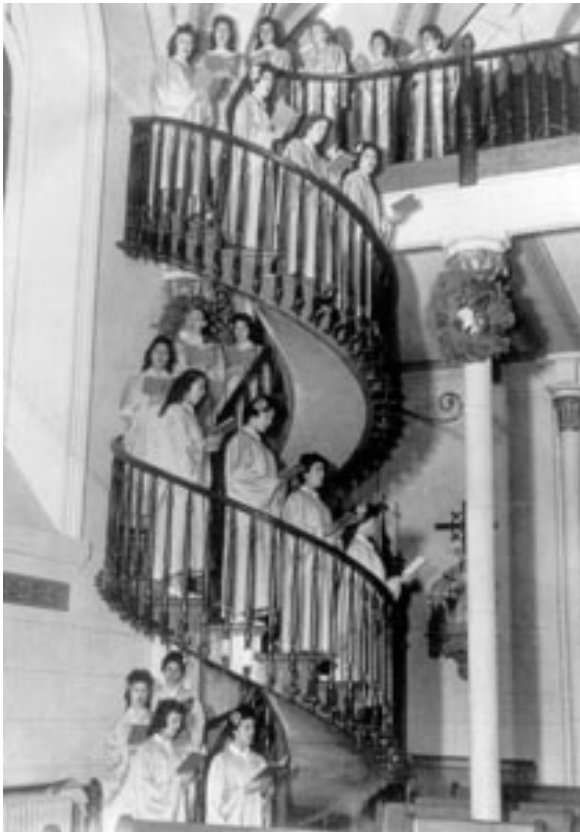
Figure 3: Photograph used to estimate loads.

Parameter, unit	Value	Notes
Height, m	6.706	
Outside radius, m	1.224	Excludes railing structure
Inside radius, m	0.300	Excludes railing structure
Number of steps	32	The 33 rd step is the balcony floor
Thickness of boards, mm	50.8	Assumed for all boards
Thickness of inner and outer helices, mm	76.2	
Weight of railing structure, N/m	200	Rough estimate. Small load.
Number of persons on stair	16	Heavy load based on Fig. 3
Weight of each person, N	800	Conservatively heavier than persons in Fig. 3

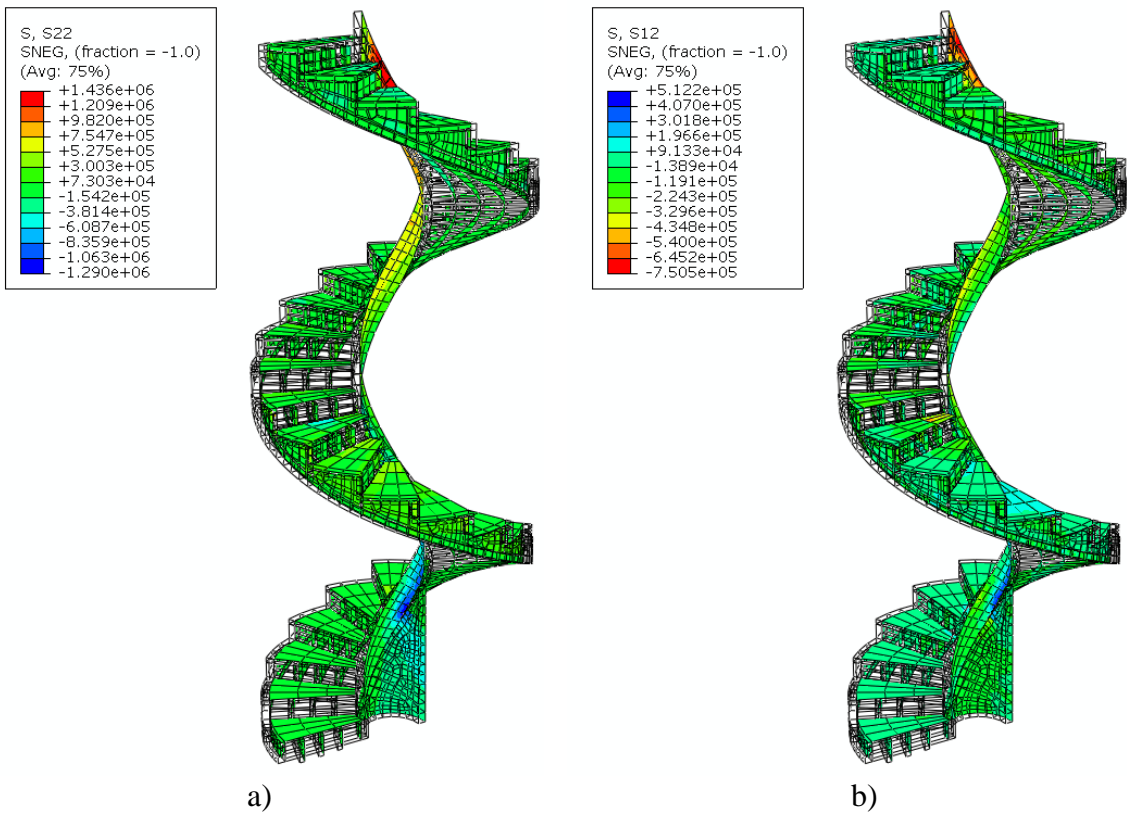
Figure 7: Damaging stress a) Compression; b) Shear

The material of the stair must be strong enough to withstand the above stresses. Knight (1997) investigated the material and concluded that it was a sub-species of spruce. If the material is Engelmann spruce (which is stronger than most other spruces), it would break at its ultimate strength of 2.0MPa if compressed in the direction of the grains (which is the most damaging stress loading. Wood is much stronger in other loading directions.) If more weights load the stair (for example, a heavy person on each step), it is quite possible that the weights of the persons and the weight of the stair together will break the stair structure. The most likely location of the fracture is the center helix. It is also possible that the stair material is an even stronger Sitka spruce whose ultimate strength is 4.0MPa (Green, 2001). However, the cold location where Sitka spruce grows is many hundreds of miles away from Santa Fe, and it would have been difficult in the 1870's to transport the wood to Santa Fe. On the other hand, Engelmann spruce grows in New Mexico (Green, 2001).
