## SEISMIC VULNERABILITY ASSESSMENT OF A ROMANIAN HISTORICAL BUILDING UNDER NEAR-SOURCE EARTHQUAKE

**Abstract.** *The ground motion vertical component is generally ignored in the analysis of ordinary building structures, even though observed damages after last earthquakes highlighted its marked influence especially on the response of masonry structures. In the present research work, the effect of ground motion vertical components in case of near-source excitations has been analysed. The investigation has been made on the Banloc Castle, a historical masonry building damaged by the Banat-Voiteg earthquake occurred on December 1991 in the Region of Banloc in Romania. A FEM model of the building, setup with the DIANA FEA analysis software, has been investigated in the non-linear dynamic field. In particular, the records have been referred to the Banloc site, located 7.01 km far from the epicentre with a moment magnitude  $M_w=5.5$  and a focal depth of 9 km. The behaviour of the ground motion components has been characterised by the V/H peak ground acceleration ratio. In order to estimate the influence of the vertical seismic motion in terms of both displacements and stress regime, tw

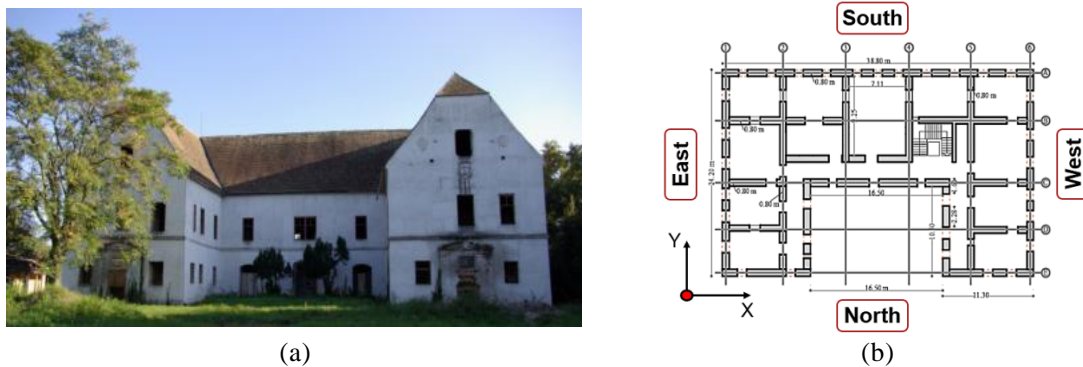
The Castle of Banloc (Figure 2) is the most important monument of the municipality. It is a massive building with a "U" plan built in the early nineteenth century. The main façade faces south, while on the opposite side the two wings border a terraced courtyard. The castle is a massive historical masonry building with very heavy perimeter brick walls, having generally thickness of 0.90 m, while the internal walls, made of the same material, have thickness of 0.80 m.

On the top, vaulted ceilings with thickness of 0.25 m are present. The inter-storey heights of first and second floors are 4.00 m and 5.70 m, respectively. The roof is solid and robust, with

**Figure 2:** Castle of Banloc: (a) external view and (b) architectural plan layout.

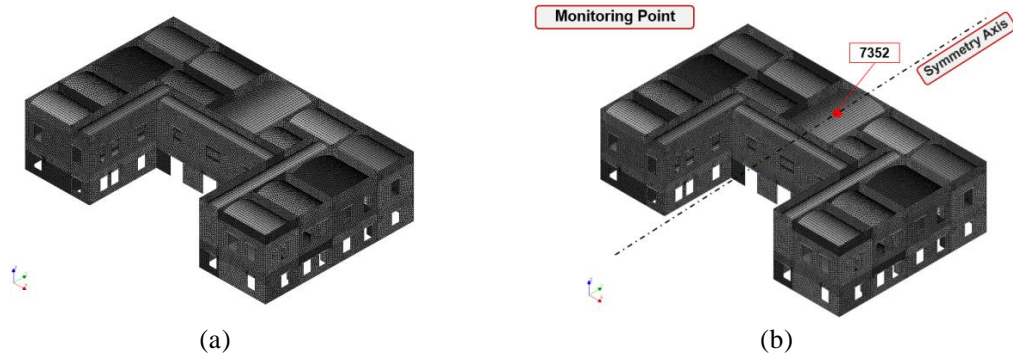
Time-history analysis provides a global assessment of the castle dynamic structural response varying specified ground motion accelerograms. The implementation of the model was set-up using the DIANA FEA software [13], where the structure has been modelled as set of interconnected shell elements (Figure 5).

**Figure 5:** 3D-shell element model (a) and selected monitoring points (b).

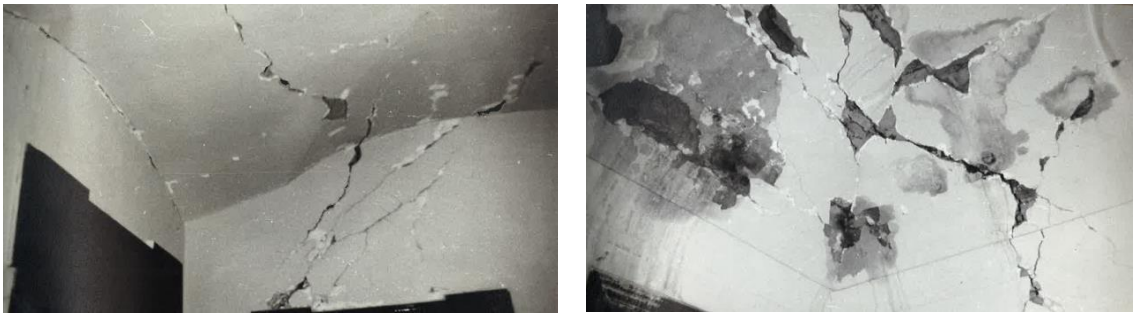
In particular, several failure mechanisms closely related to the seismic event were identified. More specifically, in the first two seconds of the time-history, the maximum vertical peak acceleration produced an extensive damage in the vaults, characterized by a brittle behaviour (Figure 8) [19].

**Figure 8:** Damages detected in the second-floor vaults mainly due to ground motion vertical component [19].

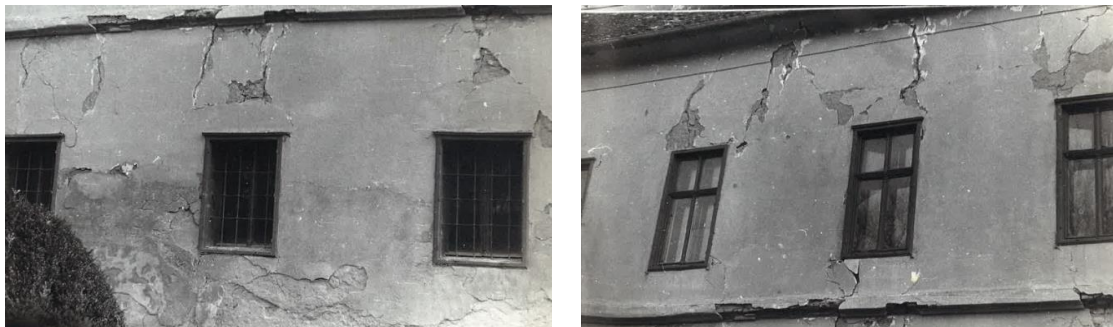
Consecutively, following the impulsive action, the arrival of the horizontal components produced damage to the vertical structures, mainly in the spandrel beams due to the formation of shear failures, as shown in Figure 9 [19].

**Figure 9:** Vertical and diagonal shear cracks detected in the South façade of the case study building [19].

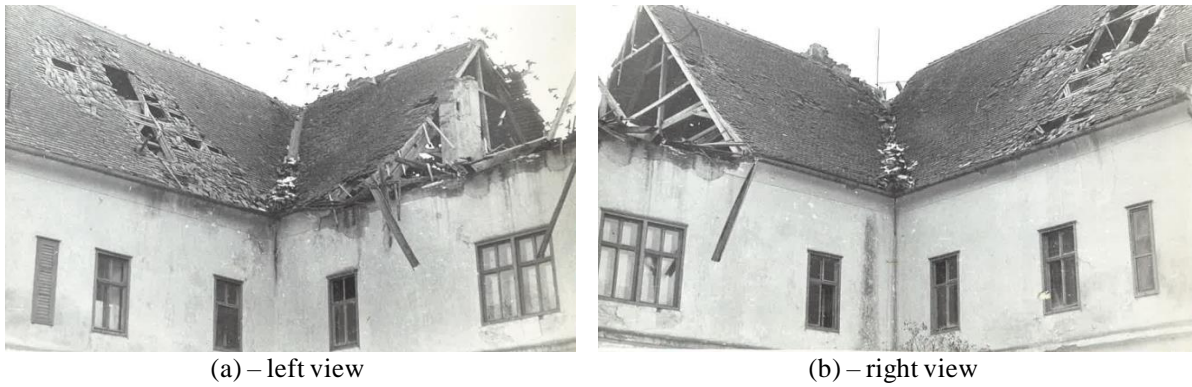
Finally, in the internal court of the building, a partial collapse of the roofing structure was observed. This collapse mechanism was triggered by the impulsive seismic action, as depicted in Figure 10 [19].

**Figure 10:** Failure mechanisms observed in the internal court of the case study building [19].

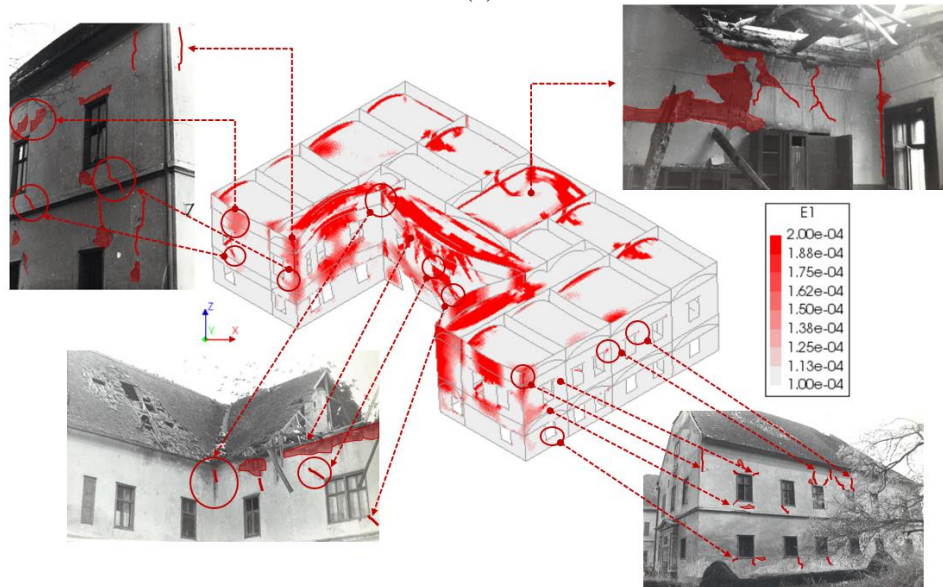
The damages achieved from numerical analyses have been presented and compared to experimental ones in Figure 11.

(c)  
**Figure 11:** Numerical damages obtained simulating the Banloc-Voiteg event and comparison with experimental evidences.

From the above comparison, it appears that the non-linear analysis identified local damages very similar to those produced by the earthquake. The identification parameter used to evaluate the damage state in the numerical analysis is the *tensile fracture energy* ( $G_f$ ), according to which, when the maximum principal stress reaches the defined cracking criterion, the fracture begins to distribute in the structural element. In particular, the numerical model catches in a satisfactory way the detected local damages and failure mechanisms, providing, as depicted in Figure 11, the right distribution of *Principal Total Strain* (E1).

- The numerical damage assessment was carried out considering the *Principal Total Strains* (E1), which take into account the overcoming of the tensile fracture energy in the structural elements. The numerical analysis results provided with satisfactory accuracy the same damage mechanisms really detected in the castle, namely cracks in the vaults (produced by vertical components) and vertical structures (mainly caused by horizontal components), as well as the out-of-plane horizontal bending mechanism in the façade facing the courtyard, which was produced by the partial collapse of the roofing structures.
