# LABORATORY AND IN-SITU CHARACTERISATION OF MASONRY MATERIALS IN A LARGE HISTORICAL INDUSTRIAL BUILDING IN BARCELONA

ALBERT CABANÉ<sup>1\*</sup>, LUCA PELÀ<sup>1</sup> AND PERE ROCA<sup>1</sup>

**Abstract.** *This paper presents an experimental campaign carried out in an historical industrial building of Barcelona from the 19<sup>th</sup> century, considering in-situ and laboratory minor destructive testing (MDT) techniques. The results obtained showed a good relationship between the in-situ MDT techniques and the tests carried out in the laboratory. The experimental results from different portions of the large-scale building allowed the discovery of different material typologies deriving from different construction phases.*

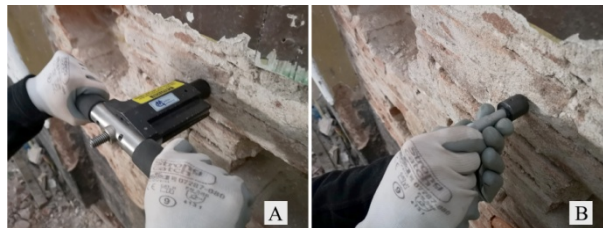
**Figure 1:** Pin Penetration Test operation: (A) the device is positioned perpendicularly to the surface to be tested, and, after firing the pin, (B) a micrometer is inserted to the bottom of the produced hole.

The PPT was executed on six zones of masonry walls and four zones of mortar plasters. Figure 1 illustrates the operations. A 3 mm diameter pin, with a conical end, is inserted into the device. The retraction nut is tightened until the trigger mechanism closes to hold the spring in place and is then it completely loosened. The device is positioned perpendicularly to the surface to be tested (Figure 1a). The trigger is pulled while holding the device against the surface. After the pin is taken out, a bulb air blower is used to remove the residual material inside the hole. Then, a micrometer is inserted to the bottom of the hole using the knurled thimble on the head of the micrometer (Figure 1b). The micrometer reading is noted. The penetration is obtained by subtracting the reading from one inch (25.4 mm).

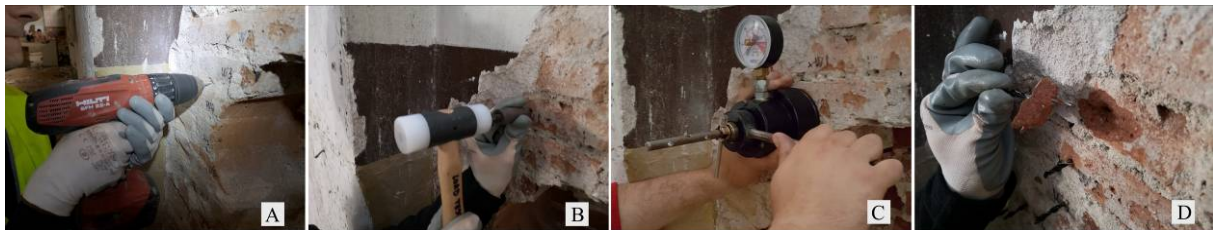
**Figure 2:** Helix Pull-out Test operation: (A) drilling the pilot hole, (B) hammering the tool until the helical tie is introduced in the pilot hole, (C) loading by turning the grip lever until failure, (D) failure in the brick.

The procedure for HPT is executed as follows. A pilot hole of 3 mm diameter is made in the mortar joints with a drill working at the minimum speed and with the tightening power adjusted at the weakest position. A pilot hole of 4 mm diameter is made in the bricks using a rotary-hammer drill with a masonry bit (Figure 2a). A high-strength steel helical tie with a diameter of  $\frac{1}{4}$  in. (6.3 mm) is mounted into a supplementary tool. While holding it horizontally, the tool is hammered carefully until the helical tie is introduced into the pilot hole to a depth of 30 mm and results embedded in the masonry component (Figure 2b). This process allows the helical tie to rotate and cut a thread in the mortar or the unit during insertion. After insertion, a Load Test Key (LTK) is screwed onto the remaining outer part of the tie. The LTK restrains from rotating the helical tie during the test, assuring a shear failure in the tested material. The Load Test Unit (LTU) is connected to the LTK and the mechanism is rotated to screw down the tie and take up any slack. The LTU provides the contact with the material's surface by means of a steel circle. The load is applied by turning a grip lever to increase progressively the load until failure (Figure 2c). The maximum load reached during the test is recorded as the pull-out force. Figure 2 shows the test layout, as well as the sequence of the operations during the HPT.

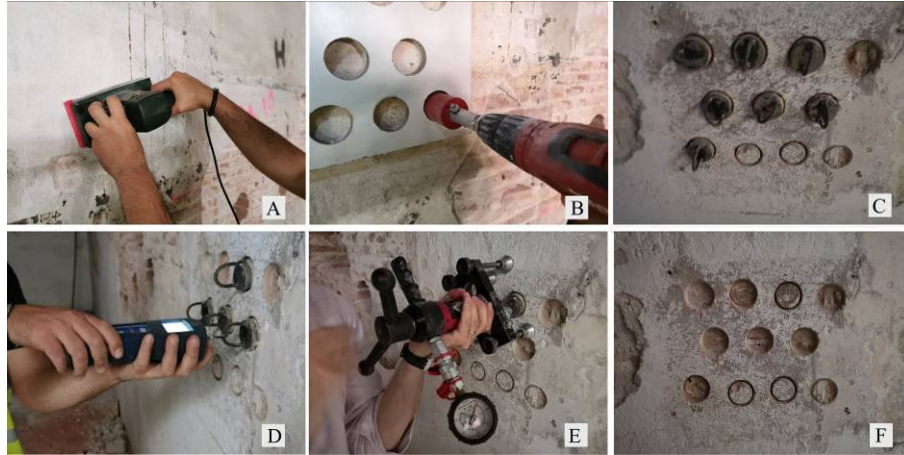
**Figure 3:** Pull-off test operation: (A) removing the surface paint layer with a mechanical sanding, (B) drilling the plaster until reaching the masonry substrate using a 50 mm diameter core bit, (C) sticking the metal discs, (D) manual dynamometer, (E) mechanical dynamometer support, and (F) failure of plaster substrate.

The pull-off test (POT) is a test developed to evaluate the adhesion strength of gypsum and lime mortar plasters [9]. The POT was executed on lime mortar plasters in the investigated building. Figure 3 shows the sequence of operations of the experimental in-situ tests. The first operation consists in removing the surface paint layer with a mechanical sanding that does not alter the physical and chemical characteristics of the lime mortar and ensures proper adhesion (Figure 3a). The plaster is cut until reaching the masonry substrate by using a core bit with 50 mm diameter (Figure 3b). After notching a number of circles, 50 mm diameter metal discs are stuck to the coating with a two components adhesive consisting of methylmetacrylate (Figure 3c). Once the adhesive has hardened, the disc is pulled off with a dynamometer by applying a perpendicular force to the surface. Two different dynamometers were used. A manual reaction dynamometer with a capacity of 500 N and a digital accuracy of 0.1 N was used in the position ZA. This position was characterised by lower adhesion strength (Figure 3d). In zones with higher adhesion strength, a different device with a mechanical dynamometer support, capacity of 5000 N and manual reading was used (Figure 3e). The pull-off load applied to the metal disc

is increased steadily until failure (Figure 3f). The peak load reached during each test is recorded as the pull-off strength.

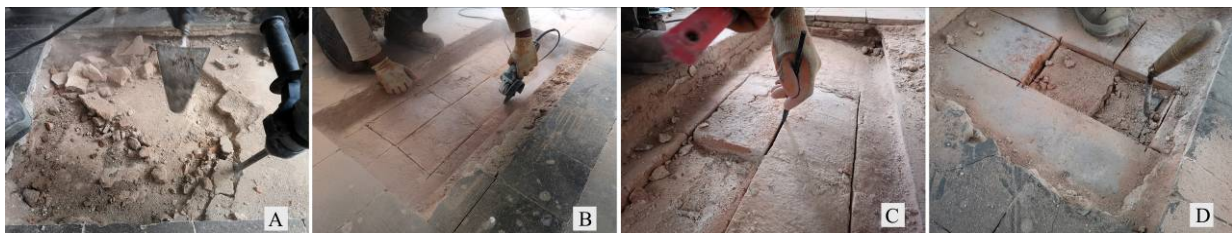
**Figure 5:** The sequence of operations of the extractions of samples from the timbered vaults: (A) removing the pavements and the vault filling, (B) removing the mortar between tiles by using a radial saw, (C) extracting the tiles with a chisel, (D) extracting the tiles with a gauging trowel.

Figure 5 shows the sequence of operations of the in-situ extractions, executed from the top of the timbrel vaults by removing first the pavements and then the vault filling (Figure 5a). The

mortar joints between tiles were marked with a radial saw (Figure 5b) and then extracted carefully with a chisel and a gauging trowel (Figure 5c and d).

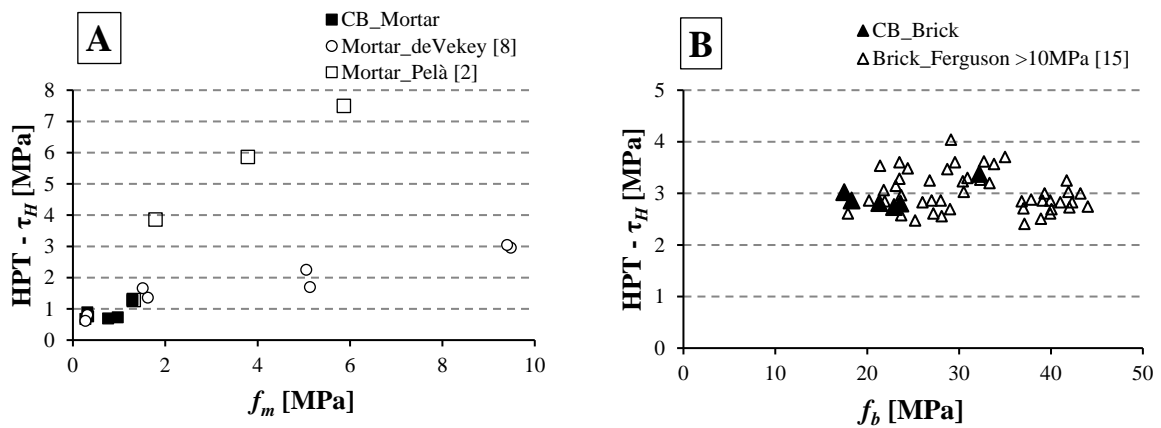
**Figure 7:** (A) Tangential stress of HPT on mortar joints compared with Pelà et al. [2] and de Vekey et al. [8] values. (B) Tangential stress of HPT on bricks compared with Ferguson values [15].

Figure 7a shows the comparison between the HPT results and the laboratory results for this campaign, together with those reported in previous research studies by Pelà et al. [2] and de Vekey et al. [8]. Figure 7b shows the same results for bricks tested in this campaign, together with literature values of units of compressive strength over 10 MPa according to Ferguson [15]. The HPT on mortars provides a good relationship with the laboratory values for this campaign, as well as with the values reported in the previous researches, especially for low strengths. However, the case of bricks no clear relationship is obtained between HPT and compressive strength test as already observed by Ferguson [15]. As explained by de Vekey et al. [8], the stress could exceed the elastic limit of the tie when the material tested had a compressive strength over 10 MPa. Actually, reliable relationships for historical masonry constituents are still under investigation.
