# EFFECT OF SLOW-MOVING LANDSLIDES ON CHURCHES IN THE LIGURIA REGION: A GEOTECHNICAL APPROACH

**Keywords:** Slow-moving landslide, Historic masonry churches, Damage assessment.

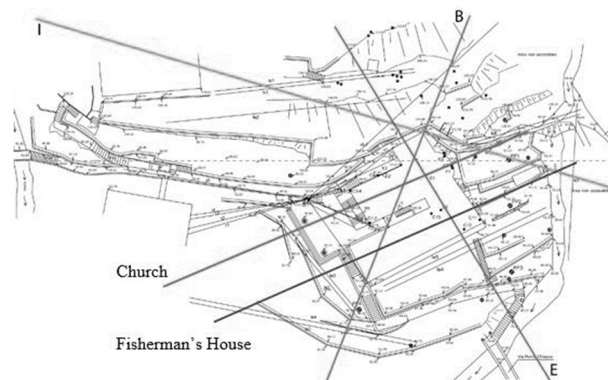
**Figure 2:** Slope sections analysed.

Once the geotechnical and structural data were collected, several FEM analyses were carried out using PLAXIS 2D software. Figure 2 shows the different sections analyzed and the position of the available investigations for section E. The groundwater level was varied in different positions (according to piezometric monitoring) to evaluate its influence on slope stability, under both free-field conditions and introducing the presence of superstructures. In [12], the different soil types were modelled firstly with the elastic-perfectly plastic Mohr-Coulomb model; then, more accurate FEM analyses were performed by adopting the HSM (Hardening Soil Model), a non-linear isotropic hardening model used to better simulate the real behavior of soils [12]. In this paper, the HSM model was further refined using the Van Genuchten model to simulate the variation of the degree of soil saturation due to groundwater level oscillation as well as rain simulation.

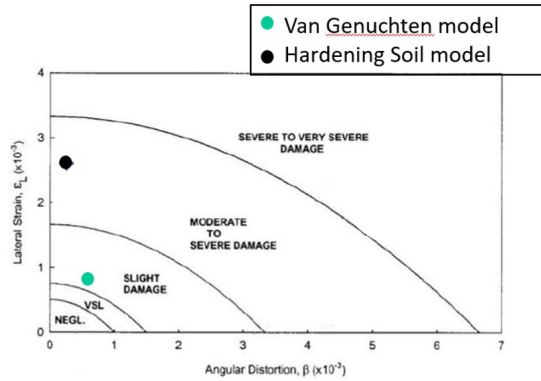
**Figure 4:** Correlation between angular distortion and lateral strain (obtained from vertical and horizontal displacement, respectively) and damage level, from [15].

The displacement patterns obtained from numerical analyses were also correlated with the damage levels proposed by [13]. It is important to underline that, while the analyses performed using the HSM model indicated a moderate damage level [12], the more refined analyses carried out with the Van Genuchten model classified the damage as slight, in good agreement with the real damage level of the structure (Figure 4). These results demonstrate that a refined geotechnical modeling, possible only in the presence of soil tests, is necessary in order to predict realistically the damage induced on churches by slow-moving landslides.

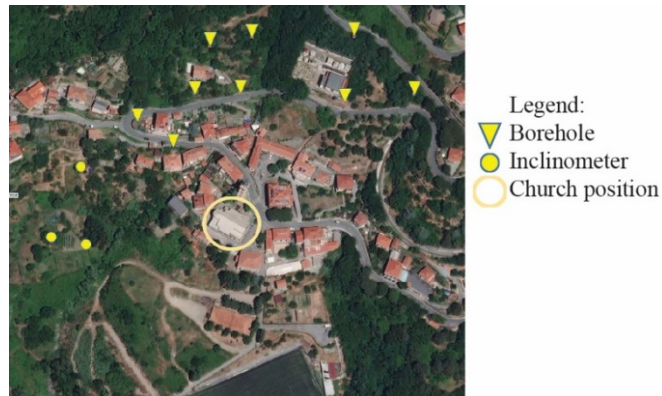
**Figure 6:** Localization of boreholes and inclinometers in the area of interest.

The church is situated on a slope characterized by a slope angle of  $15^\circ$  (low inclined slope). The area of interest belongs to a large complex active landslide of about  $1.09 \text{ km}^2$ . From Figure 6, it can be observed that two inclinometers, installed in the framework of the REMOVER monitoring project of the Liguria Region, are present in the landslide area in the slope adjacent to the one where the church is located (Figure 6). They report a horizontal displacement of 175mm in 9 years, over 15mm/yr. However, no inclinometers can be found on the slope on which the church is situated.

It is important to point out that the area surrounding Sant'Olcese church is not actually well monitored. Only few boreholes, which allowed to define the stratigraphic sequence as well as to model soil stratigraphy, are available in the area uphill of the church. Conversely, no boreholes are present in the downhill area, as shown in Figure 6. Furthermore, no geotechnical tests for the characterization of the soil were performed.

The results of numerical analyses do not appear to be in good agreement with the crack pattern observed in the church. In fact, the heavy damage exhibited by the building as well as the occurrence of parallel cracks in vaults and floors oriented perpendicular to the landslide direction clearly indicates that the church has been subjected to slope movements. The absence of significant soil displacements obtained from numerical analyses can be attributed to the fact that the lack of detailed geotechnical data did not allow for an accurate modeling of the soil. The latter could be achieved by performing new in-situ tests and boreholes, especially in the area downhill of the church, in order to obtain a detailed stratigraphy and fully characterize soil parameters.

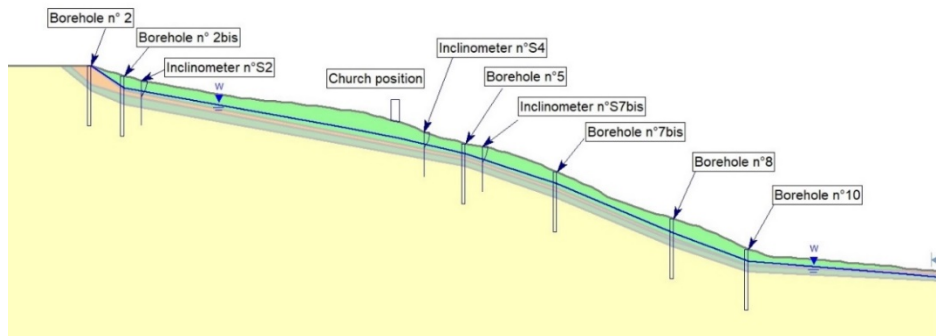
**Figure 9:** Boreholes and inclinometers localization along the section analysed.

Thanks to the GIS software and the acquisition of DTM data of the area, it was possible to obtain a sufficiently precise topographic survey, in order to trace representative sections along the slope, particularly in the direction of the landslide. Figure 9 shows a section of the slope created in SLIDE along the landslide direction. The position of boreholes and inclinometers as well as of the adopted stratigraphic sequence are also indicated.

Regarding horizontal displacement, a maximum value of about 20 mm is obtained under the church when analyzing the slope section along landslide direction. This displacement value is in good agreement with the horizontal displacement recorded by the inclinometers and reflects the width of the gaps of the floors. These latter can be, indeed, attributed to the significant horizontal movement experienced by the church in the direction of the landslide. As for vertical displacements, they may explain the rotation of the apse towards the interior of the church.
