SEISMIC DAMAGE MECHANISMS FOR CHURCHES AND DAMAGE SEQUENCE: CONSIDERATIONS FROM A CASE STUDY

4.1 The church of San Bartolomeo at Quistello

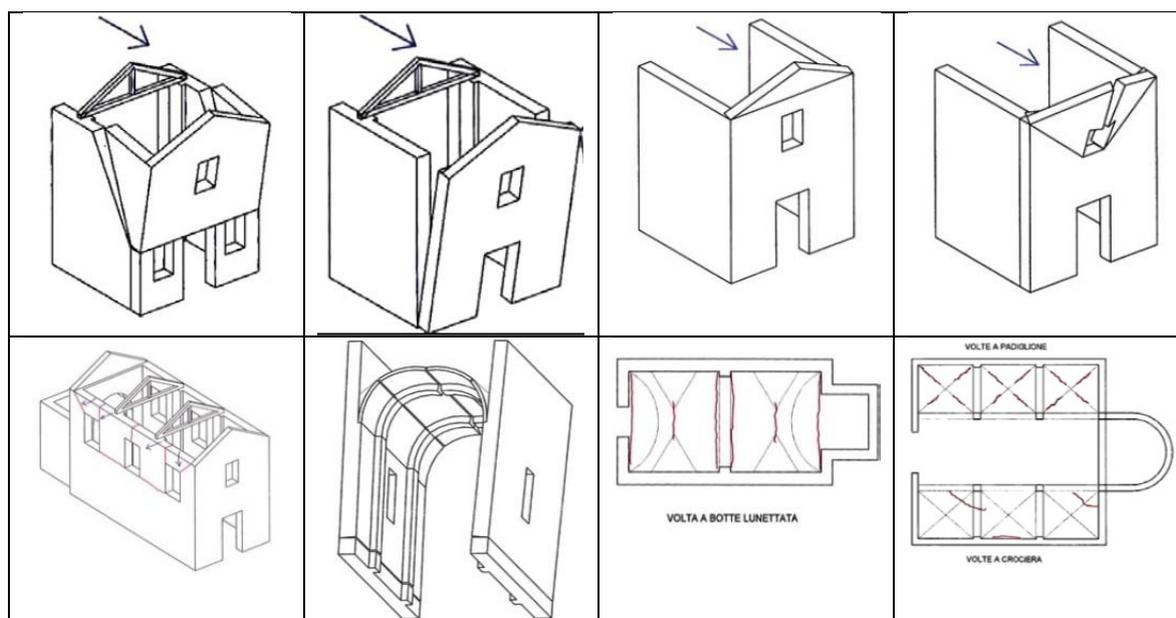
Figure 1: Reference mechanisms for analyzing churches; at the top, façade out-of-plane mechanisms; at the figure bottom, nave wall mechanisms (left) and crack patterns for vaults (right)

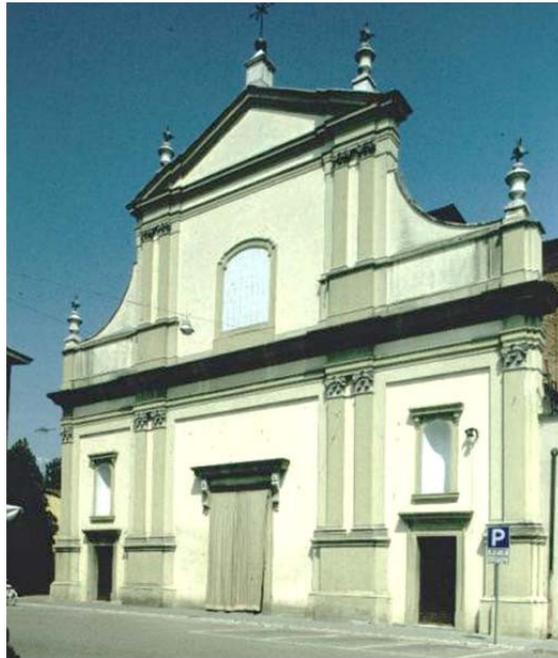
Figure 3: The church of San Bartolomeo Apostolo at Quistello
