FROM THE CURE OF THE SIMPLE STRUCTURAL ANALYSIS TO THE CONTROL OF THE FINAL TECHNOLOGICAL QUALITY – THE CONSERVATION OF “SANTA MARIA DEGLI ANGELI” ORPHANAGE IN CASTELGRANDE (POTENZA, ITALY)

FRANCESCO P.R. MARINO^{1*}, GIANLUCA AULETTA¹, FABRIZIO
BALDANTONI¹, FELICE C. PONZO¹ AND FILIBERTO LEMBO¹

¹ Università della Basilicata - School of Engineering (SI-Unibas)
Campus Macchia Romana, 85100 Potenza, Italy
e-mail: francesco.marino@unibas.it*, gianluca.auletta@tiscali.it, fbba6@hotmail.it
felice.ponzo@unibas.it, filiberto.lembo@unibas.it (*corresponding author)

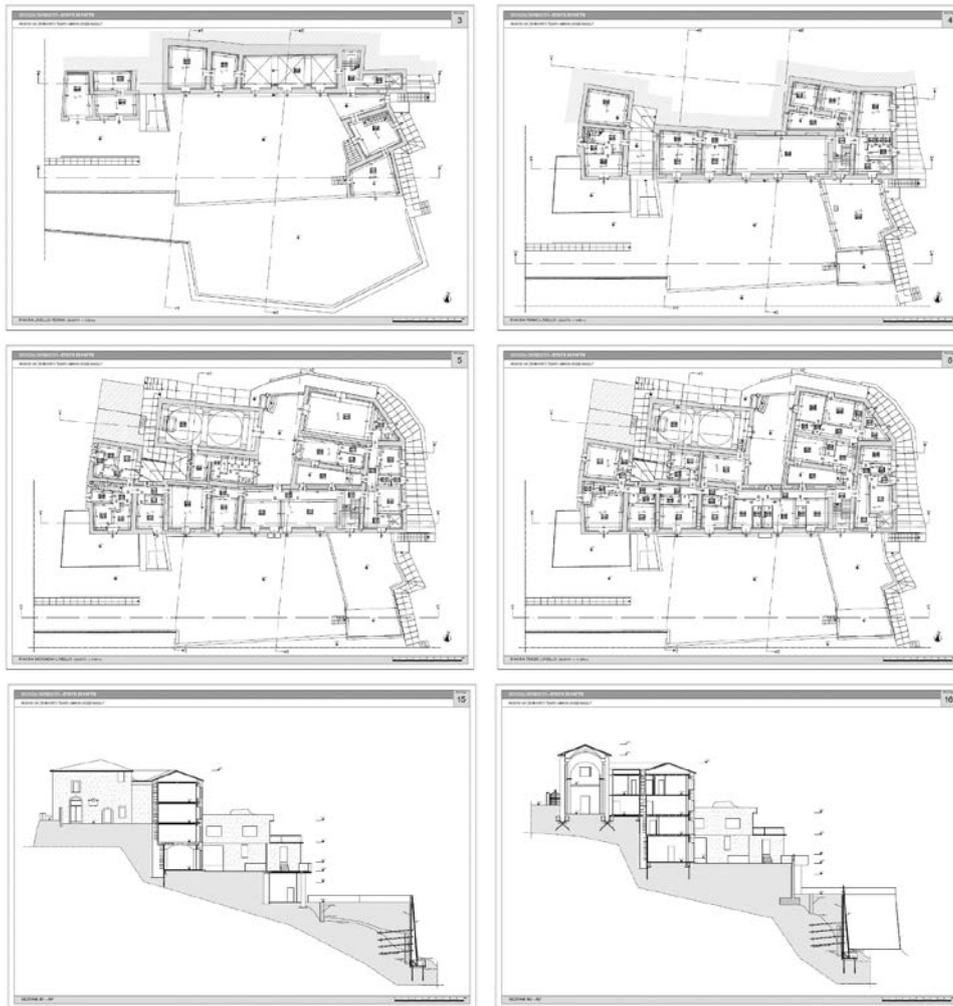
Figure 3: Plans and sections of the consolidation intervention done

For the floors, they were all *"demolished and redone with "Bausta type" joists at a distance of 50 cm with interposed light brick pots and overlying r.c. slab, not less than 4 cm thick* [14] (Fig. 4). It was foreseen that the floors of the building buried on the mountain side were tied to the rock with traction poles placed at the height of the horizontal floors, so as to block them. And that the floors were connected to the walls with curbs of a height not less than that of the floor itself, made in traces or, wherever possible, for the entire width of the walls. As for the roofs, both of the Church and of the rest of the building, the wooden ones were demolished and replaced with pitched floors made of IPE 140 steel beams every meter, clay tables and upper r.c. slab (Fig. 5).

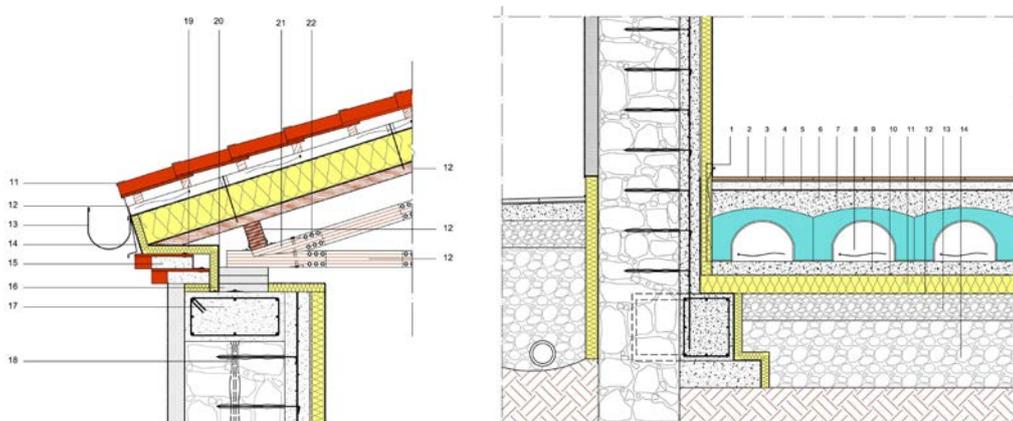
Figures 10 and 11: Details of the vertical closure-cover node (left) and the ground connection (right)

The relative pitched floor is provided in the same wood, insulated and ventilated and covered with double-roof tiles as well as the original one (see below, Fig. 10). Other interventions are necessary to drain the surface waters at the boundary and under the buildings and limit the phenomena of capillary rise, favoring the evaporation of the water contained in the ground through cavities and floors permeable to steam (see below, Fig. 11).

The most efficient way to isolate a building is undoubtedly the one from the outside [20]. It avoids the thermal shocks that are produced with the insulation from the inside, following the sudden change in temperature in the insulation thickness, in correspondence with the connection between plug walls or vaults and facade walls. The Ancients had already solved the problem by applying plaster crusts, based on aerial lime and pumice and crushed earthenware chips, one palm thick (8 cm) and beyond, with λ also of 0,5 W/mK. As has happened in many regions of southern Italy, especially in volcanic areas, such as the *Anaktoron* of Torre di Satriano (530 b.C.), a few tens of kilometers from Castelgrande [21]. The industry has developed even more performing mineral insulating plasters ($\lambda = 0,066$ W/mK and less), which can be considered the legitimate heirs of the ancient ones, and whose finishes are the lime-based mineral ones of historic buildings. This choice was combined with that of “open diffusion”

insulation from the inside, in expanded perlite ($\lambda = 0,045 \text{ W/mK}$), which is aimed at minimizing energy consumption and contributing decisively to transforming the building in an nZEB. With limestone walls 60 cm thick, plated with the existing reinforced concrete counter-wall, 15 cm thick, the current transmittance is $U = 1.93 \text{ W/m}^2\text{K}$. By adding 10 cm of insulating plaster on the outside and 8 cm of expanded perlite on the inside, the transmittance after the hypothesized intervention becomes $U = 0.265 \text{ W/m}^2\text{K}$ (Fig. 10). Cornices and stone windowsills are safeguarded, dismantled and reassembled ten centimeters further out, in order to maintain the same previous ratio with the plane of the walls, connecting them with stainless steel shelves for balconies, like Halfen type. The ground connection of the heated rooms is assumed to be drained, insulated and ventilated through the internal environment (Fig.11) in order to be dehumidified. Its transmittance, which is now $U = 3.549 \text{ W/m}^2\text{K}$, would become $U = 0.208 \text{ W/m}^2\text{K}$. The whole building is assumed to be equipped with Controlled Mechanical Ventilation systems divided by zones and equipped with dehumidification batteries, since the average relative humidity of the external environment only in July and August drops below 60%, and for the rest of the year is much higher, reaching an average of 80% in the winter months. These systems would also dissipate the moisture transmitted by the soil through the ventilated cavities and the wall or floor coverings. The roof, which currently has a transmittance $U = 2,723 \text{ W/m}^2\text{K}$, with the new package, insulated with 20 cm of wood wool and ventilated, would assume a $U = 0.176 \text{ W/m}^2\text{K}$. Photovoltaic tiles substantially indistinguishable from the traditional ones are expected to be placed on the roof slopes correctly oriented to South, for a surface equal to 327.5 m^2 , with the possibility of producing 20 kWp. Passive house wooden frames have been hypothesized, with $U_w = 0,82 \text{ W/m}^2\text{K}$.
