COLLAPSE OF THE ARECIBO OBSERVATORY IN PUERTO RICO: REFLECTIONS FROM A STRUCTURAL ENGINEERING PERSPECTIVE¹

Juan C. Morales² and Luis E. Suárez³

Keywords: Arecibo Observatory, collapse, fatigue, corrosion, socket

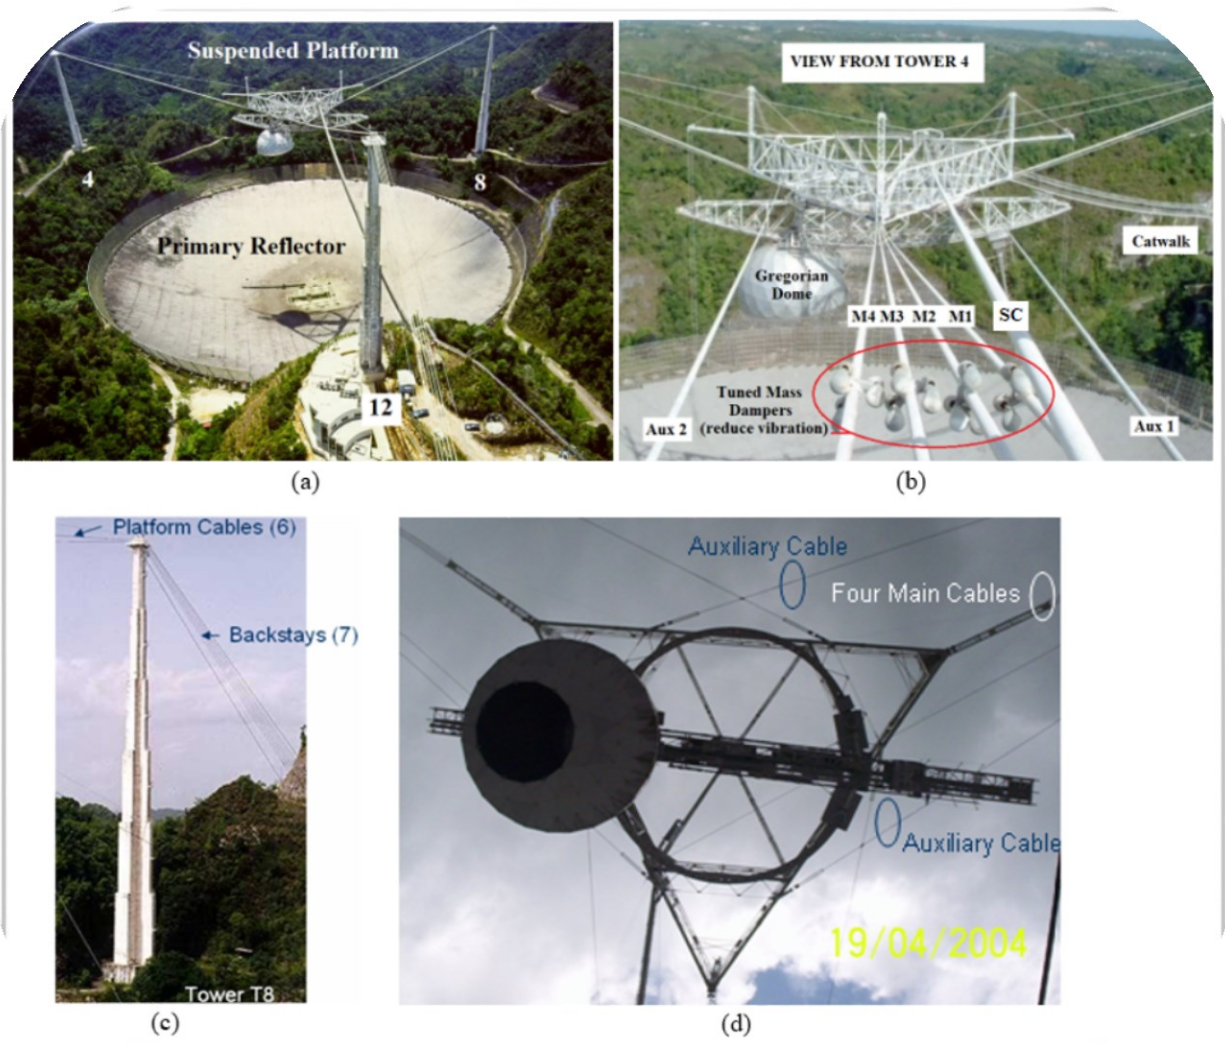
The three towers reached the same height; however, tower 8 was 120 feet taller because it was founded at the foot of a hill (Figure 1(c)). The towers had a cruciform cross section which gave them two equally strong axes, one of them aligned with the cables. The cross-sectional dimensions changed approximately every 60 feet in height as the towers were stepped in by approximately 3 feet on all sides while the thickness remained constant at 6 feet.

Figure 1: Several views of the structure that identify its main components. Taken from Morales (2006) except (b) which was taken from <https://ecommons.cornell.edu/handle/1813/33229>.

The first press release from the Arecibo Observatory (NAIC, 2020d) reported that one of the auxiliary cables of Tower 4 broke on August 10 at 2:45 am. A later press release (NAIC, 2020e) reported that the break was caused by the auxiliary cable slipping out from its socket (anchorage) at tower 4. The structural engineering of record confirmed it: "...the cable pulled from its socket and fell..." (Thornton Tomasetti, 2020). The cable is identified as "Aux 1" in Figure 1(b).

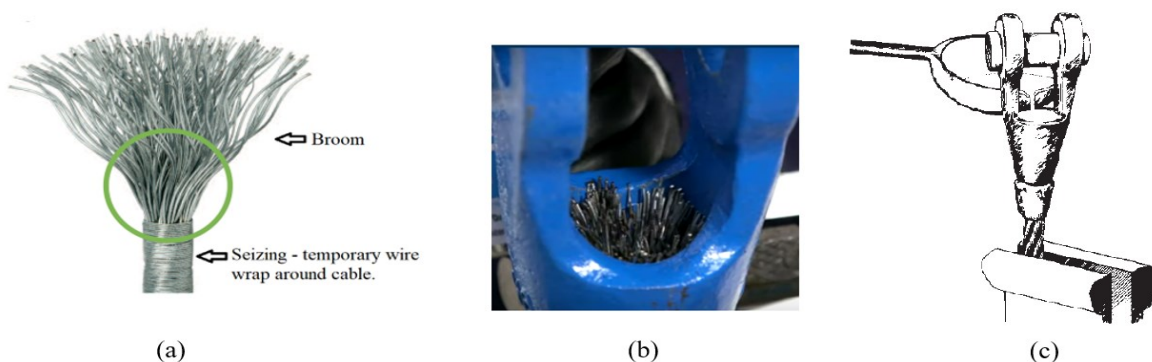
2. Prepare the broom at the end of the cable, i.e., unwind and separate the wires all the way down to the seizing. (Figure 4(a)). The brooming procedure increases the surface area available for bonding because each wire participates in transferring load to the socket. The greater the surface area for bonding, the greater the resistance. For example, for a hypothetical 3.25-inch diameter cable fabricated from 76 individual wires with an average diameter of 0.274-inch, the bonding surface area increases by a factor of 6.4 when each individual wire is bonded versus simply bonding the outside diameter of the 3.25-inch cable.

6. Untie the broom and separate the wires into the cone shape inside the basket. The wires must extend to the top of the basket (Figure 4(b)). “Use extreme care in aligning the socket with the cable’s centerline”.

7. Pour the molten zinc (spelter) into the socket basket (Figure 4(c)) at a temperature of 950-1000 degrees F. “A word of caution: Overheating of the zinc may affect its bonding properties”. “Pour the zinc in one continuous stream until it reaches the top of the basket and all wire ends are covered”. Allow the zinc to cool.

Figure 4: (a) Broom at the end of the cable and the “seizing” (taken from Wirelock, 2017). (b) Socket after inserting the cable and re-separating the broom wires (taken from Wirelock, 2017). (c) Pouring the molten zinc into the socket (taken from Certex, 2020).

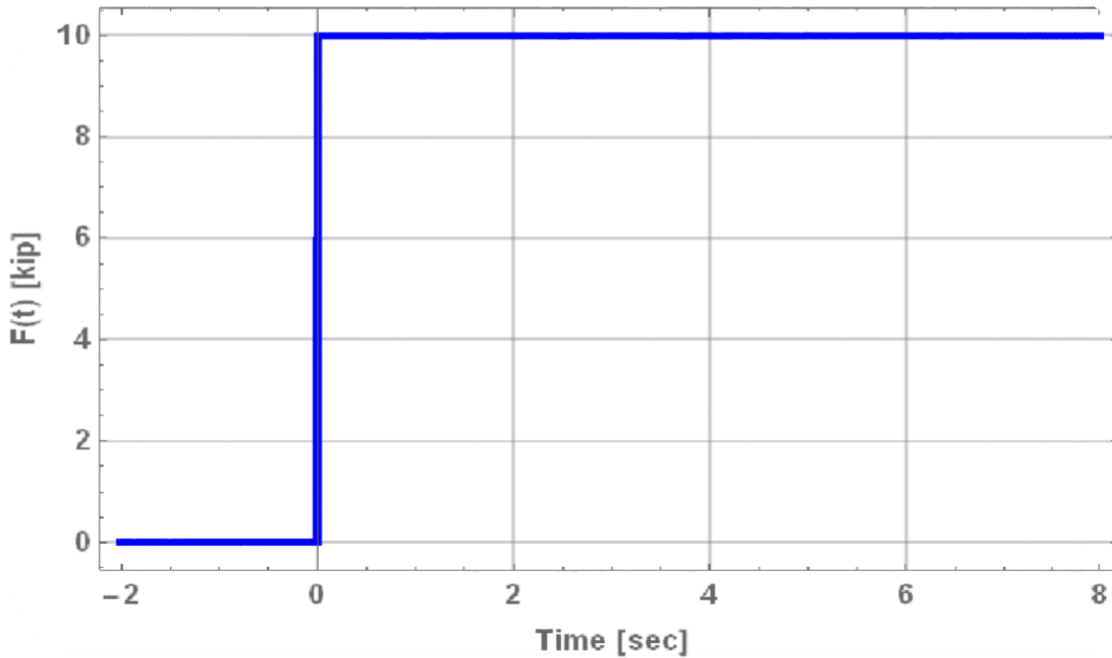
This force is shown in Figure 6 where a value of 10 kip was arbitrarily selected for F_{add} .

Figure 6: Step function load applied to the remaining cables.

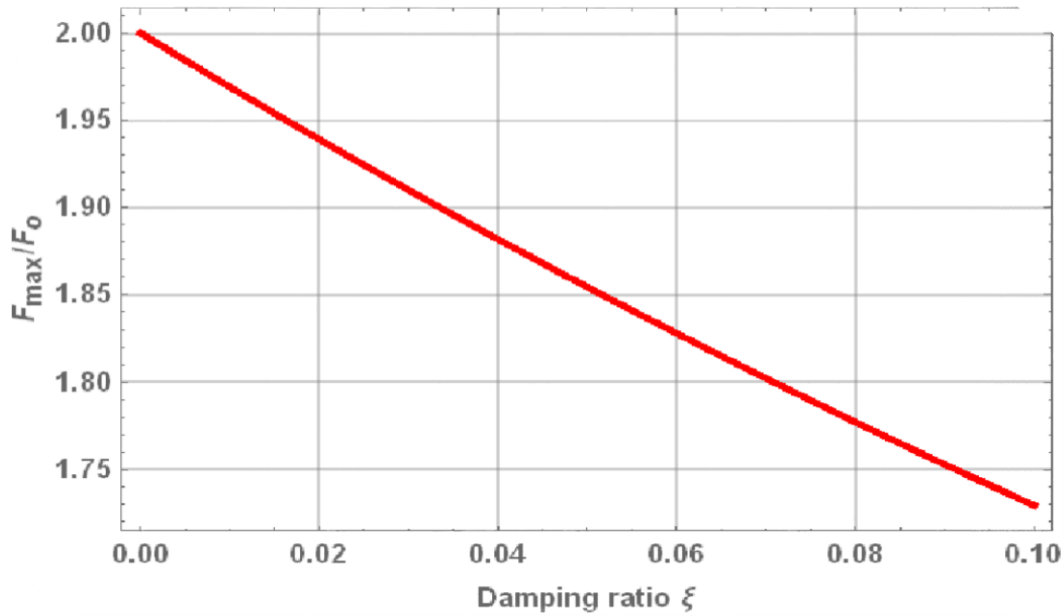
For an undamped system (with $\zeta = 0$), the maximum force F_{\max} in the spring is $2x F_{\text{add}}$, i.e., twice the value as if the force $F(t)$ were applied very slowly. For other values of the damping ratio, the ratio α between the maximum dynamic and static force varies as shown in Figure 7.

Figure 7: Variation of the ratio α between the maximum dynamic and static force as a function of the damping ratio.

Note that a damping ratio equal to 0.1 or higher is only achievable by adding external devices, such as viscous fluid dampers, treatment with damping layers, etc. For a naturally occurring energy dissipation and for a metal structure with the material below yielding, the values of ζ range from 0.005 to 0.02. For these values, the ratio $\alpha = F_{\max}/F_{\text{add}}$ varies from 1.98 to 1.94. The value $\zeta = 0.05$ is usually adopted when the material is at or above the yielding level.

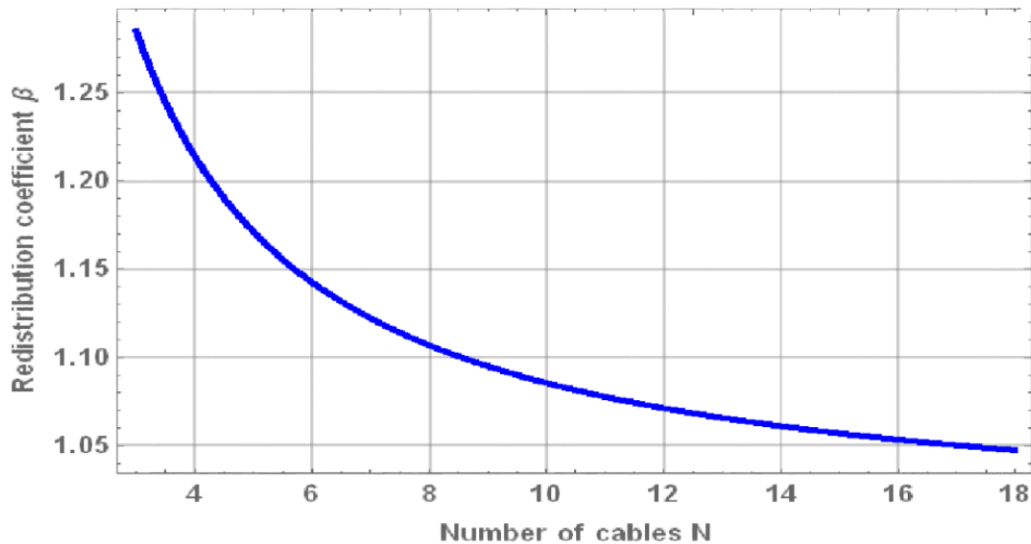
Figure 8 displays the variation of the dynamic distribution coefficient β that permits to calculate the maximum dynamic force by amplifying the static force as $F_{dynamic} = \beta F_{static}$:

Figure 8: Variation of the dynamic redistribution coefficient β as a function of the number of cables for a 5% damping ratio.

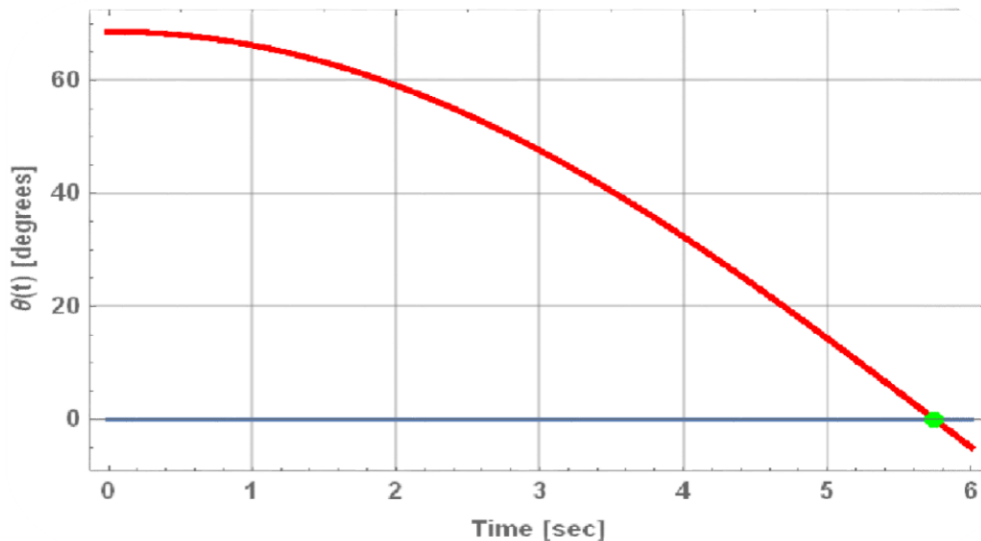
Figure 10 shows the variation with time of the angle $\theta(t)$ obtained by solving the nonlinear equation of motion (15). The initial position is $\theta(0) = 68.6^\circ$. The green dot indicates the instant at which the pendulum passes through the vertical position.

Figure 10: Time variation of the angle $\theta(t)$ of the pendulum.

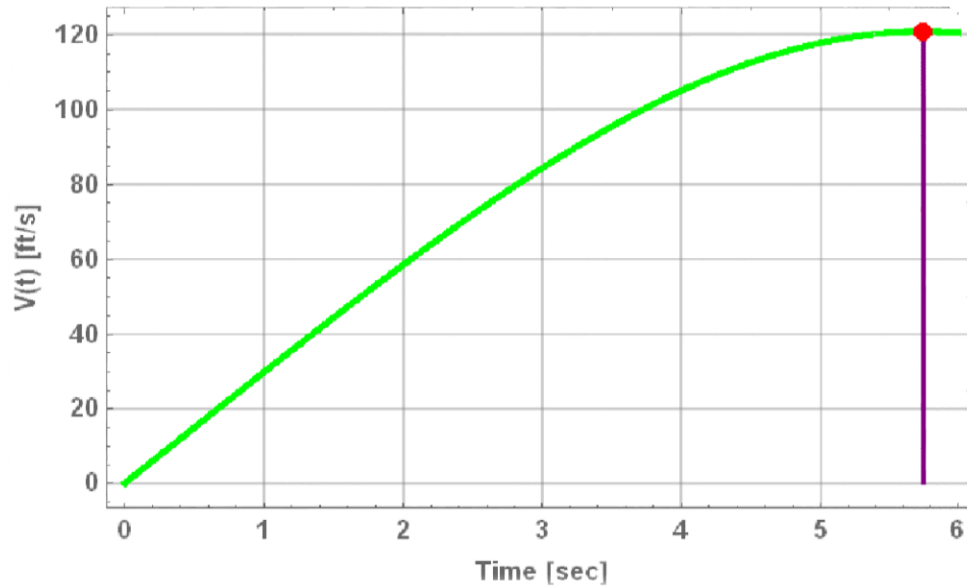
Figure 11 displays the tangential velocity of the bob of the pendulum as a function of time. The green dot indicates the instant at which the pendulum passes through the vertical position and the velocity attains a maximum.

Figure 11: Time variation of the tangential velocity $V(t)$ of the pendulum.
