# Investigation of Pipelines Integrity Associated with Pump Modules Vibration for Pumping Station 9 of Alyeska Pipeline Service Company

October 2009

Prepared by  
John Jy-An Wang,  
Oak Ridge National Laboratory

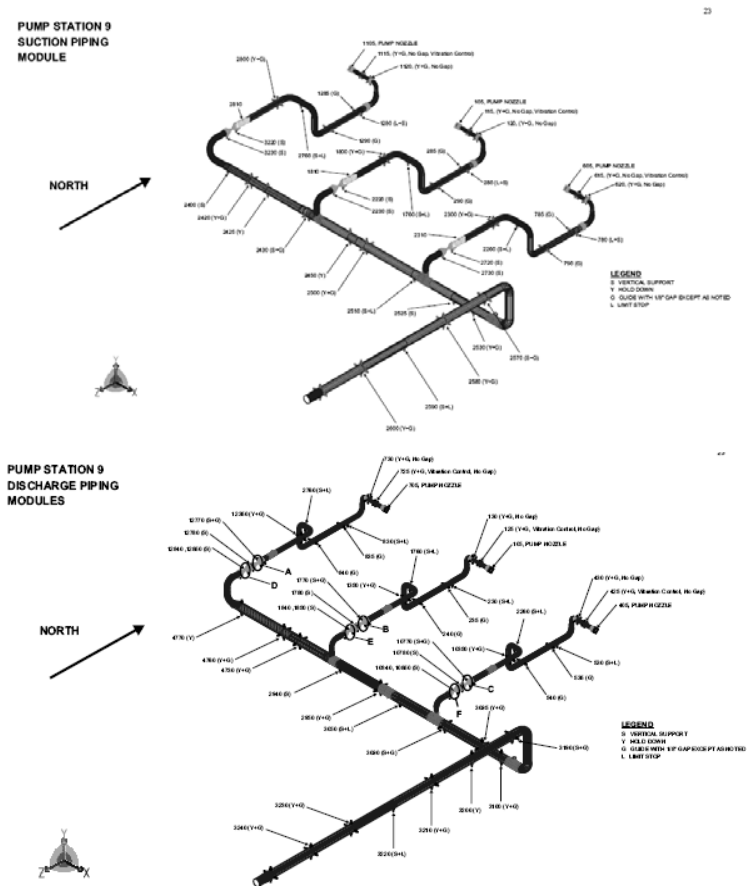
**Figure 2 Suction and discharge piping systems**

The pump suction and discharge piping connects the three new mainline pumps to the existing pump station suction and discharge header piping. The pumps and related piping are configured for parallel operation; the physical configurations of suction and discharge piping systems are illustrated in Fig. 2. Sufficient piping and valves are provided to permit the independent operation of any or the entire new pump sets. Unit and station recirculation piping is provided for pump startup, station startup, cold restart and possible load bank purposes.

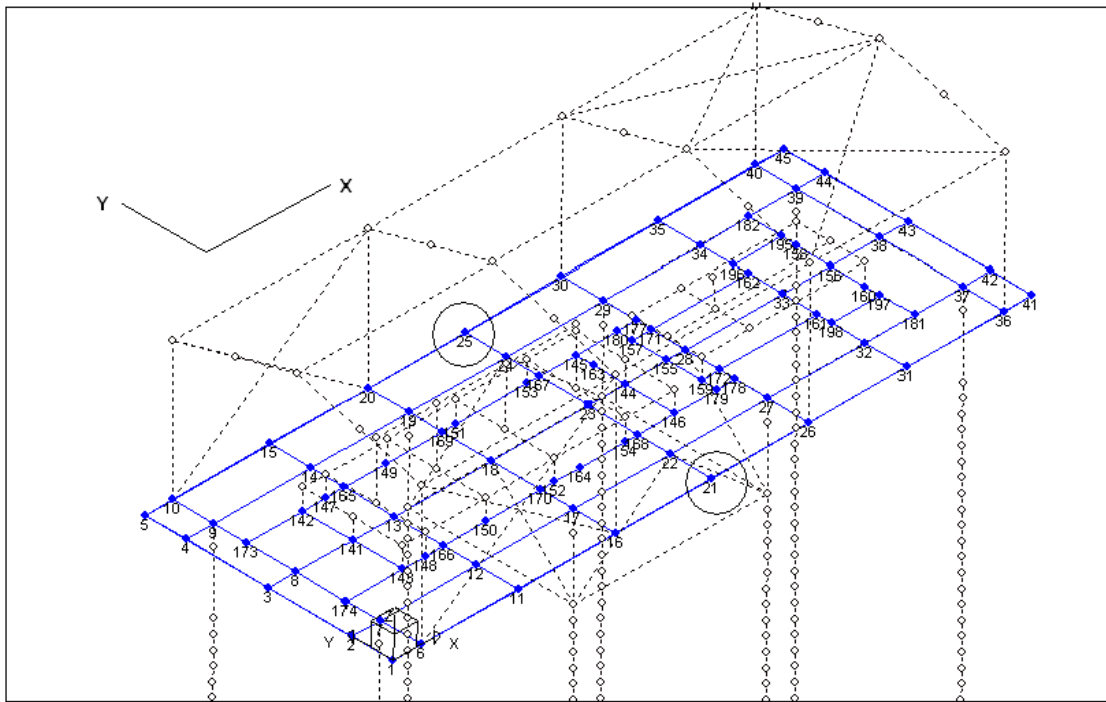
Pump Module seismic displacements are estimated for the nodes 21 and 25 marked on the scheme below.

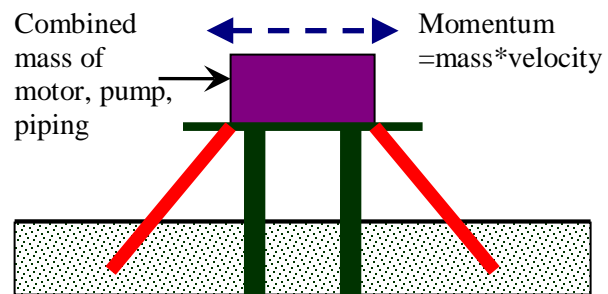
**Figure 4 Schematic diagram**

From this initial investigation, the pump and motor hardware of PS09 would be better off if directly laid on a concrete pad on the ground floor instead of on an eight-foot high platform supported on the piles. Due to relative large mass from motor, pump, and the associated piping system as compared to that of pump module structure components, the momentum induced by the vibration motion inherited from the combined mass inertia of the motor, pump, and the piping system would be difficult to be constrained by the current pump module structure. Furthermore, the low natural frequency of the current pump module could be synchronized with the fluid-dynamic response; and the consequence is the increase of the overall vibration amplitude.

Planned braces and other reinforcement to the piles and deck will be the first step to reduce the lateral displacement and the associated vibration phenomena. Nevertheless, such modification will also need the concurrence from the structure engineering on the seismic or other dynamic response consideration. The other option is to directly transmit the dynamic load to the ground by using the lateral support column and the associated piles. A schematic diagram of the momentum induced by combined mass of motor and piping is illustrated in Fig. 4. It is not difficult to visualize that the option of using lateral support reinforcement (marked with red line) would be an effective means to transmit the momentum or energy generated by the combined mass of motor, pump, and piping (including the fluid dynamic momentum), directly to the ground, if the space allows for such modification to mitigating the inertia impact on the overall vibration of the pump module.

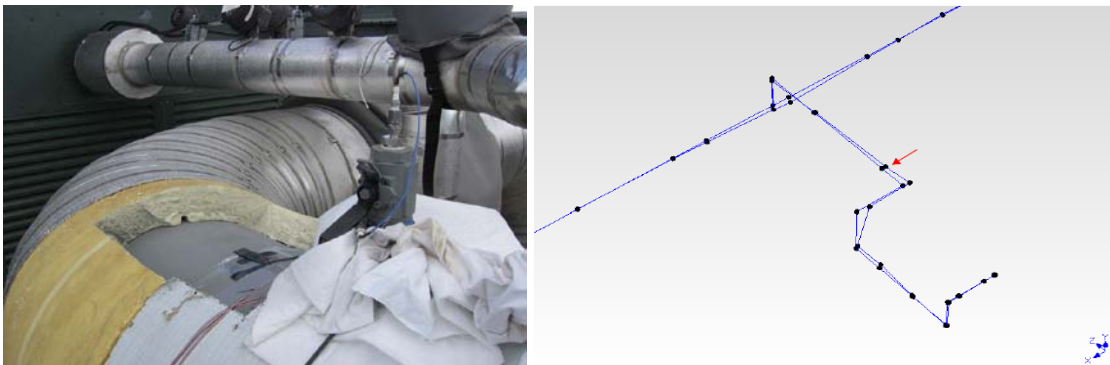
My earlier requests to obtain strain-time history data are based on the lack of in-situ piping stress profiles from the vendor. EDI has performed some pilot testing on this initiative, and concluded that there is no concern on the dynamic stress level. However, on detailed examination of these strain gage locations and the specified vibration modes, the strain-gage locations are all located in out-of-plane locations for the specified vibration mode. For large piping, such 14-in, 20-in, 24-in and 36-in of PS09, these strain-gage results can be very misleading. This is because these strain gages are all located in alignment with the central neutral axis of the flexural bending piping curvature, as illustrated below. The maximum flexural strain will be located on the side of the pipe, instead of the top of pipe where the pilot testing was performed, Fig. 8. The strain gage at the top of pipe in this vibration frequency is out-of-plane and parallel with the flexural neutral axis of the bending piping mode, thus it will have a very small strain level. This is not representative of such piping locations with the associated mode. Fig. 9 is at the pump inlet location where the strain gage was installed on the side of the pipe wall, which is again in line with the flexural neutral axis since the pipe is bending down at this location at the specified vibration mode (the correct gage location for this case should be the top of the pipe). The rest of the strain gages are fall mostly into similar flexural neutral scenarios.

**Figure 8 Maximum strain is located at the side of the pipe wall (per this mode).**

There are two options here that can be considered to resolve this unknown effective piping stress issue: (1) carry out a detailed structural dynamics and hydrodynamics analyses, with consideration of the combined loading cases; or (2) use a well-designed strain-gage approach applied directly to key structural locations (including relative high stress and larger vibration-amplitude locations) to obtain the real-time strain history data. The later case of obtaining accurate strain-amplitude data will require the vendor to stop production; while the first option does not require the vendor to stop production. In any event, I believe that obtaining the detailed stress profiles for PS09 module structure and the associated piping system are in the best interest of the vendor, especially after the completion of the reinforcement project for the PS09 Module. The outcome of this effort is to ensure that the newly completed reinforcement structure is still consistent with the overall PS09 structural performance per seismic or other design criteria, in addition to piping integrity related to fatigue control.

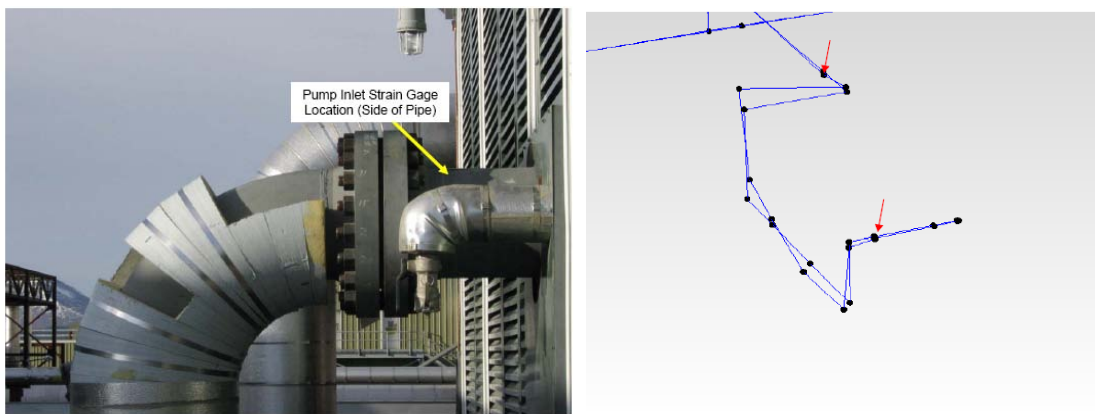
Figure 86: Strain Gage Location at Pump Inlet

Figure 85: Measured Mode Shape at 20.5 Hz

**Figure 9 Maximum strain is located at the top of pipe wall, instead on the side wall.**

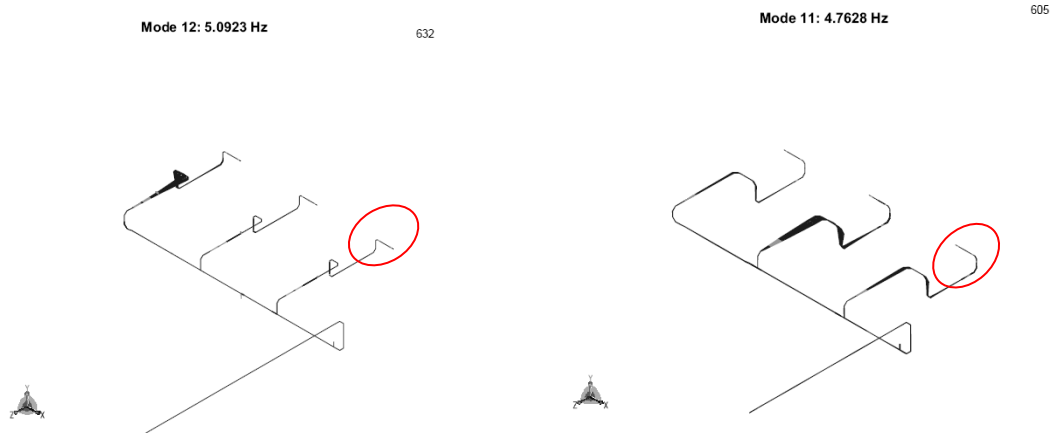
**Figure 10 Vibration amplitude profiles of 12<sup>th</sup> frequency of PS09**

Furthermore, from the Alyeska PS09 report, the vibration mode near the pump (either discharge or suction) are all very small due to multiple constraints as indicated in Fig. 4's vibration profiles (the 12<sup>th</sup> frequency modes-the highest of Alyeska's reported frequency modes, from suction and discharge pipelines are shown in Fig. 10). These plots show very limited amplitudes near the pump inlet or outlet sections and past the first elbow section. This is in contrast to DEI vibration modes shown in (report) Fig. 85, which shows significant displacement. The physical constraints at the Alyeska PS09 piping system are shown on Fig. 5, including line anchors, limit motion clamps, and guides, etc.. Note that the legends S, Y, G, and L stand for: S—vertical support, Y —Hold down, G —guide with 1/8" gap except as noted, L —limit stop. All these constraints have significant impact on the modal analyses outcome and need to be implemented into the analyses to obtain accurate amplitude profiles for the targeted frequencies.

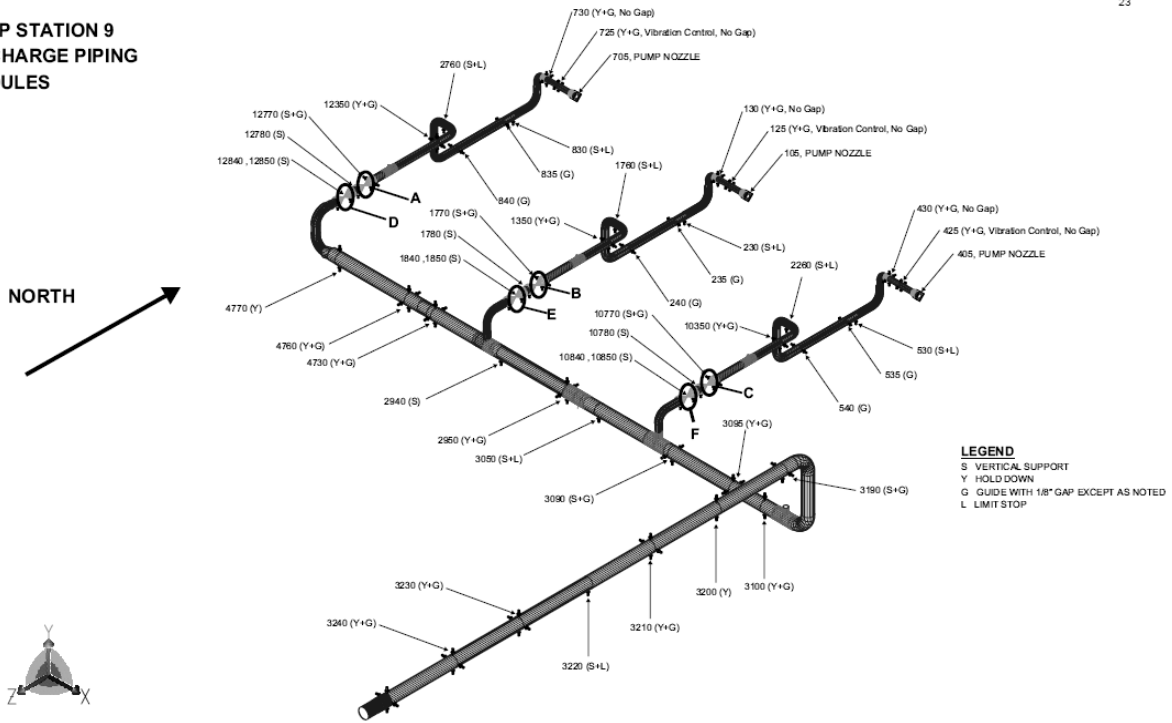
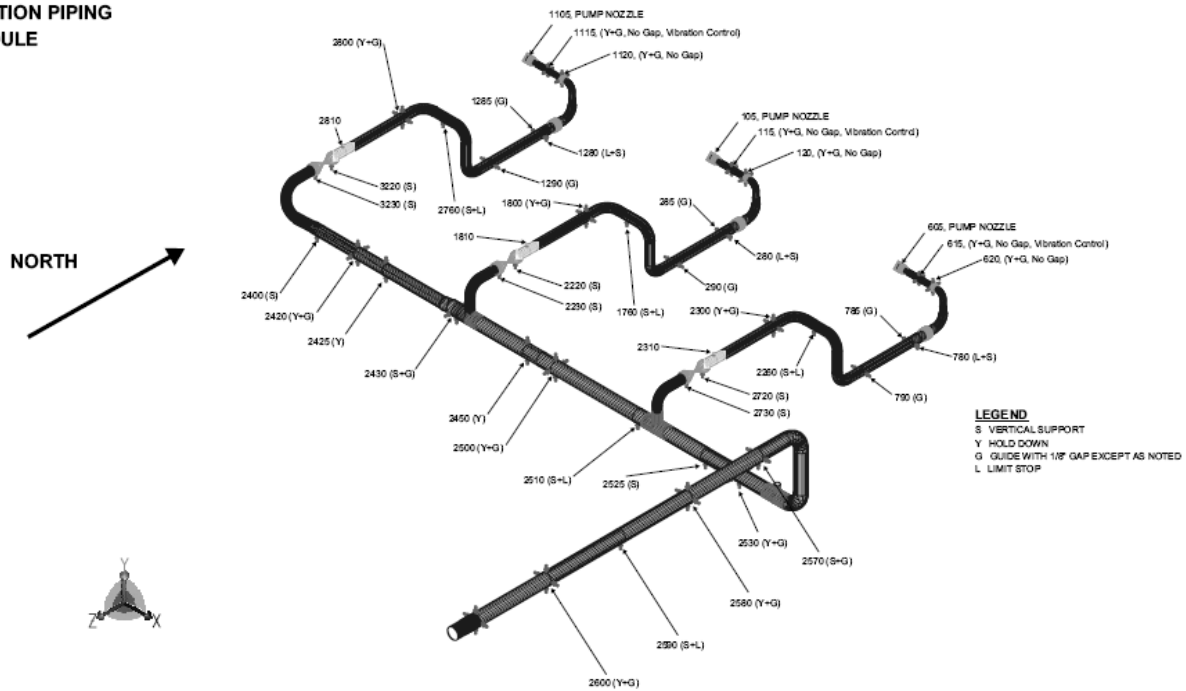
**Figure 11 The piping system of PS09 and the associated piping constraints locations**

- (1) In EDI modal analyses, I would like clarification on whether the piping constraints (shown in Fig. 11) in both suction and discharge lines were properly implemented and taken into account in the modal analyses. Also what was the damping ratio of piping used in this analysis?

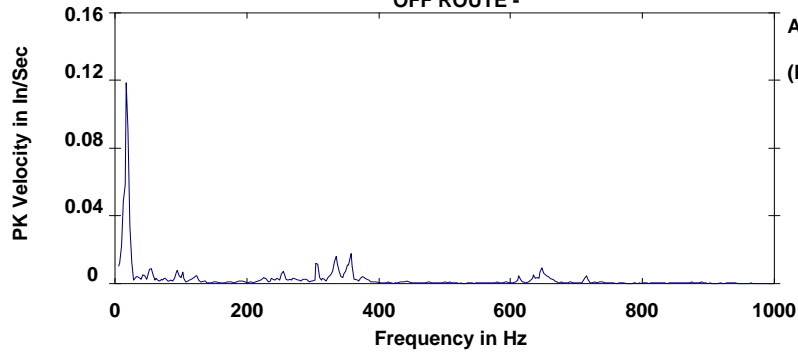
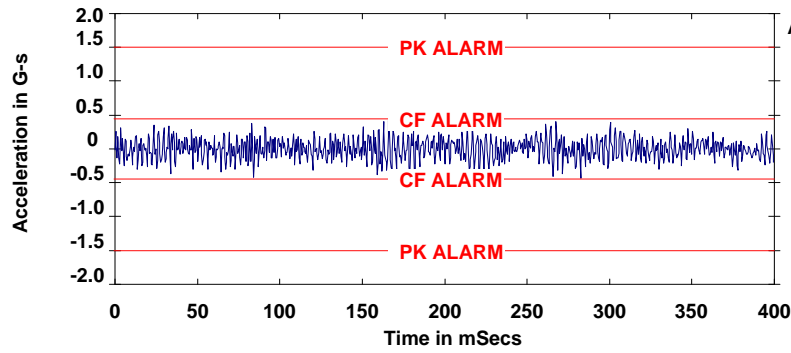
# Discharge Ring Anchor- 1<sup>st</sup> Anchor Downstream-Axial

Analyze Spectrum  
19-Sep-07 13:27:12  
(Peak Hold)  
PK = .1499  
LOAD = 100.0  
RPM = 3243. (54.04 Hz)

Analyze Waveform  
19-Sep-07 13:27:12  
RMS = .1479  
PK(+/-) = .4204/.4271  
CRESTF= 2.89

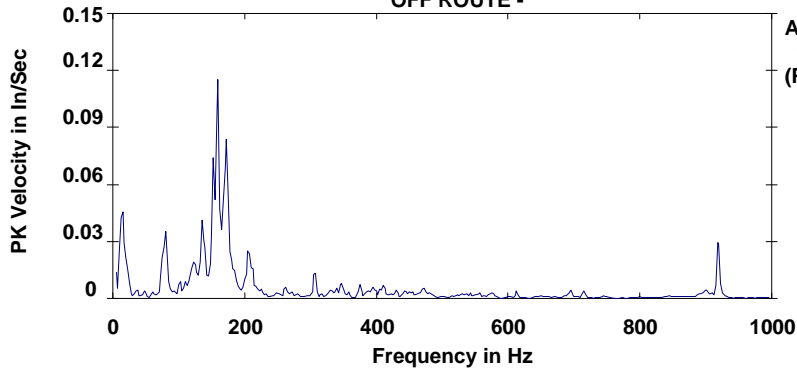
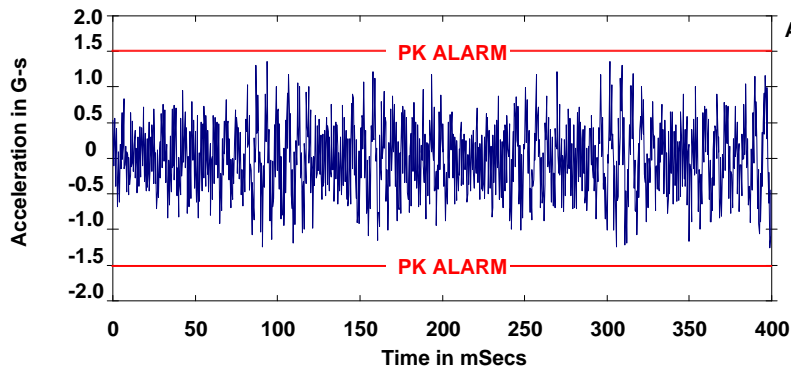
# Cantilever frame brace

Analyze Spectrum  
19-Sep-07 13:39:24  
(Peak Hold)  
PK = .2254  
LOAD = 100.0  
RPM = 3434. (57.23 Hz)

Analyze Waveform  
19-Sep-07 13:39:24  
RMS = .5054  
PK(+/-) = 1.37/1.26  
CRESTF= 2.70

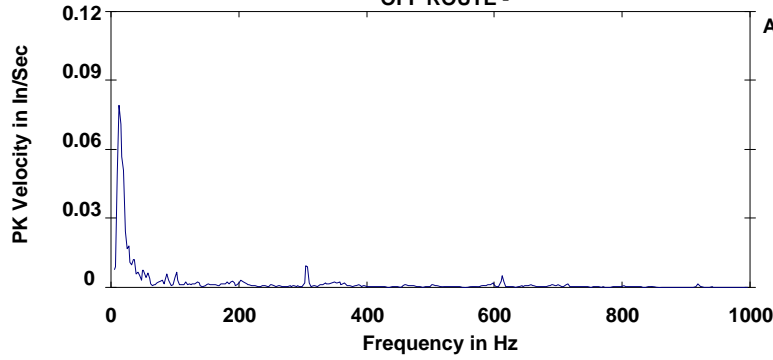
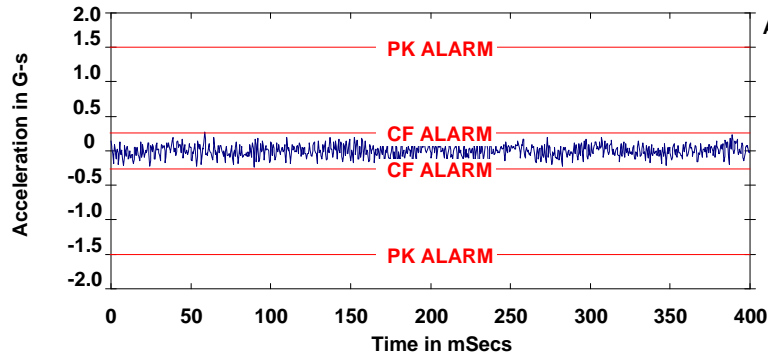
# Suction Line at Ring Anchor-Vert

Analyze Spectrum  
19-Sep-07 13:44:18  
PK = .1221  
LOAD = 100.0  
RPM = 3673. (61.21 Hz)

Analyze Waveform  
19-Sep-07 13:44:18  
RMS = .0867  
PK(+/-) = .2758/.3100  
CRESTF= 3.58

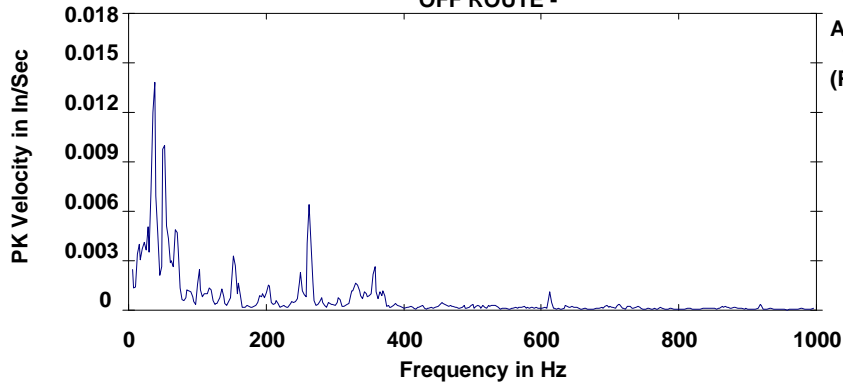
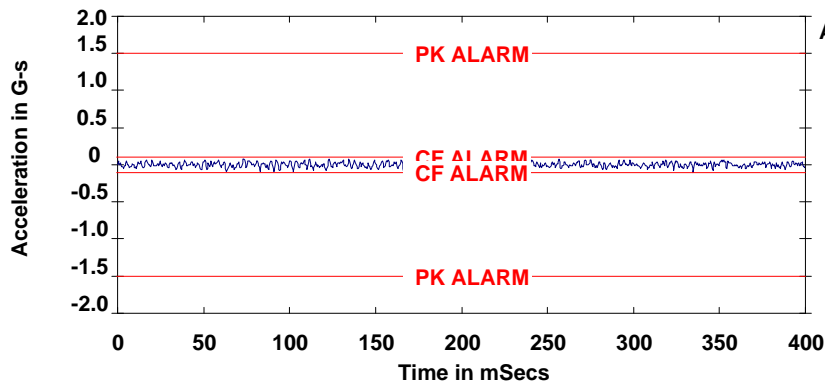
Module-NE Corner Main I-Beam-Vert

Analyze Spectrum  
19-Sep-07 14:26:19  
(Peak Hold)  
PK = .0274  
LOAD = 100.0  
RPM = 3600. (60.00 Hz)

Analyze Waveform  
19-Sep-07 14:26:19  
RMS = .0330  
PK(+/-) = .0814/.1013  
CRESTF= 3.07

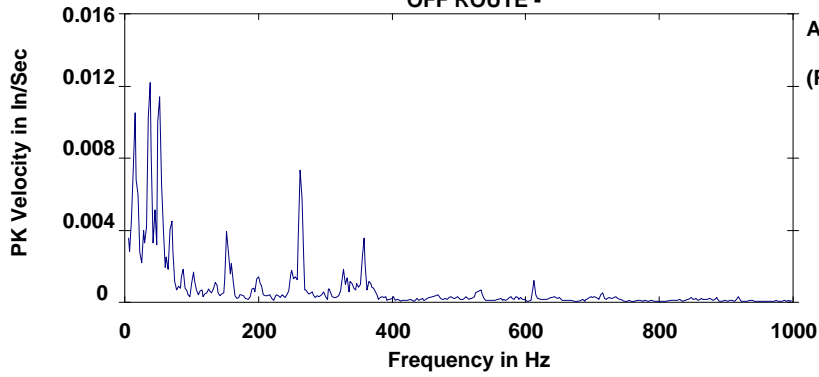
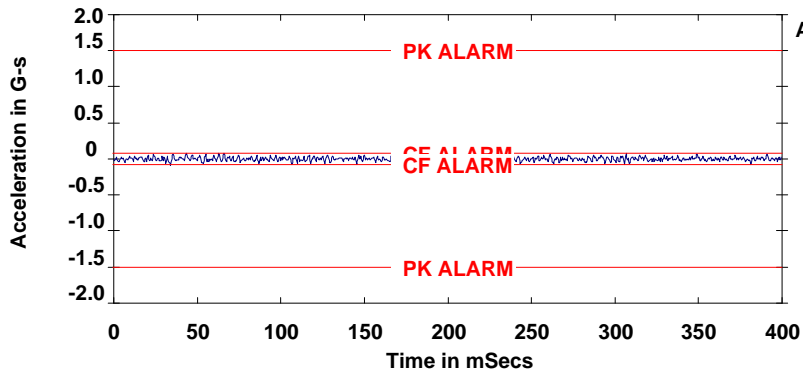
Module-NE Corner Main I-Beam-Horiz-Vert  
TRBL - OFF ROUTE EQUIPMENT  
OFF ROUTE -

Analyze Spectrum  
19-Sep-07 14:27:02  
(Peak Hold)  
PK = .0294  
LOAD = 100.0  
RPM = 3800. (63.33 Hz)

Analyze Waveform  
19-Sep-07 14:27:02  
RMS = .0279  
PK(+/-) = .0772/.0853  
CRESTF= 3.05

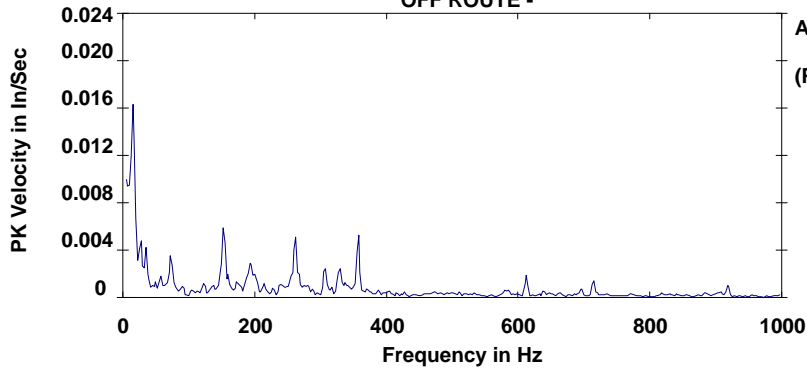
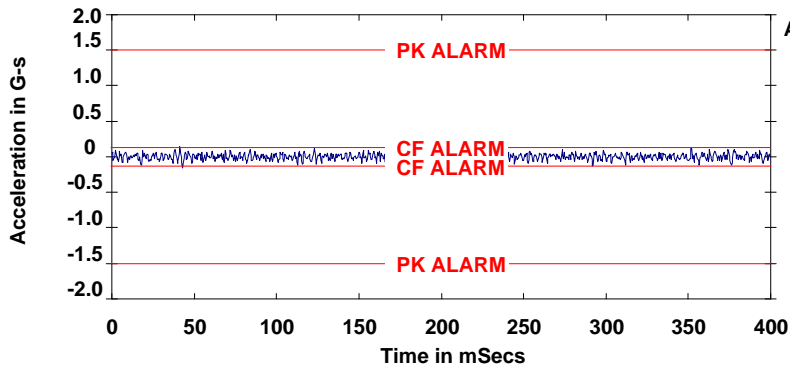
Module-NE Corner Main I-Beam-Horiz-N-S

Analyze Spectrum  
19-Sep-07 14:27:53  
(Peak Hold)  
PK = .0301  
LOAD = 100.0  
RPM = 3948. (65.80 Hz)

Analyze Waveform  
19-Sep-07 14:27:53  
RMS = .0444  
PK(+/-) = .1481/.1542  
CRESTF= 3.47
