SEISMIC DAMAGE MECHANISMS FOR CHURCHES AND DAMAGE SEQUENCE: CONSIDERATIONS FROM A CASE STUDY

4.1 The church of San Bartolomeo at Quistello

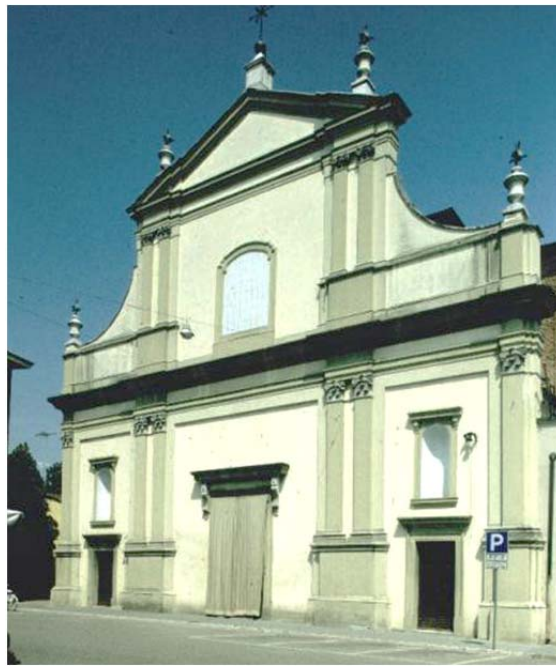
Figure 3: The church of San Bartolomeo Apostolo at Quistello

The church of San Bartolomeo at Quistello has been chosen for a study because it is representative of many similar assets both in terms of architectural characteristics and of extension and type of suffered damage. The façade before the earthquake is shown in fig. 3. Each space defined in the plan is covered by vaults, separated by arches, and by a dome at the midplan, in a complex pattern shown in fig. 4.

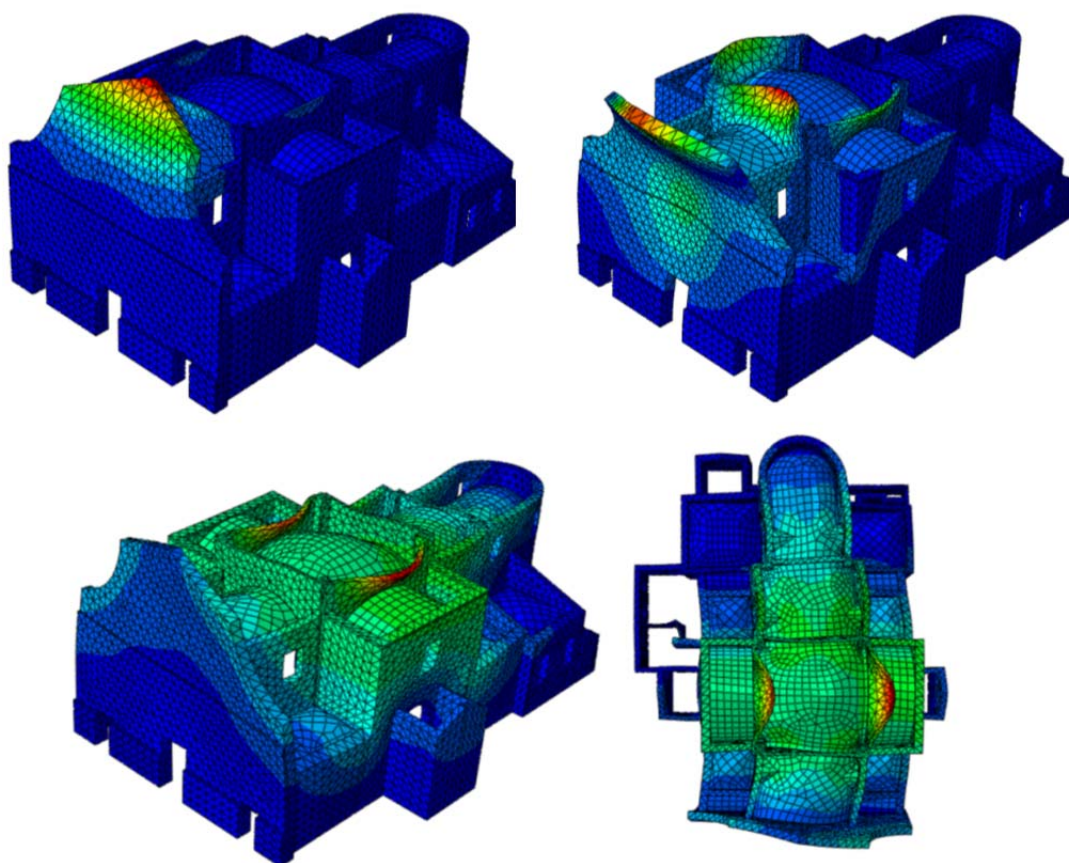
Figure 9: first and third modal shape (top) and second modal shape with two views (bottom)

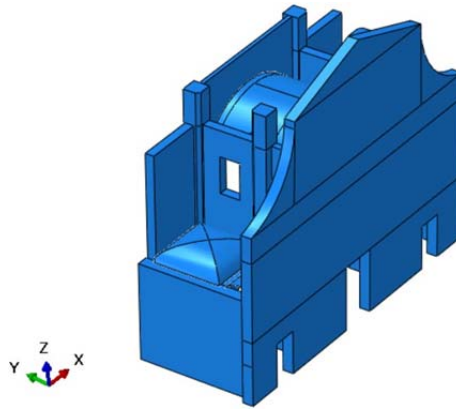
Figure 12: reduced model for nonlinear analysis

In order to adopt a reduced but significant model, extension and boundary conditions of the reduced models have been based on a calibration comparing periods and modes of the reduced part with the full model. The final simplified model, shown in fig. 12, had 31336 finite elements, which made computations still demanding but feasible on a high capacity computer.
