Aznalcóllar dam failure. Part 2: Stability conditions and failure mechanism

A. GENS* and E. E. ALONSO*

KEYWORDS: clays; dams; plasticity; pore pressure

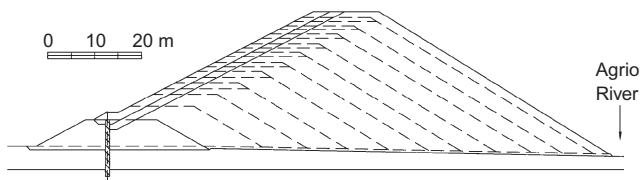
Fig. 1. Original dam design

The dam was initially designed in 1978. A representative cross-section of the initial design is shown in Fig. 1. A small upstream embankment is first constructed. Then a bentonite-cement wall, which penetrates into the blue clay, is built to provide an impervious barrier. The dam was to be built in phases of increasing height, advancing in the downstream direction. The structure is actually a rockfill dam with an upstream impervious blanket of low-plasticity red clay. This blanket is connected with the vertical cement-bentonite upstream diaphragm wall. Upstream and downstream slopes

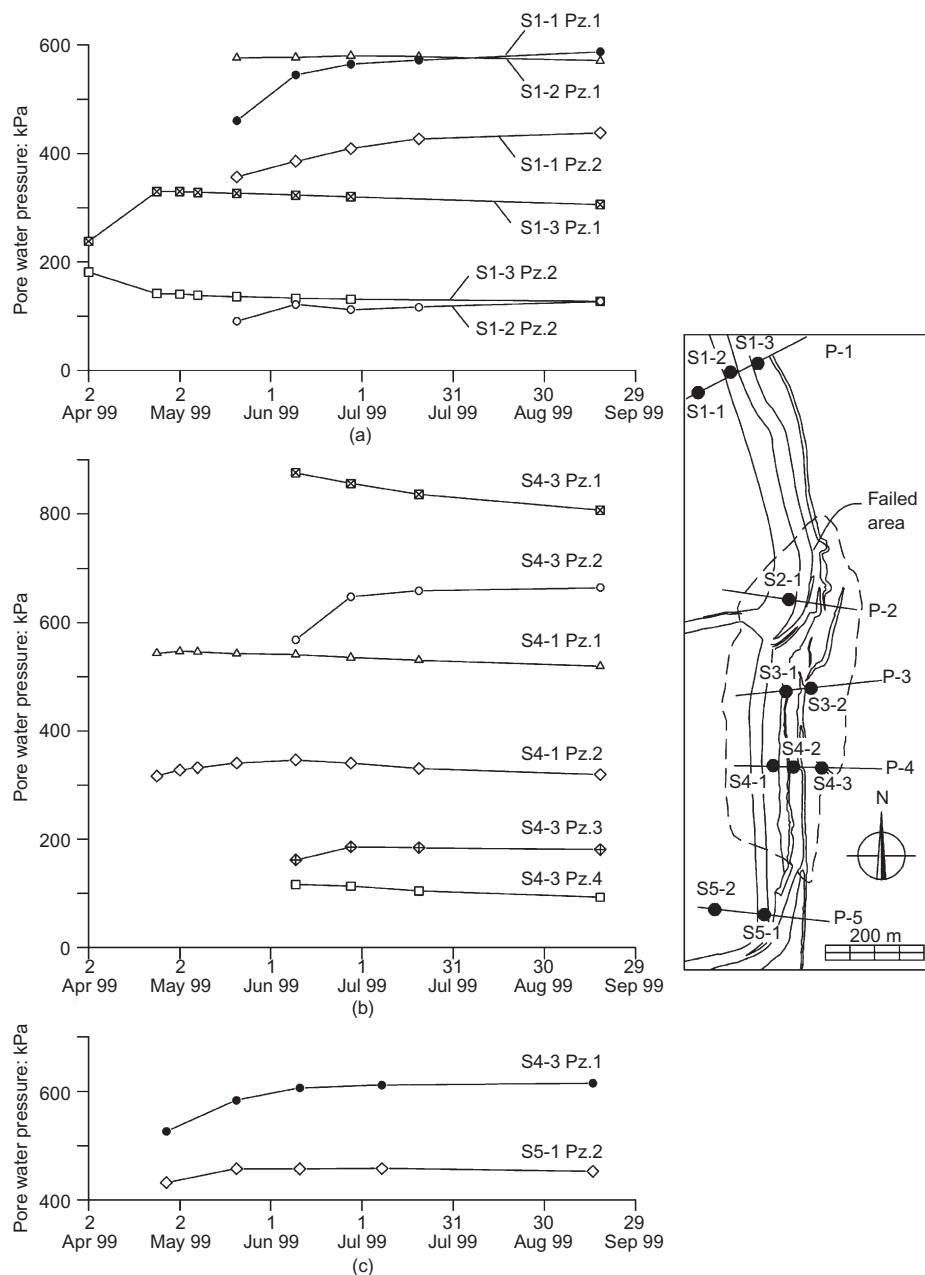
Fig. 4. Evolution of pore water pressure in piezometers located at different depths in boreholes corresponding to: (a) Profile 1; (b) Profile 4; (c) Profile 5

Fifteen vibrating wire piezometers were installed in boreholes drilled after the failure. Readings started in April–May 1999 and rapid equilibration, in general, followed (Fig. 4). Piezometer sensors were located in 1 m long sections of the corresponding boreholes, filled with saturated sand. The

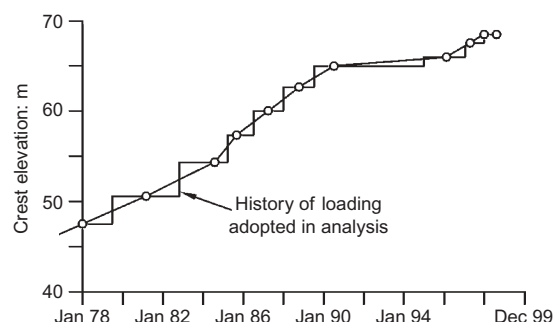
Fig. 7. History of dam construction in terms of elevation of crest and incremental sequence used in calculations

Figure 7 shows the evolution of the embankment at the failed section and the sequence of loading increments adopted in the calculations. The same history of dam elevation applies, with minor variations, to Profile 1, within the unfailed embankment, north of the breach. Data in Figs 3 and 7 define the developing geometry of the embankment from January 1978 to the time of failure, in April 1998. The level of tailings followed the embankment height, the level

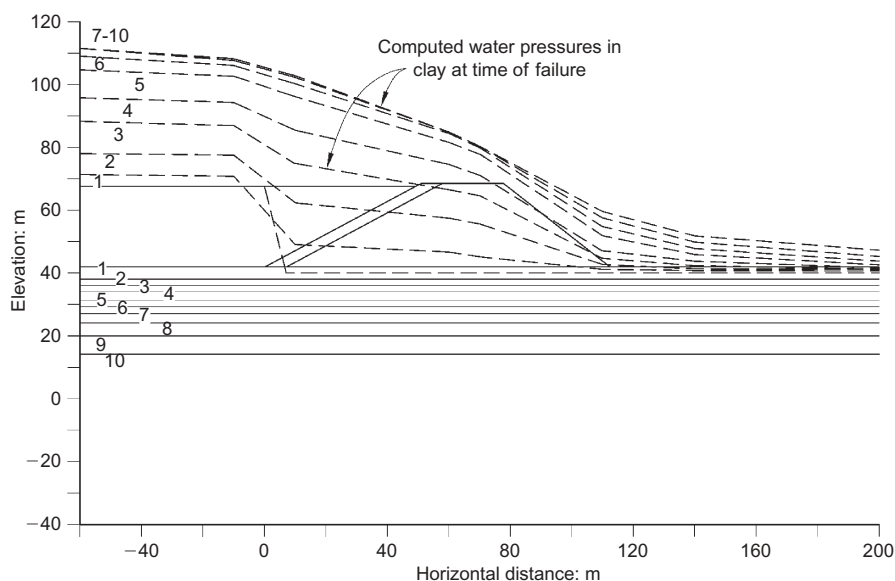
Fig. 12. Embankment geometry and pore water pressures used in limit equilibrium calculations

It is interesting to realise that the minimum safety factor is not achieved at the time of failure but at an earlier time, when the embankment had a height of about 21 m, around 1988, just before the large increment of width shown in Fig. 3. An equivalent result is obtained if one examines the friction angles for equilibrium, also shown in Table 3. These results may seem surprising. They indicate that, given a

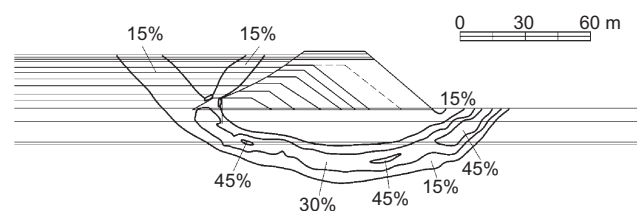
**Fig. 13. Contours of equal shear strain calculated at failure in a 2-D elasto-plastic finite element analysis: homogeneous clay****Table 3. Stability for intermediate phases of dam construction**

If peak strength parameters are adopted for the clay ($c' = 64$ kPa; $\phi' = 24^\circ$) no plastic points are calculated for the future rupture zone during the whole construction process. It is concluded that, in order to explain the embankment failure, some zones within the clay exhibited reduced strengths. In order to simulate a failure, a progressive reduction of strength parameters is introduced. In this way, the rupture mechanism shown in Fig. 13 is found (contours of equal shear strains are represented). A circular failure is predicted (as in the limit equilibrium type of analysis for homogeneous clay properties).

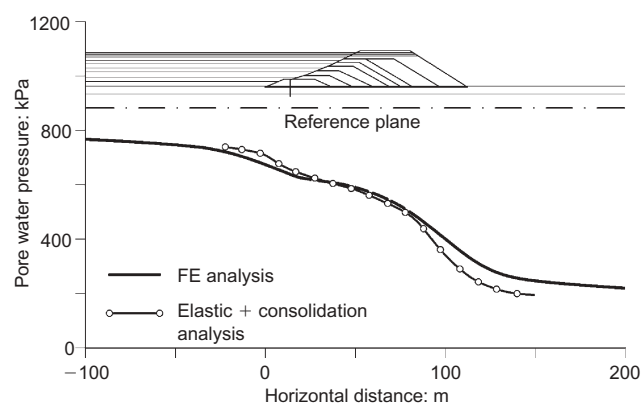
Fig. 15. Distribution of pore water pressures along failure surface (reference plane): comparison of FE and simplified elastic-consolidation analysis

This FE analysis also provided data relating to the evolution of pore water pressures in the foundation. Fig. 14 shows the distribution of pressures at the end of the calculation (just prior to rupture). Note the substantial influence of the heavy tailings and the very limited dissipation of pore pressures. A profile of water pressures along the future failure plane is shown in Fig. 15. The FE prediction is compared with the result of the elastic-consolidation analysis reported before. The correspondence is very good.

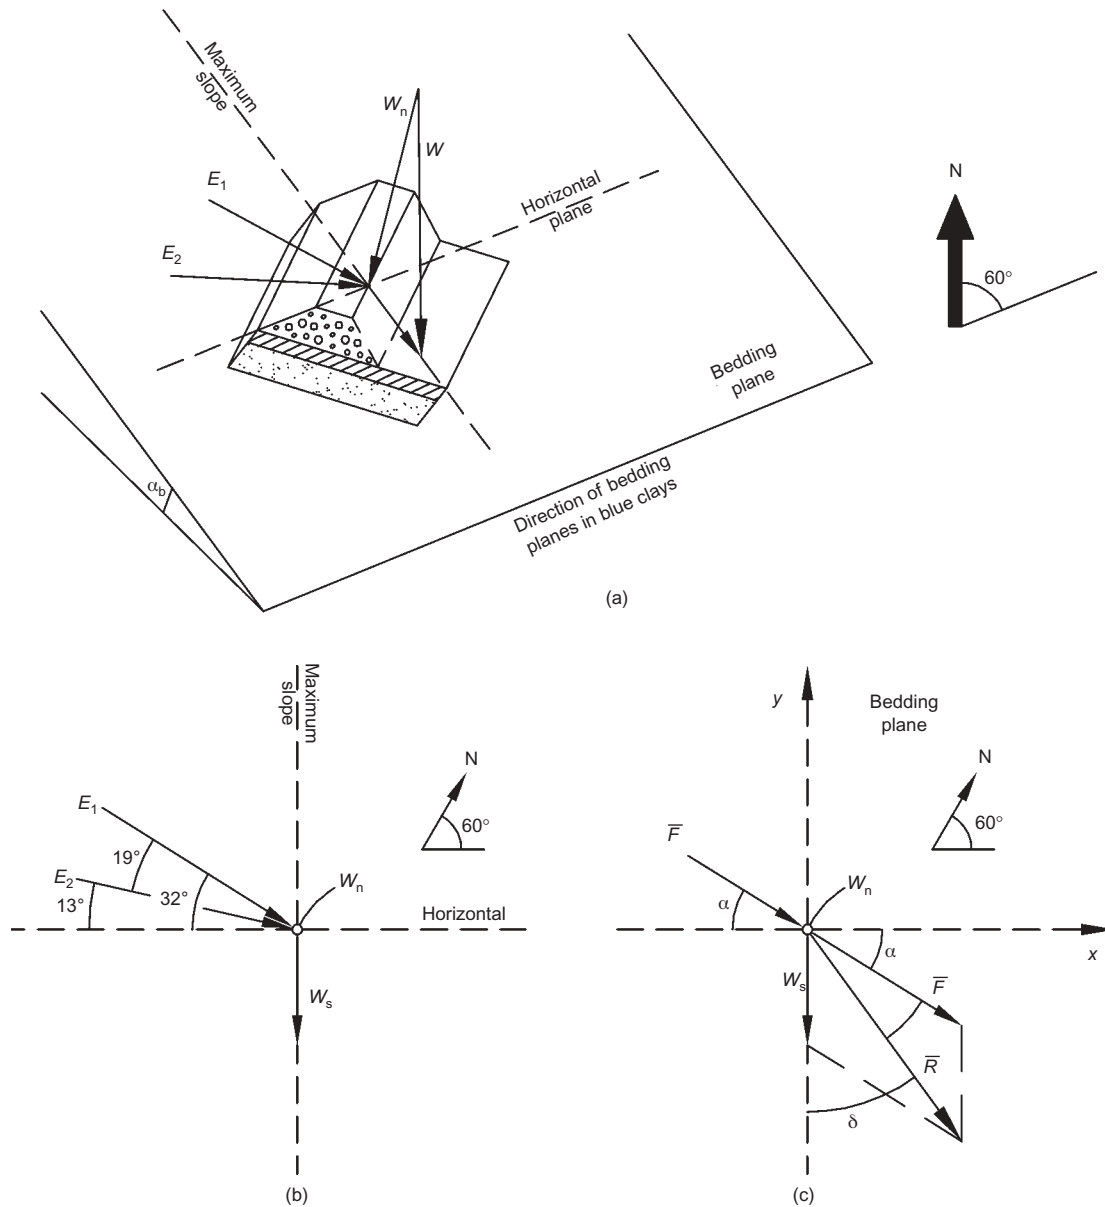
Fig. 19. (a) Three-dimensional scheme of slice of embankment sliding on a bedding plane; (b) forces acting on slice; (c) resultant force

These effects are analysed using a simple three-dimensional interpretation of the slide. Consider in Fig. 19 a free body diagram showing a slice of the failed embankment sliding on the critical bedding plane. The following reference axes need to be considered: the apparent dip of 0° ; the true dip; and the normal to the bedding plane. The external acting forces controlling the stability are also shown: the weight, \bar{W} , of the embankment (and the moving foundation soil) and the tailings' thrust (\bar{E}_1 or \bar{E}_2). \bar{W} has two components, \bar{W}_n and \bar{W}_s , in the normal and tangential direction to the bedding planes. \bar{E}_1 corresponds to the southern basin, whereas \bar{E}_2 is the thrust direction in the northern lagoon. In both cases they are assumed to be normal to the embankment direction and parallel to the bedding planes. These forces are plotted in Fig. 19(b). If the resistance offered by the sliding plane is purely frictional (friction angle ϕ'), equilibrium in the sliding plane requires

The direction of the motion may be also obtained. In equilibrium, and given that the sliding mechanism is purely frictional, the motion direction will follow the resultant disturbing force: $\bar{R} = \bar{F} + \bar{W}_s$. The sliding direction is indicated, in Fig. 19, by angle δ .

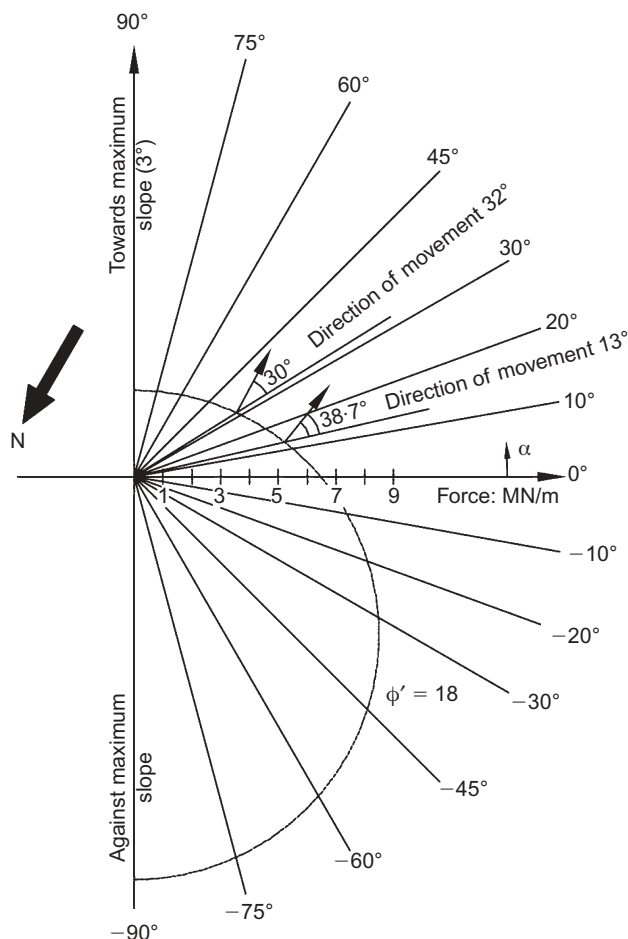
Fig. 20. Polar force diagram for equilibrium conditions

Equation (3) has been plotted in Fig. 20 as a polar diagram showing the variation of the force F in equilibrium as a function of the direction of the force, defined by α . The remaining variables in equation (3) (weight W , dip of strata $\alpha_b = 3^\circ$, water pressure resultant U , and friction angle $\phi' = 11^\circ$) are known. Two directions are particularly relevant in Fig. 20: $\alpha = 13^\circ$, representative of the northern embank-

ment; and $\alpha = 32^\circ$ for the southern basin. The corresponding forces for equilibrium are 5.27 MN/m and 4.11 MN/m respectively. In other words, if the tailings lagoon is pushing the embankment with an overall force of 4.11 MN/m, the southern embankment becomes unstable, whereas the northern embankment still has a 'safety factor' of 1.28 against sliding. This result makes it very unlikely that the northern embankment could have failed first. The displacement vectors, once sliding is initiated, are also plotted in Fig. 20. Note that they do not follow the direction of thrust but are directed towards the true dip direction of clay layers. This is consistent with observations of the sliding direction of the failed embankment. The force diagram plotted in Fig. 20 may also be interpreted as the macro yield locus for the sliding of the embankment on an inclined plane. The radius of the circle is the frictional resistance $(W - U)\tan\phi'$. The yield circle is defined by displacing the purely frictional circle, valid for a horizontal plane, a distance $W\sin\alpha_b$ in the direction of the maximum slope of the clay strata. In other words, the inclination of the strata results in a kinematic hardening in the direction of their maximum slope. The

sliding direction is normal to the yield locus defined in this way, as shown also in Fig. 20.

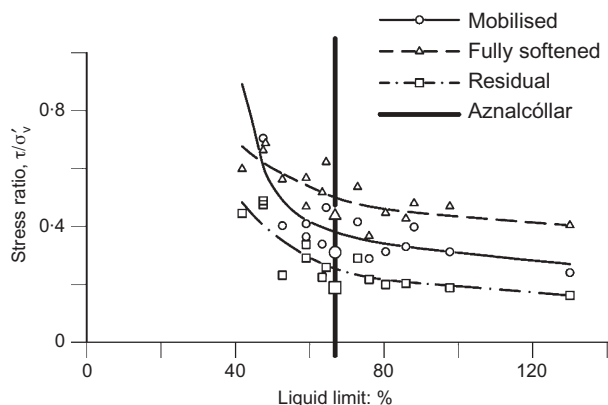
Fig. 21. Mobilised, fully softened and residual stress ratio for field case histories (Stark & Eid, 1994). Also plotted are calculated values for Aznalcóllar failure

Stark & Eid (1994) reviewed case histories involving first-time slides in stiff fissured clays, reported the value of the mobilised strength at failure, and compared it with two strength values: the fully softened and the residual value. Such a comparison is shown in Fig. 21. It can be seen that in most instances the mobilised strength at failure lies about midway between the 'fully softened strength' and the residual strength.

The results obtained for the Aznalcóllar embankment yield a value of R approximately equal to 0.76 if the peak strength of the intact material is considered. However, if the failure initiated along a bedding plane, the post rupture strength may be more relevant as the initial strength of the material. In that case, the mobilised friction angle ($\phi'_{\text{mob}} = 17^\circ$) lies approximately half way between the post-rupture friction value ($\phi'_p = 24.1^\circ$) and the residual value ($\phi'_r = 11^\circ$). Therefore the value of R is 0.46. The post-rupture, mobilised and residual stress ratios have also been plotted in the graph published by Stark & Eid (1994) in Fig. 21, for the corresponding liquid limit of the Guadalquivir blue clay (identifying for this purpose post-rupture strength with fully softened strength). One should be careful, however, in accepting it as a well-established fact that this average can be used in design, as a number of case-specific factors, already mentioned, control the development of progressive failure.
