Relationships between Outside and Interior Appearance Inspection and Actual Bio-Deterioration of Structural Members in Existing Wood Houses

Keywords: *Appearance Inspection, Degradation, Bio-Deterioration, Used Wood House.*

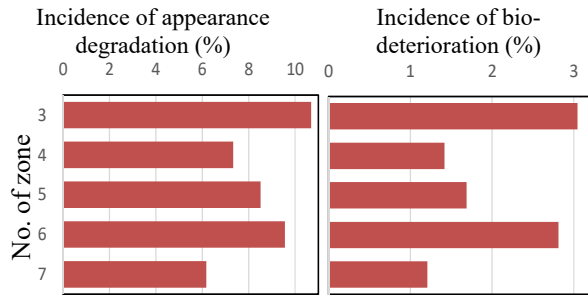
Figure 3. Incidence of the appearance degradation (left) and the bio-deterioration (right) for each building location.

All of the 103 houses had the degradation in appearance, and 97 houses had the bio-degradation. Out of 65,000 segments, the appearance degradation was found in 5,667 segments, corresponding to 8.7 %, and the bio-deterioration of the structural members was found in 1,421 segments, corresponding to 2.2 %. In other words, most existing wood houses have the bio-deterioration of structural members, but their range is generally limited. Figure 2 and 3 shows the frequency of the appearance degradation and the bio-deterioration of the structural members for each building age and each construction area, respectively. The incidence of the appearance degradation and the bio-deterioration increased with older building age, except for over 50 years whose sample was very few. The incidence of them was lowest in zone No. 7 with high temperature and humidity. In others, the incidence increased in warmer zone, except for zone No. 3 where the sample was very small.

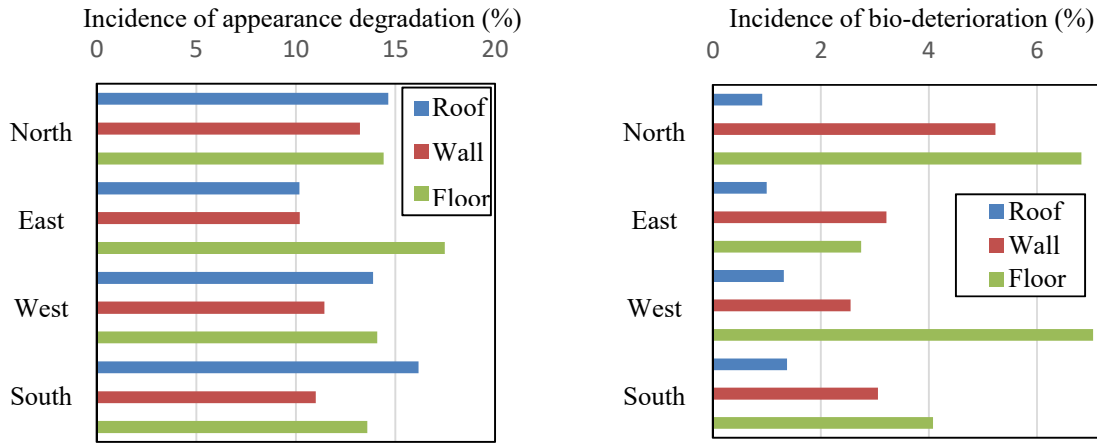
Figure 6. Relationships between the incidence of the appearance degradation (left) and the bio-deterioration (right) and the orientation of the segments.

Figure 6 shows the effect of the segment orientation on the incidence of the appearance degradation and the bio-deterioration of the structural members. The orientation of the segments

had no obvious effect on the incidence of them.
