Earth Construction Durability: In-Service Deterioration of Compressed and Stabilized Earth Block (CSEB) Housing in Algeria

Abstract. *The present work deals with a unique in-service valuation of CSEB structures in Algeria. The inspection tries to bring out the impact of long time exposure under different and opposite climate and micro-seismic contexts. The diagnosis methodology is inspired by the approach largely adopted for the rehabilitation of traditional architecture. It involves the compilation of the previous survey reports, visual inspection of the structures, in-situ and laboratory tests to assess the residual CSEB mechanical properties. The CSEB constructions are located in the coastal north and the desertical south part of Algeria and were exposed respectively to a long-term Mediterranean and Saharian climate. The results of the investigation show that the CSEB in the construction located in the northern region is increasingly altered by the humidity. As the relative humidity rises, the fouling layers grow over some level. The surface pitting which is the consequence of long exposure to the wetting/drying cycles is also observed. The outer surfaces of the walls were hone

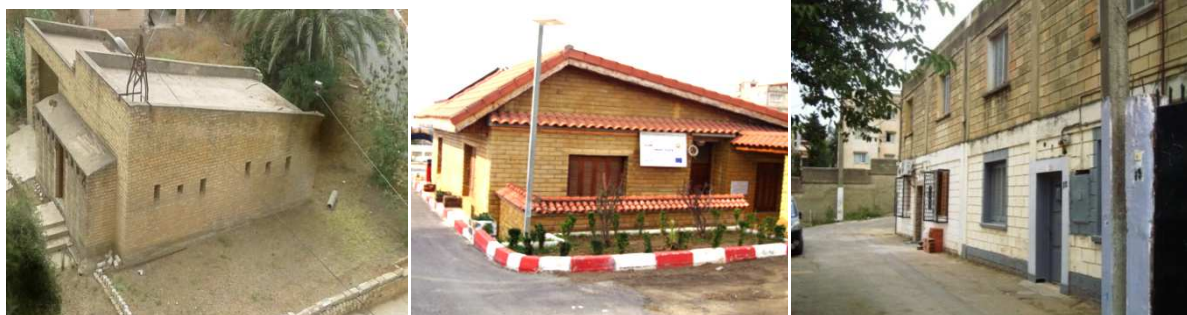
Figure 2. Load bearing soil–cement block residential building in the northern region.

The buildings are ground dwellings except in one residential site situated in the north region (see figure 2.c). The stabilisation of the earth blocs are both chemical and mechanical. The portion of cement exceeds 7 % and could be in some places more than 10 %. The second stage of stabilisation relies on reducing the pores volume by applying a compactive effort with at least 7 MPa of stress, using as a matter of fact a manual or a hydraulic semi-automatic press. This moulding pressure raises the bulk density of the block as it improves the block performance against the water runoff erosion phenomenon. The cure process involves a storage of the blocks under roofing or hat for 28 days. It requires also a light watering for a week with a wrap. The dimensions of the blocks used in these constructions are different from one site to another. For instance, the dimensions of the blocks manufactured and used to build the first bioclimatic prototype at Souidania in 1984 (Algiers, figure 2.a) are 250 mm in length, 125 mm in width and 70 mm in height. In 2007, blocks with the dimensions of 295 mm in length, 140 mm in width and 90 mm in height were prepared to construct the second bioclimatic prototype (figure 2.b). Over all the surveyed houses, the earth blocks are entire except in the site of Beni Messous where compressed earth hollow blocks were used.

a) Bioclimatic prototype
Souidania (1984, Algiers)

b) Bioclimatic prototype
Souidania (2007, Algiers)

c) Houses at Beni Messous
(1987, Algiers)
